List of issues to be investigated

List of issues

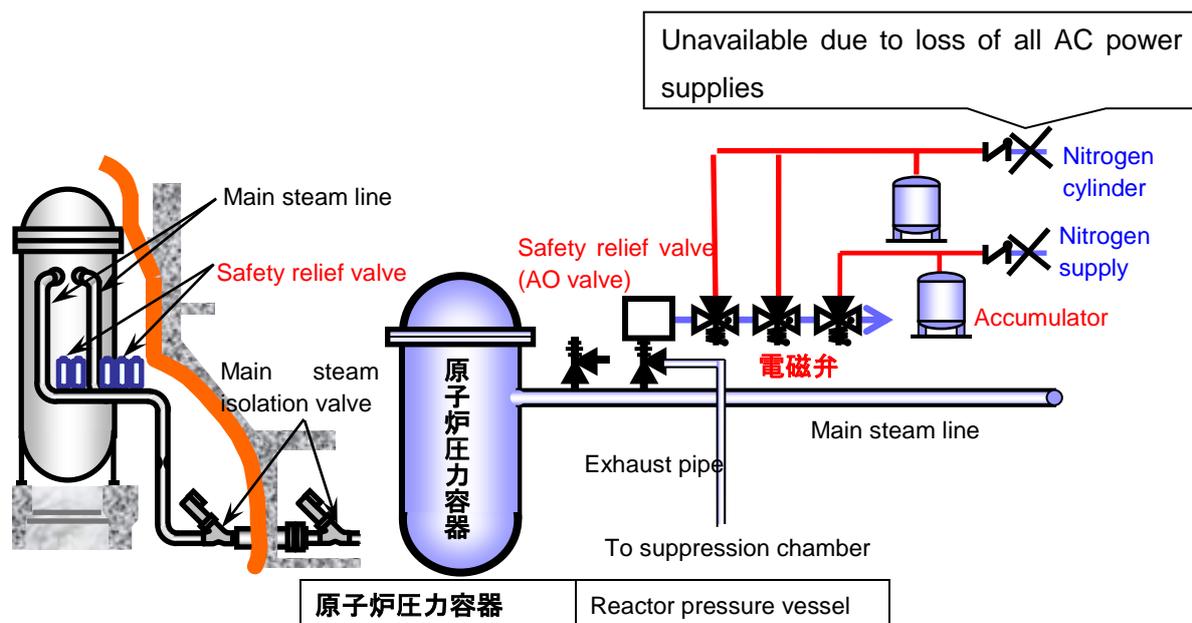
Figure Schematics of the main steam safety relief valves.

For example, at Unit-3, the SRV opening operation was attempted from the main control room (MCR) control panel after the HPCI had been manually shutdown at 02:42 on March 13, but no response was observed in the reactor pressure. Therefore, the operators recognized that the SRVs had not worked.

Possible causes of SRV failure to function may include insufficient pressure of driving nitrogen gas and the insufficient voltage to activate motor-operated valves. But other relevant matters, such as the SRV opening/closing operation after core damage or reactor pressure changes, are also to be examined in order to clarify the causes why the SRVs did not function, because there is not enough knowledge on the SRV functionality under severe accident conditions.

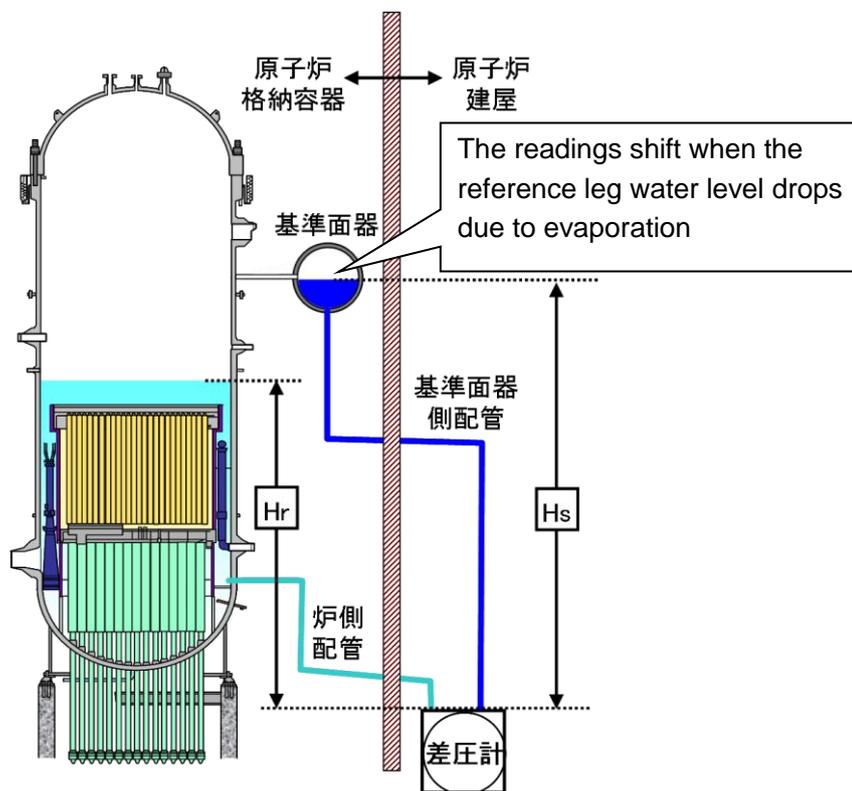
At Unit-1, the reactor water level could not be temporarily measured after the station blackout caused by the tsunami. When the reactor water level indicators were restored by temporary battery supplies at 21:19 on March 11th, the water level indicators showed an increase despite the fact that no water was being injected into the reactor. In view of the measurement principle of water level indicators, the apparent increase of the water level is considered to be due to incorrect readings caused by water evaporation in the reference leg (piping on the reference water level side) of the water level indicators. Ultimately it is considered that Unit-2 and Unit-3 also experienced similar incorrect readings of the water level indicators.

Examination is to be done to clarify when and why the water level indicators began to give incorrect readings, because it may provide some clues to estimate the reactor situations at those times.

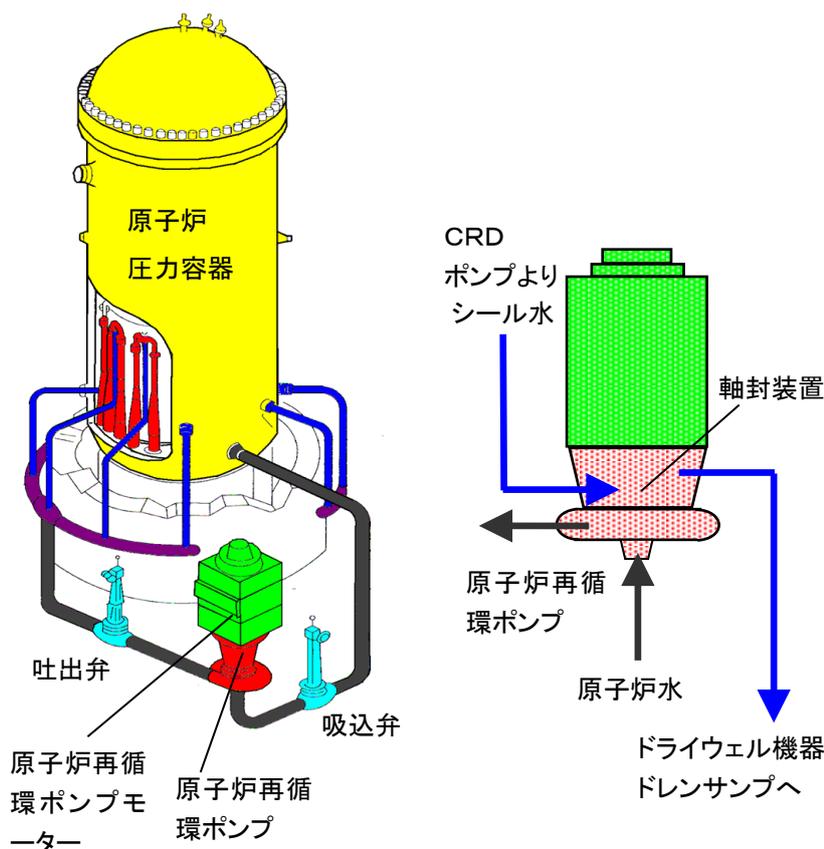
Figure Illustration of PLR pumps

Mechanical seals are mounted on the primary loop recirculation (PLR) pumps as the shaft seal. During normal operations, sealing water for the shaft seals provided from the control rod drive (CRD) pumps prevents reactor water from leaking. When the external power supply is lost, CRD pumps are shut down and sealing water is lost from the CRD pumps; then the high pressure reactor water is discharged to the drywell (D/W) equipment drain sump via the PLR pump shafts and shaft seals.

As a matter of fact, at Unit-4 of the Fukushima Daini NPS, which did not need to run the D/W spray, it was found during a post-earthquake patrol in the PCV that water had filled the pedestal, which had housed the equipment drain sump, and reached even the diaphragm floor (the D/W bottom floor). Water discharge from the equipment drain sump stopped after the earthquake. Therefore, it is highly possible that this water was the leaked water from the reactor via the PLR pump shafts

As long as the mechanical seals are not damaged, the water leak from the reactor is expected to be below the design leak rate and has little impact on the reactor behavior. But, if the seal functions were lost in the process of accident progression, as O-ring damage for instance, the leak rate might have increased. It is necessary to clarify whether leaks actually occurred which might have influenced the reactor water levels, and the PCV temperatures, pressures and water levels.

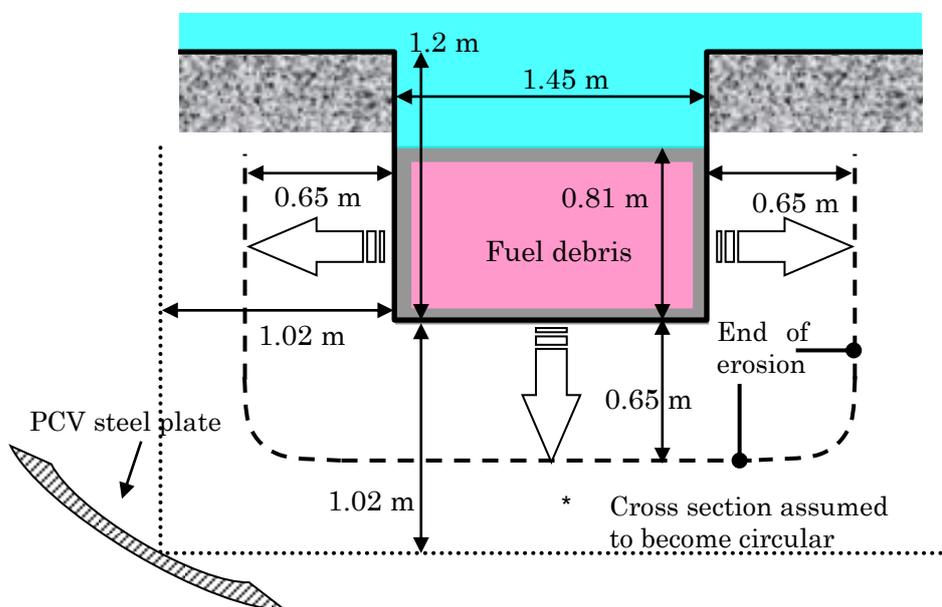
Figure Estimation of the scale of Unit-1 core-concrete reactions

TEPCO presented the analysis results of core-concrete reactions at Unit-1, which was thought to have had the largest fraction of fallen fuel debris to the PCV, in the Technical Workshop on “Estimation of the damage status of reactor cores of Fukushima Daiichi Units-1 to 3” (organized by the former NISA and held on November 30th, 2011).

There is also a possibility of shell attacks which could open leak paths from the PCV by direct contact of molten fuel and PCV liners. However, no clear evidence has been observed to date which supports the occurrence of shell attacks: the pressures increased at Units-1 and 2 when nitrogen gas started to fill the PCV, while at Unit-3 the PCV water level was sufficiently high to have prevented them.

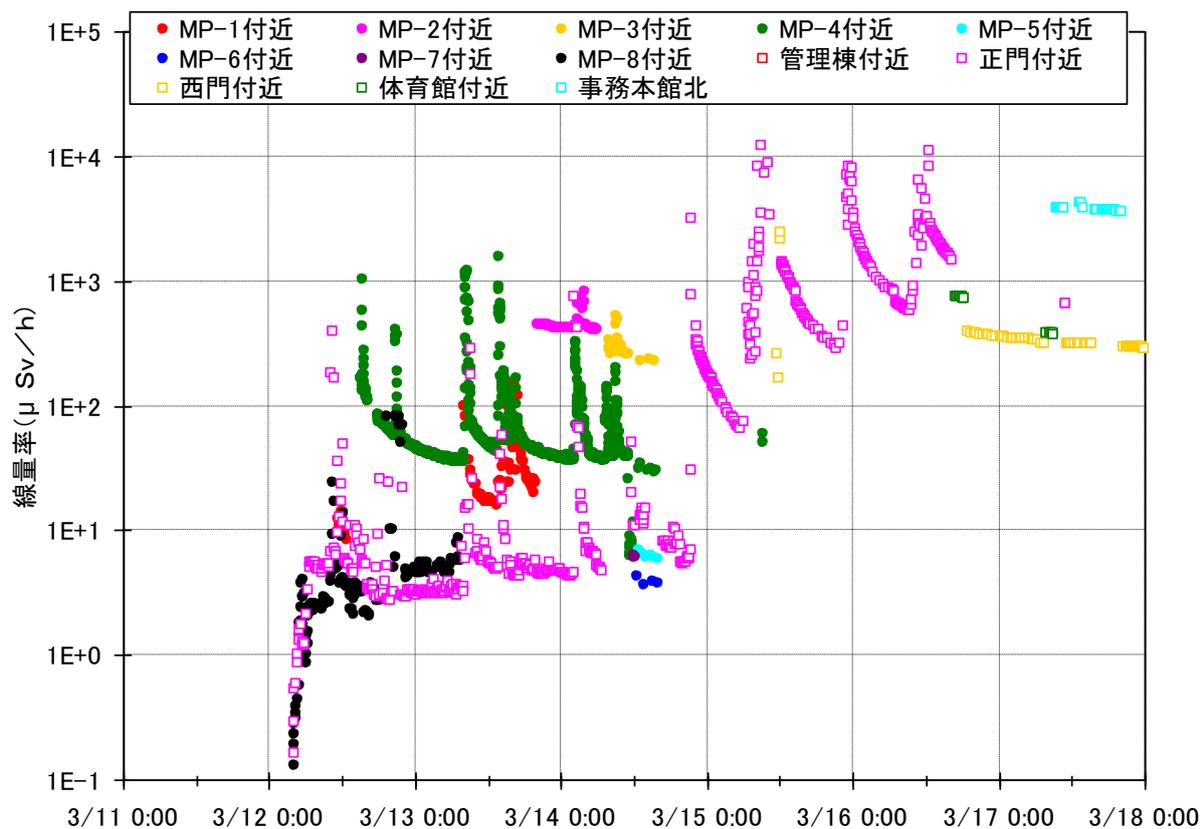
Figure Air dose rate changes on the site during March 11th to 18th.

Some of the radioactive materials released from the fuel during the accident progression were eventually released to the air via the PCV venting, the reactor building explosion, direct leaks from the PCV, etc. To date, TEPCO has been investigating the amount of radioactive materials released to the air per each main incident in the course of accident progression, and the reason of high contamination in the northwest area of the Fukushima Daiichi NPS. The investigations are based on the air dose rates observed by the monitoring cars and the meteorological data such as precipitation observed at a meteorological weather station

However, not every correlation is clear yet between the air dose rate changes measured on the site boundary measured by the monitoring cars, etc. and the radioactive materials release behavior from their origin. The air dose rates do not tell everything about the release situation from the origin of the radioactive materials but these rates provide information that is useful in interpreting the release conditions. The attenuation behavior of air dose rates may provide some information relevant to the contribution of deposits of radioactive materials released or their nuclear species.

In order to interpret the accident progression resulting in the release of radioactive materials, it is necessary to evaluate the air dose rate changes and the correlation of these rates with the timings, origin and paths of the radioactive materials released.

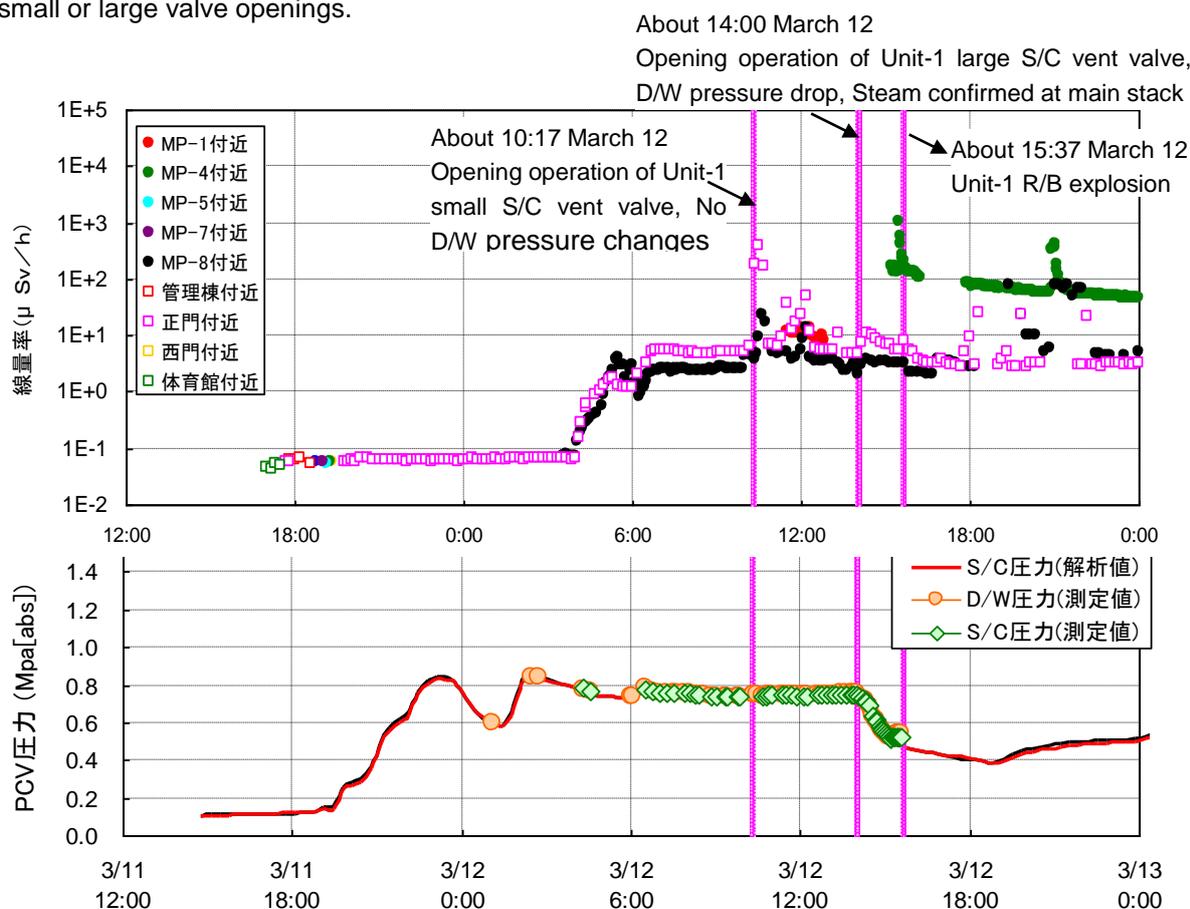
Figure Air dose rate changes from March 11th to 12th, and the changes of D/W and S/C pressures

At Unit-1, three attempts were made from the MCR to open the small S/C vent valve, at 10:17, 10:23 and 10:24 on March 12th. No clear decrease was noticed in the D/W pressures, but the air dose rates near the main gate showed a short increase at 10:40. Thereafter, a temporary air compressor was connected to open the large S/C vent valve and it was activated at about 14:00 on the same day. Steam exhaust from the stack was observed on the live camera monitor and the D/W pressure showed a decrease through 14:30 to about 14:50. At this timing, no increase was noticed in the air dose rates measured by the monitoring car near the main gate (southwest) and near Monitoring Point 8 (south).

As seen in these incidents, the D/W pressures and the air dose rates at the monitoring car occasionally responded to the S/C vent valve operations, but occasionally they did not. This may indicate a possibility that a small release of radioactive materials through the small vent valve, not sufficient to cause noticeable D/W pressure changes, might have occurred, or a possibility that a direct release to the air from the reactor building might have occurred. The opening of the small vent valve causes only a small vent flow rate change and the D/W pressure decrease may be too limited to notice. It is necessary to clarify the radioactive materials release behavior in detail upon PCV venting by the small or large valve openings.

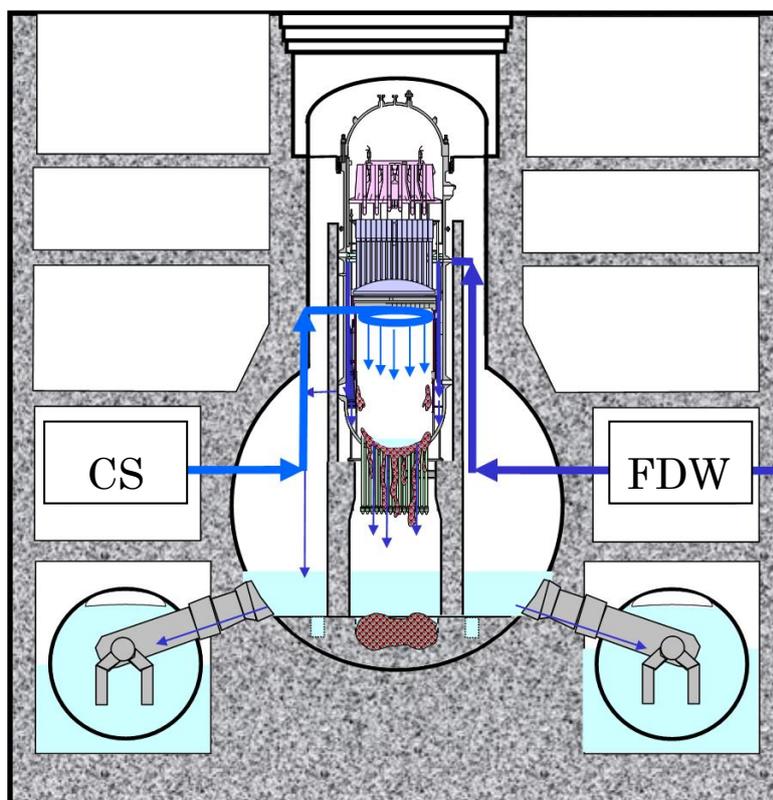
Figure Estimated conditions of the core and PCV of Unit-1

MAAP predicts that almost the whole Unit-1 core dropped to the RPV lower plenum and most of it fell further to the PCV pedestal, while the Unit-2 and Unit-3 cores remained in the core region, although there were partly molten fuel pools. Unit-1 lost all its existing water injection functions at an earlier stage and considerable time was taken to start water injection by fire engines. On the other hand, at Unit-2 and unit-3 the RCIC (Unit-2 and Unit-3) or HPCI (Unit-3) could continue injecting water to the reactor till a later stage. As a consequence, decay heat was lower when no more core cooling became possible by existing water injection means and less time was taken thereafter for the fire engines to start injecting water.

It should be noted, however, that MAAP analysis has uncertainties in setting its conditions, the analysis itself and the modeling. The results obtained have also uncertainties accordingly. MAAP predicts no RPV damage in Unit-2 and Unit-3, but the results depend greatly on the amounts of water injected to the reactor. As a matter of fact, the plant conditions thereafter indicate the reactor water levels were at very low levels and the RPVs are very likely to have been damaged. Further, core damage might have occurred even earlier at Unit-3 because the water injection by HPCI had been insufficient after the RPV pressure had decreased.

Currently, the location of debris, the ultimate result of the accident progression, is still unknown. It should be noted that the calculation results still have large uncertainties. Since this information is important input to decommission planning, further examinations are needed, based on the outcomes of the investigative research and development projects of the PCV and RPV, and other relevant projects.

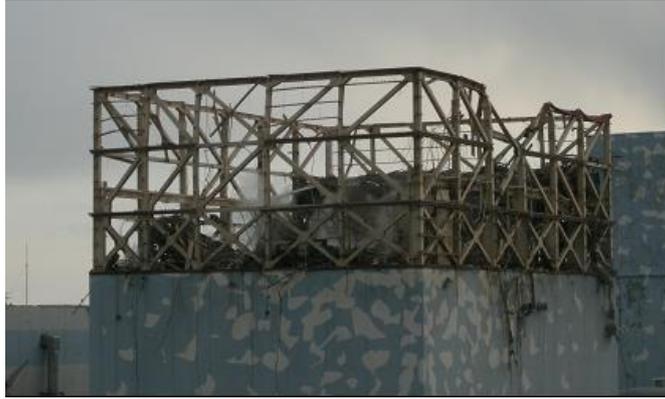
Figure Unit-1 reactor building after the hydrogen explosion

At Unit-1, the D/W pressure decrease was confirmed from 14:30 through around 14:50 on March 12th following the large S/C vent valve opening operation. At 15:36 on that day, hydrogen exploded in this reactor building and the roof and the outer walls of the top floor were heavily damaged.

These hydrogen explosions are considered to have been caused by hydrogen gas generated mainly by zirconium-water reactions which leaked out with steam to the reactor buildings. It is necessary to clarify the amounts of hydrogen gas generated and leak paths.

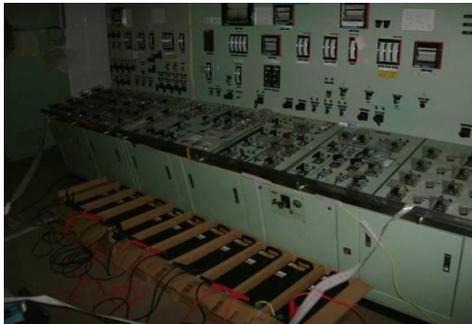
Connecting employees' private car batteries to power necessary instrumentations

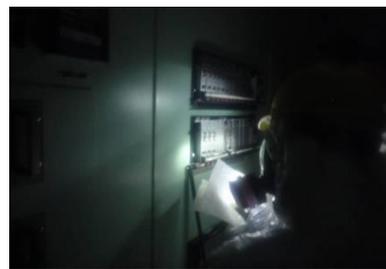
Indicator readings being checked with a flashlight in total darkness

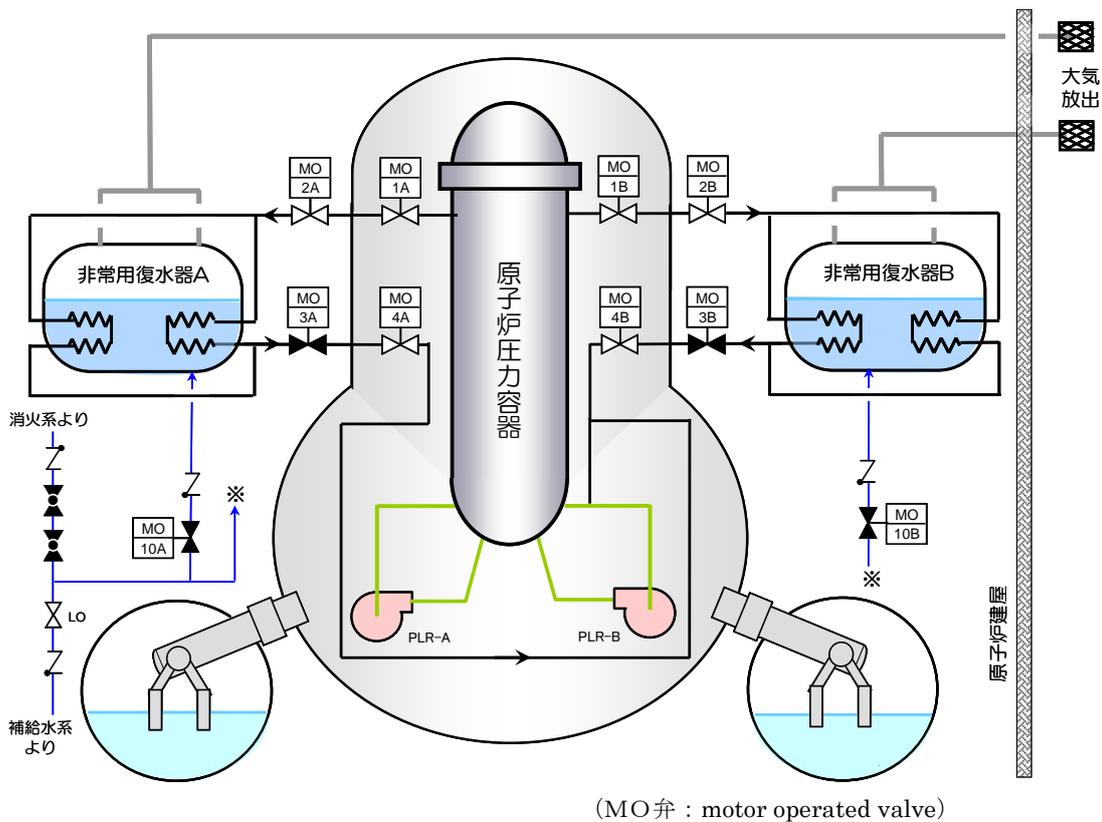
Figure Schematic illustration of IC systems

At Unit-1, the reactor pressure was being controlled after the earthquake by intermittent operation of the emergency isolation condensers (ICs). Immediately before all power supplies were lost due to the tsunami, the IC operation had been incidentally in a halted situation. In the station blackout condition, the shift operators in the MCR noticed the display lamps indicating the IC (Sub-system A) isolation valves (MO-2A, MO-3A) as “Closed” outside the PCV at around 18:00 on March 11th. They took opening action of the valves at 18:18 on March 11th, and confirmed the steam generating sounds and saw the steam when looking above the reactor building, but the amount of steam was limited and it stopped a while later. Concerned about the water inventory left in the IC shell side tank, at 18:25 the operators closed the isolation valve (MO-3A) on the return line.

It is considered that the non-condensable hydrogen gas generated by the water-zirconium reactions upon decrease of the reactor water level deteriorates the heat removal performance when it mixes in the IC cooling tubes. According to the analysis results, the reactor water level was slightly below TAF as of 18:18, and hydrogen gas might not have been being generated in large amounts. But hydrogen might have been generated by radiolysis as well. It is necessary to clarify how much the heat removal capability was actually deteriorated.

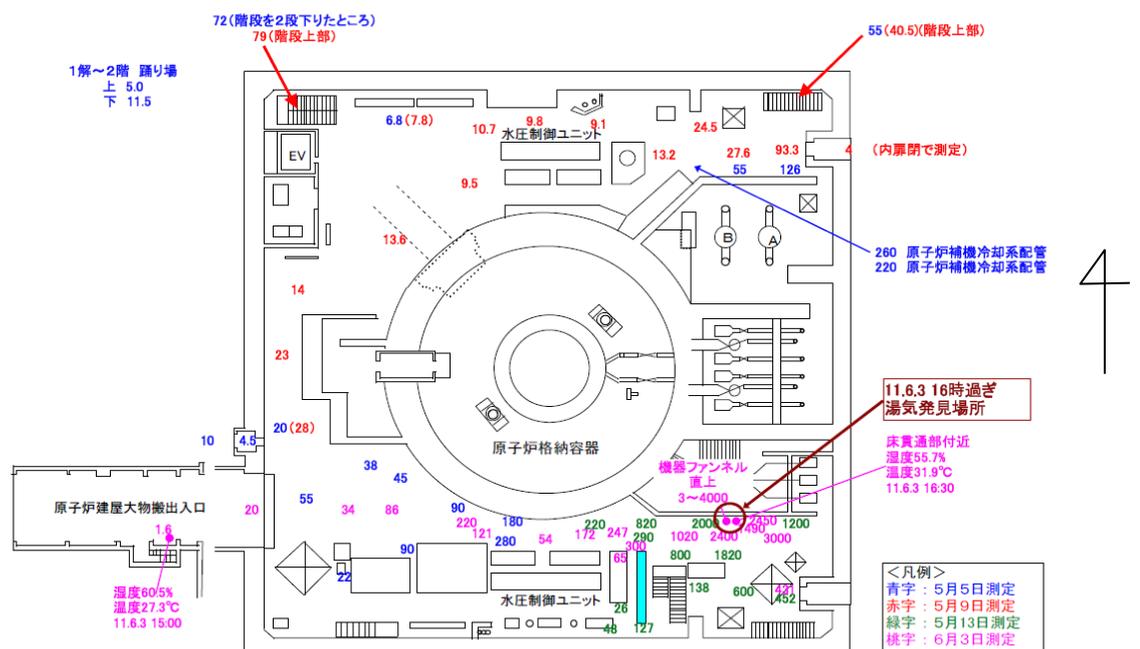
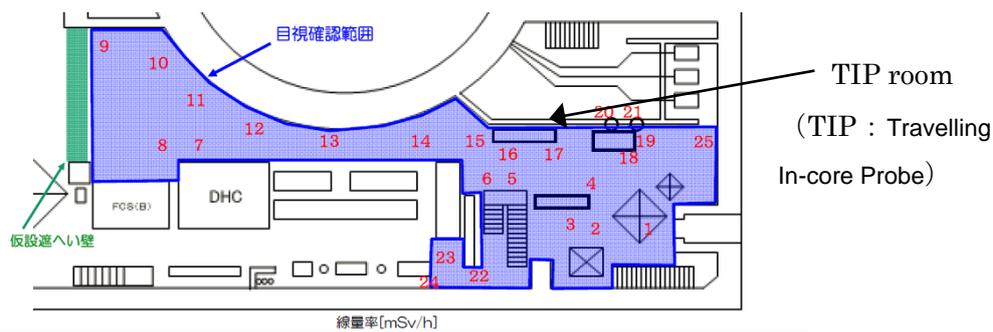
The investigations in May, June and October of 2011, and in July of 2012 located high dose rate areas of several thousand mSv/h in the southeast area of Unit-1 reactor building. In the June 2011 investigation, steam was also confirmed to be blowing out from a penetration of the floor in the area. In the July 2012 investigation, a robot attempted but failed to unlock the traveling in-core probe (TIP) room door in the area. The inside of the TIP room has not been investigated yet.

The high dose rate in the southeast area of the reactor building ground floor may be related to the steam blown from the floor penetration of the S/C venting line or possible damage of the TIP dry tubes due to the uncovered and overheated core. The causes of the high contamination are to be investigated.

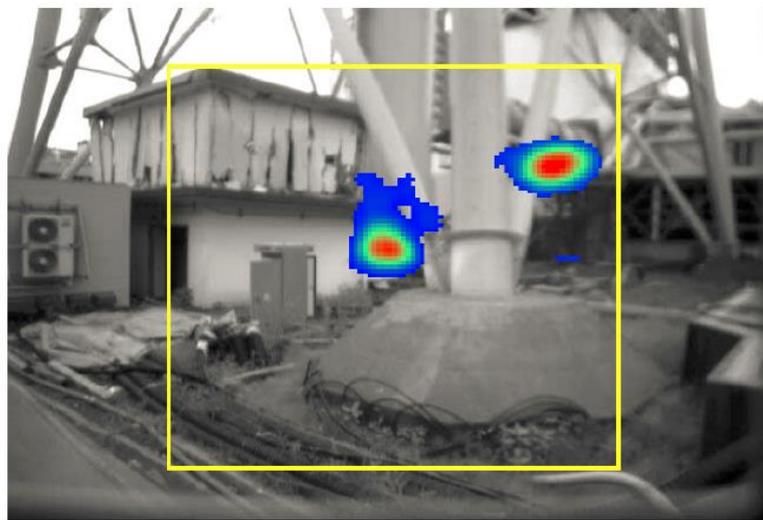
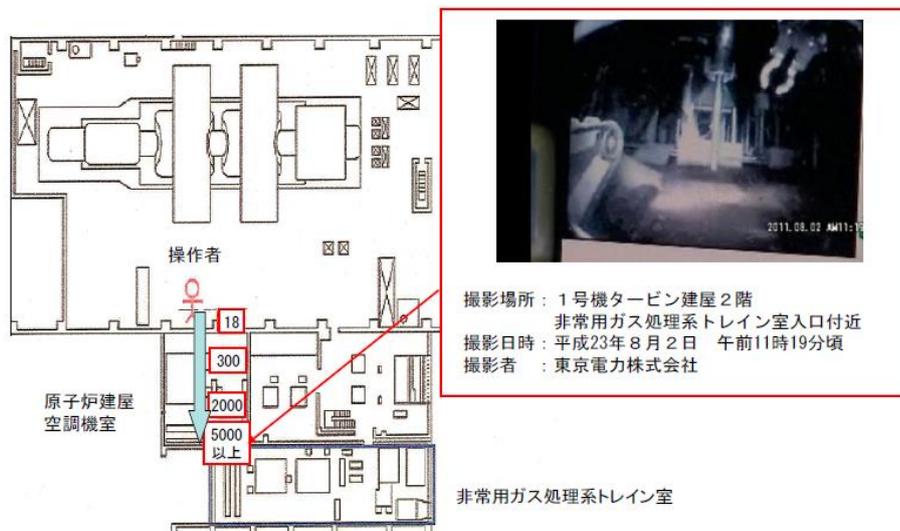
The high dose rates near the SGTS piping can be considered to be caused by the deposited radioactive materials which were released from the damaged core. The detailed causes of the contamination are to be clarified.

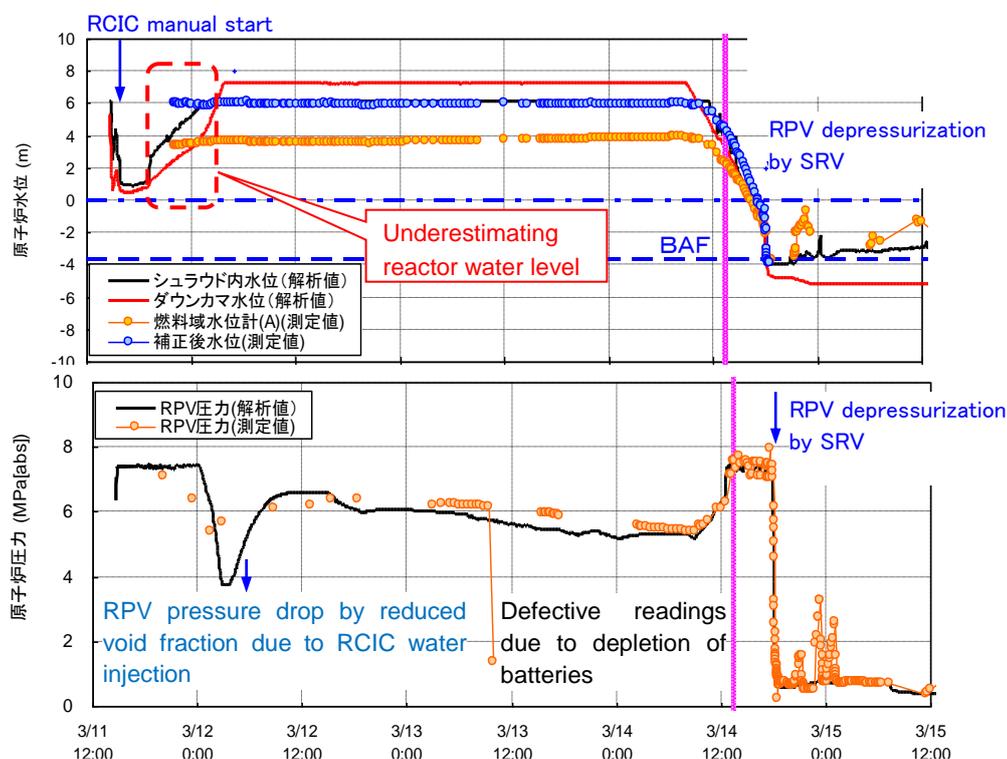
Figure Reactor water level and pressure changes at Unit-2

The measured reactor pressures after the tsunami arrival were maintained below the normal operating pressures, lower than the SRV working pressure. The RCIC operating conditions, which could cause such plant conditions, could be such that the RCIC had been driven by a mixture of steam and water, because the elevated reactor water level above the main steam lines had allowed water to flow into the main steam lines which had been designed to transfer only steam. In the MAAP analysis, the amount of water injected to the reactor was set at 30m³/h, one third of the rated value so that the measured reactor pressures could be reproduced. The overall plant behavior while the RCIC was in operation could be well reproduced in this simulation.

The RCIC operational conditions need to be clarified after the loss of the control power supply due to the tsunami.

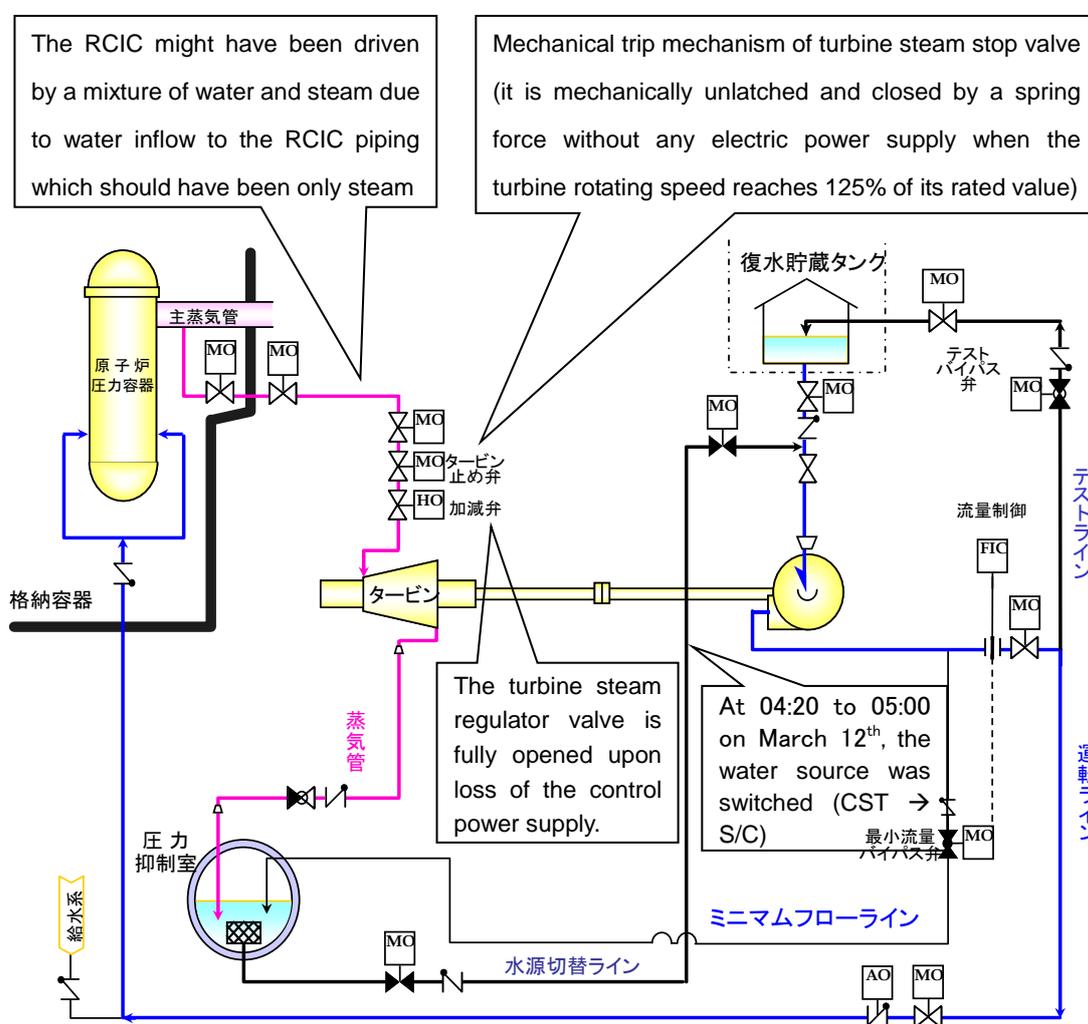
Figure RCIC schematic diagram

At about 09:00 on March 14th, the reactor pressure showed an increasing trend, and at about 12:00 noon the reactor water level showed a decreasing trend. The Emergency Response Center at the Fukushima Daiichi NPS concluded at 13:25 that the RCIC had lost its functions, but it is necessary to clarify why it lost them.

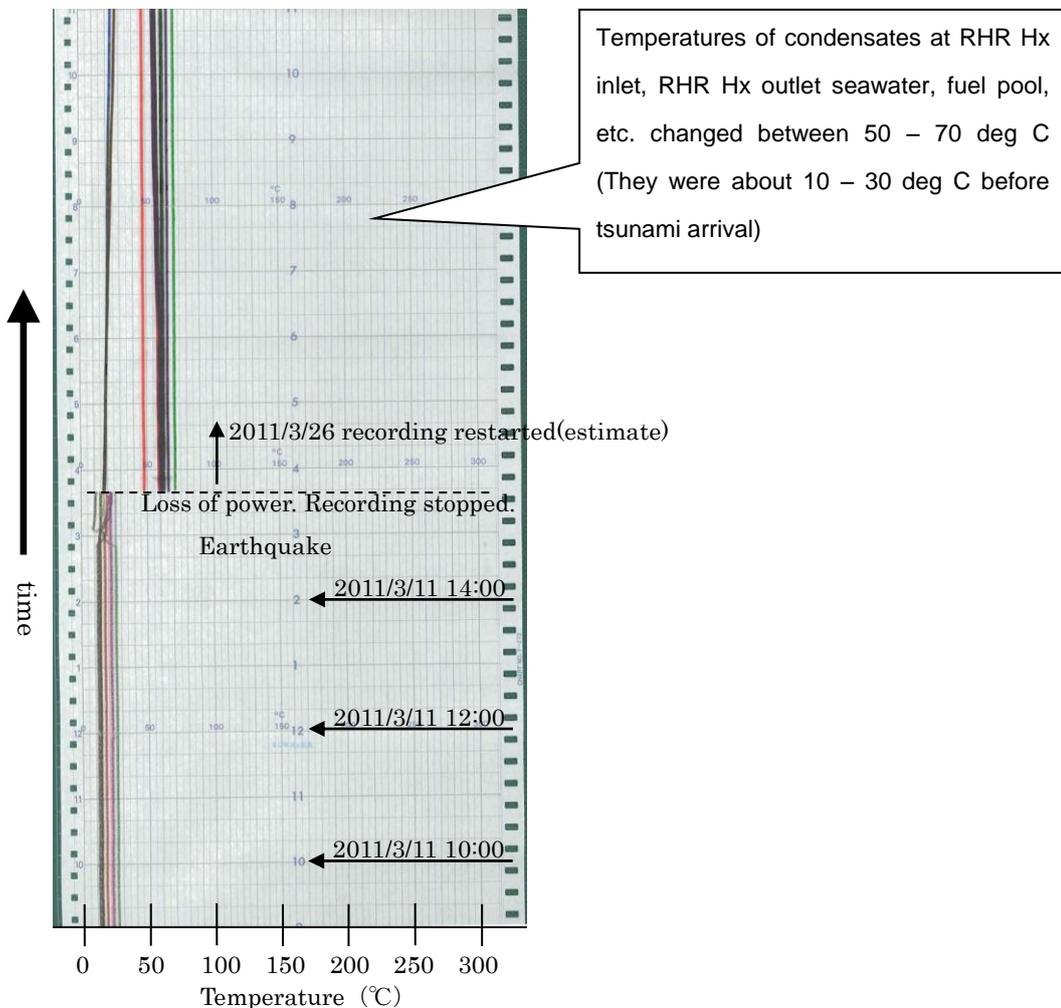
Figure Temperature recorder chart of Unit-2 (RHR and fuel pool temperatures)

Examination will be done on the reason for the temperature increase and its possible connection to the post-earthquake RHR operation. , No temperature records are available for comparison at Unit-1 and Unit-3.

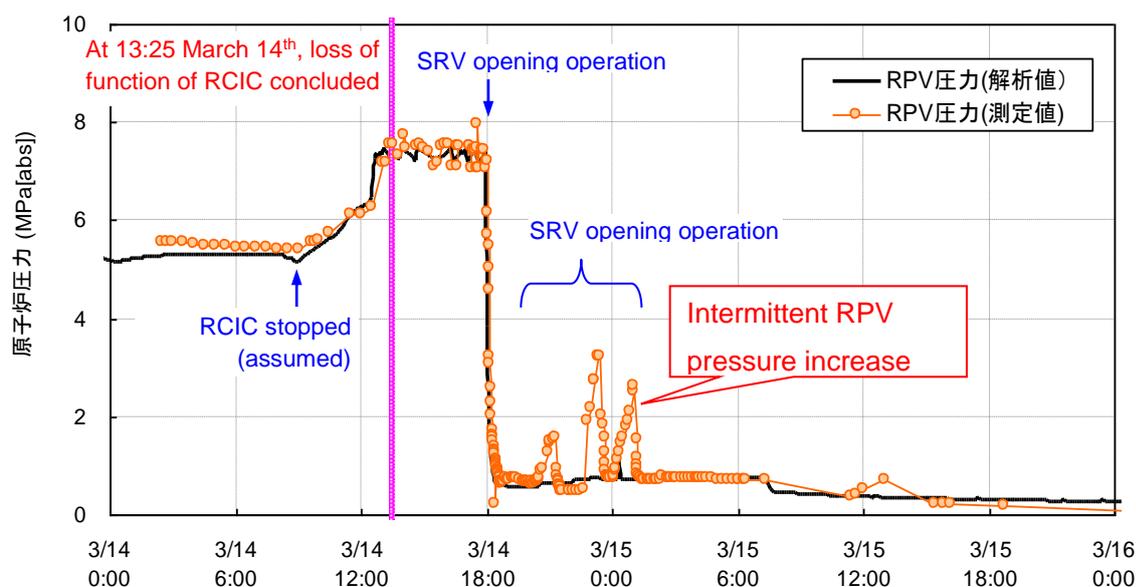
Figure RPV pressure changes at Unit-2

After the forced depressurization of the reactor, fire engines continued to inject water. Therefore, possible causes of the pressure increase are: steam production due to the increased water level; steam production due to corium slumping to the lower plenum; steam production by the zirconium-water reactions; or even the SRV closures. RPV and PCV pressure behavior after the reactor forced depressurization is to be examined.
