## The cause of RCIC shutdown in Unit 3

## 1. Outline of the incident and issues to be examined

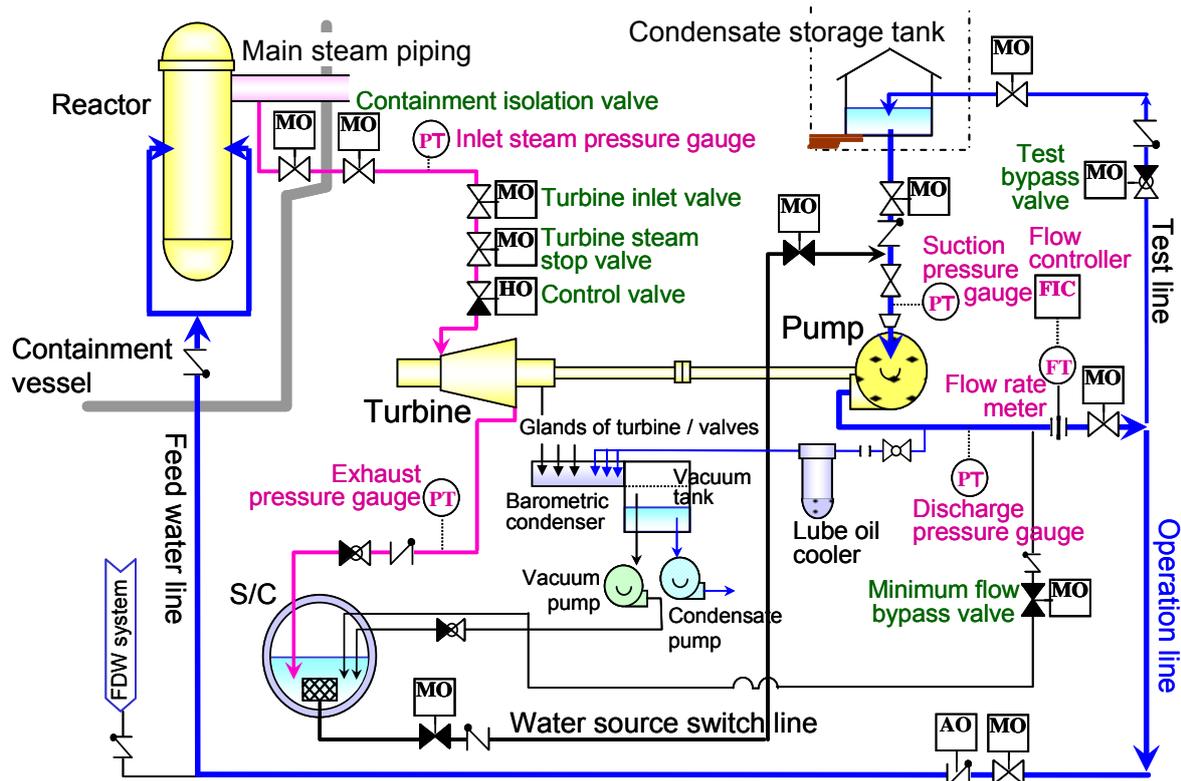
Figure 1 RCIC system diagram

Under these circumstances, the operators configured the water injection line through both the RCIC injection line and its test line by valve operations on the RCIC control panel. This was done to avoid battery depletion due to RCIC startup and shutdown, and to maintain the stable reactor water level by using the condensate storage tank (CST) as the water source. In order to ensure moderate transition of the reactor water level, the flow rate was controlled within a predefined range by adjusting the test line valve apertures and the flow indicator and controller (FIC). Figure 1 shows the RCIC diagram and the operational status.

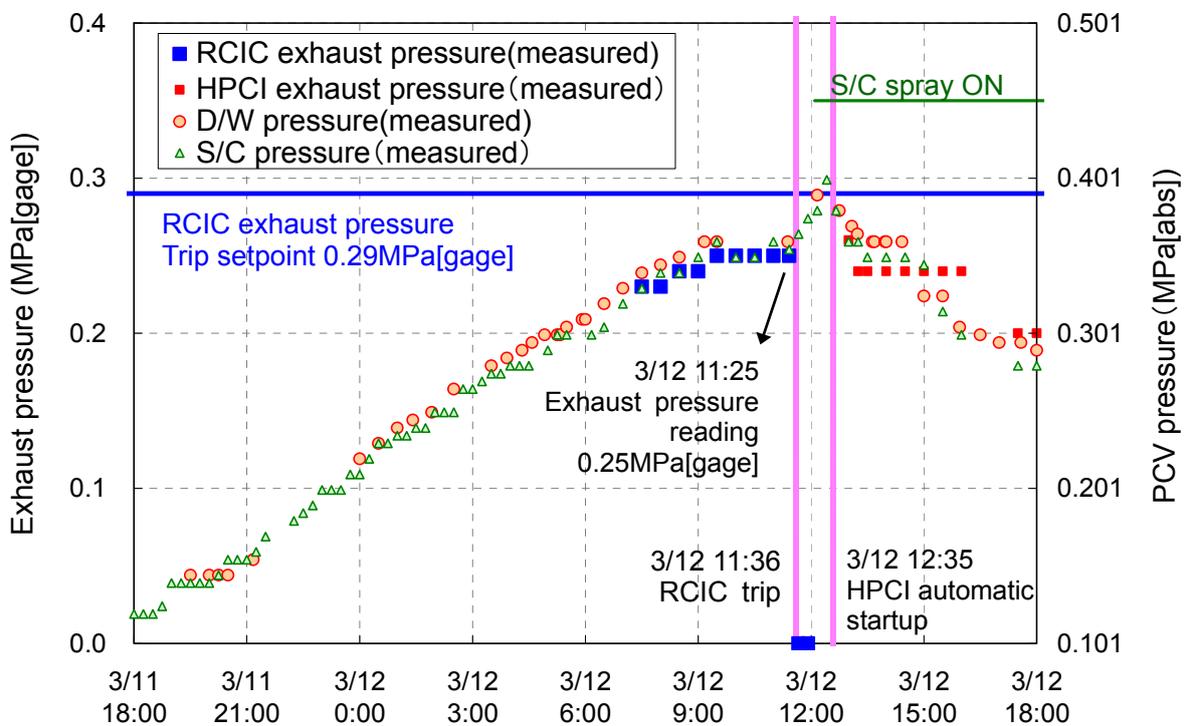
Figure 7 RCIC exhaust pressure change and PCV pressure change

Figure 7 shows the RCIC turbine exhaust pressure changes observed by the operators. Due to loss of heat removal functions, the exhaust pressure was increasing with the increase in both the D/W and S/C pressures, and as of 11:36 on March 12<sup>th</sup>, when the RCIC tripped, they were at a level very close to the preset high exhaust pressure trip level. The exhaust pressure reading was 0.25MPa[gage] as of 11:25 on March 12<sup>th</sup>, and had not reached the preset trip level (0.29MPa[gage]). Further, there is no record on the exhaust pressure at the very instant of the RCIC trip, and so no direct evidence of observation exists concerning the RCIC trip due to high exhaust pressure.

It should be noted, however, that the D/W and S/C pressures showed an increasing trend again, after remaining stable at one level for almost 3 hours before the RCIC trip, in the particular circumstance in which the PCV pressure should have simply increased under the situation of no final heat sink. Consequently, it is possible to consider that the turbine exhaust pressure reached the trip level at 11:36 on March 12<sup>th</sup>, based on the following.

It is considered, therefore, the turbine exhaust pressure might have reached the trip level when the D/W and S/C pressures increased from 11:25 through 11:36, although the exhaust pressure, at 11:25 on March 12<sup>th</sup> had not reached the trip level, but was close to it (0.29MPa[gage]).

As was shown in Figure 7, the turbine exhaust pressure reading was about 0MPa[gage] after the RCIC trip at 11:36 on March 12<sup>th</sup>. This is because the steam in the exhaust piping was condensed and because the S/C pressure (back pressure) was blocked by the check valve in the downstream side of the exhaust piping.

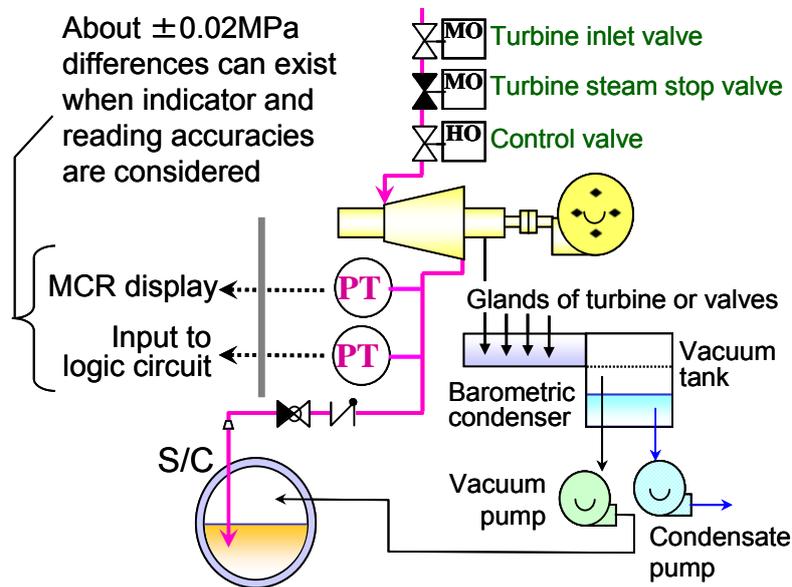
Figure 8 Positional illustration of RCIC exhaust pressure gauges

As is shown in Figure 8, exhaust pressure gauges for the MCR indicator and the logic circuit input are different, and about 0.02MPa difference could exist in these two instrumentations due to instrumentation accuracies and reading errors. Even taking these inaccuracies into account, the

pressure reading of 0.25MPa[gage] at 11:25 on March 12<sup>th</sup> is considered not to have reached the trip level (0.29MPa[gage]).

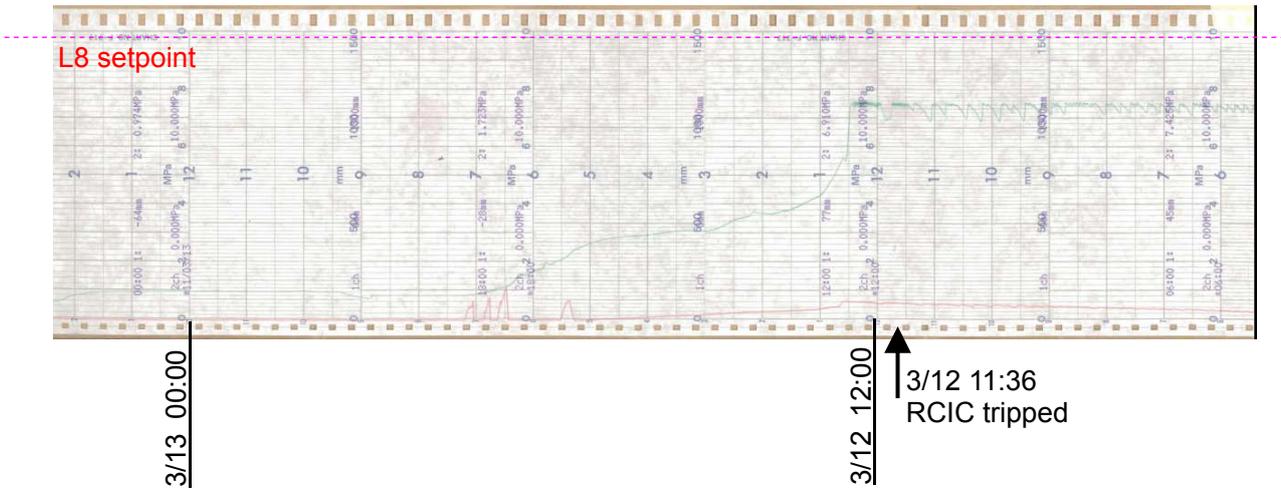
Figure 9 Chart record of reactor water level/pressure

Figure 9 shows the chart record of reactor water level (narrow range) and Figure 10 shows the measured water level changes which operators read in the indicators. The RCIC flow rate was being controlled by the FIC while monitoring the reactor water level, and as of 11:36 on March 12<sup>th</sup>, when the RCIC tripped, the reactor water level had not reached the level L-8. An RCIC trip due to high reactor water level interlock is not possible.
