Progress Status and Future Challenges of the Mid- and Long-Term Roadmap toward the Decommissioning of TEPCO's Fukushima Daiichi Nuclear Power Station Units 1-4 (Outline)

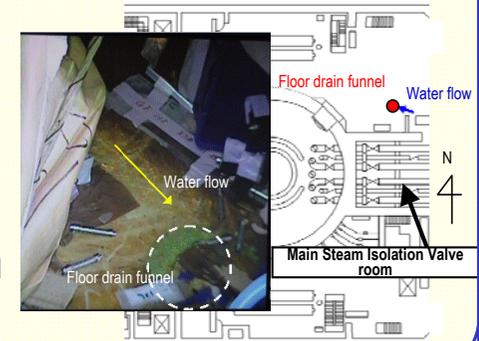
\* Main Steam Isolation Valve: A valve to shut off the steam generated from the Reactor Building. <Outline of the water flow status>

On January 18, water flowing from around the door of the Steam Isolation Valve room in the Reactor Building Unit 3 1st floor northeast area to the nearby floor drain funnel (drain outlet) was detected. As the drain outlet connects with the underground floor of Reactor Building, there was no possibility of outflow from the building. Based on analytical results of temperature, the water flow of radioactive materials, and examination of drawings, there is a significant likelihood of accumulated water, for which an indoor investigation will be conducted.

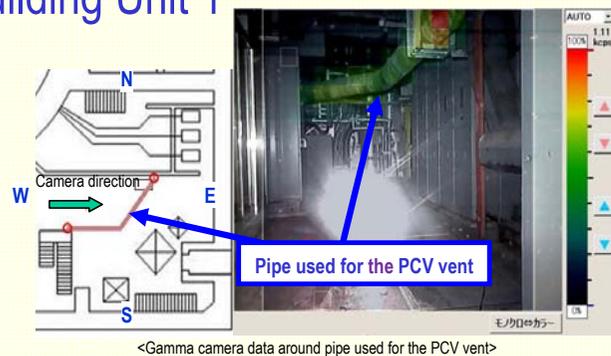
<Gamma camera data around pipe used for the PCV vent>

The data recorded by the gamma camera showed a high radiation dose on the surface of the pipes where steam traversed the PCV vent at the time of the accident (pipes through which the steam passed).

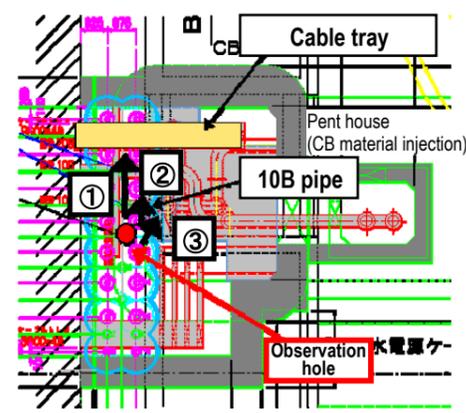
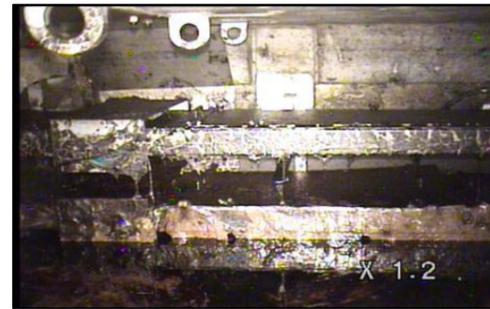
① Cable tray (above the water surface)

- As for the Main Trench Units 2 and 3, treatment of contaminated water using the mobile treatment equipment is in operation (Unit 2: from November 14, Unit 3: from November 15). The operation was suspended to inspect the power panel (Unit 2: from January 16-27, Unit 3: from January 17-28) and resumed after the suspension period.
- Toward contaminated water removal from May 2014, drilling and installation of frozen ducts are in operation (Unit 2: from December 2013 to early April (provisional)). The status of the points for the planned freeze and water stoppage of Main Trench Unit 2 (Vertical Shaft A) was investigated using a camera (see Figure 1), which confirmed that the

cable tray and pipes had been equivalent to the design drawing.

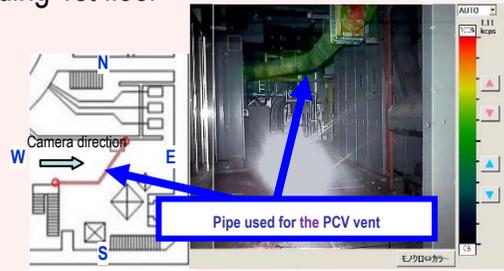
<Gamma camera data around the pipe used for the PCV vent>

- Toward implementing the radiation dose reduction plan and decontaminating the Reactor Building, a radiation-source survey using a gamma camera\* got underway on the south side of the Reactor Building Unit 1 1st floor (from December 22-24, 2013).
- From the recorded data, a high radiation dose was confirmed on the surface of pipes used for the PVC vent.

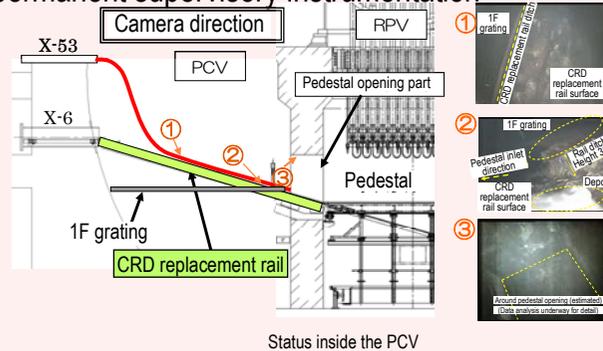
Status inside the PCV

- To identify the status inside the PCV, re-investigation was conducted (August 2, 12, 2013). From the through-hole of the PCV, the investigative equipment was led to the CRD exchange rail to investigate down to near the pedestal opening. The camera images will be analyzed and reflected in the future investigation plan inside the pedestal.
- Some of the permanent supervisory instrumentation for PCV could not be installed in the planned places due to interference with the existing grating (August 13, 2013).
- The estimated reason is the fact that the instrumentation got stuck in the grating due to twisted cables. After training the workers, the relevant supervisory instrumentation will be reinstalled (in early April).

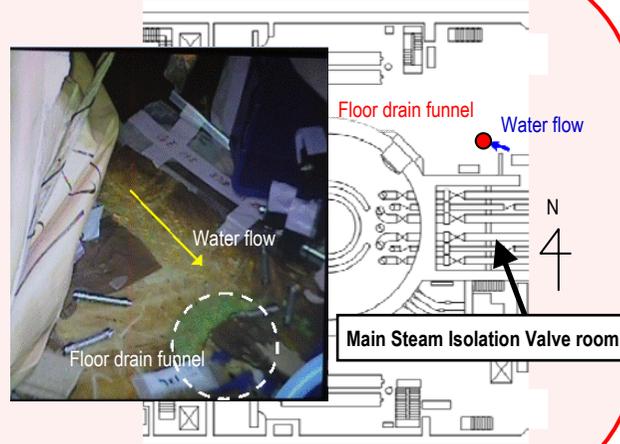
<Outline of the water flow status>

Based on the analytical results of temperature and radioactive materials of the water flow, and examination by drawings, there is a high likelihood of accumulated water, for which an indoor investigation will be conducted.

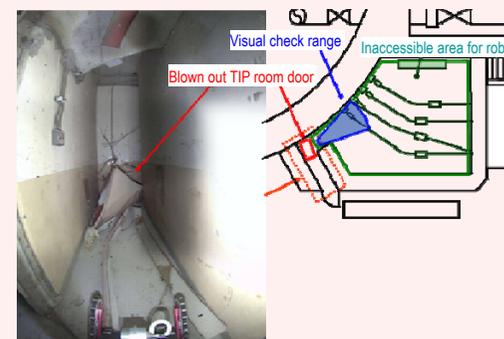
- Disturbed by the blown out TIP room door, the robot could not move beyond the labyrinth part.
- A staff member, who visually checked around the entrance into the TIP room, **detected no significant damage to the equipment**, including the TIP guiding pipe, within the visual range.
