Investigation of the cause of hydrogen explosion at the Unit 4 Reactor Building

24th July 2012

Tokyo Electric Power Company, Inc.

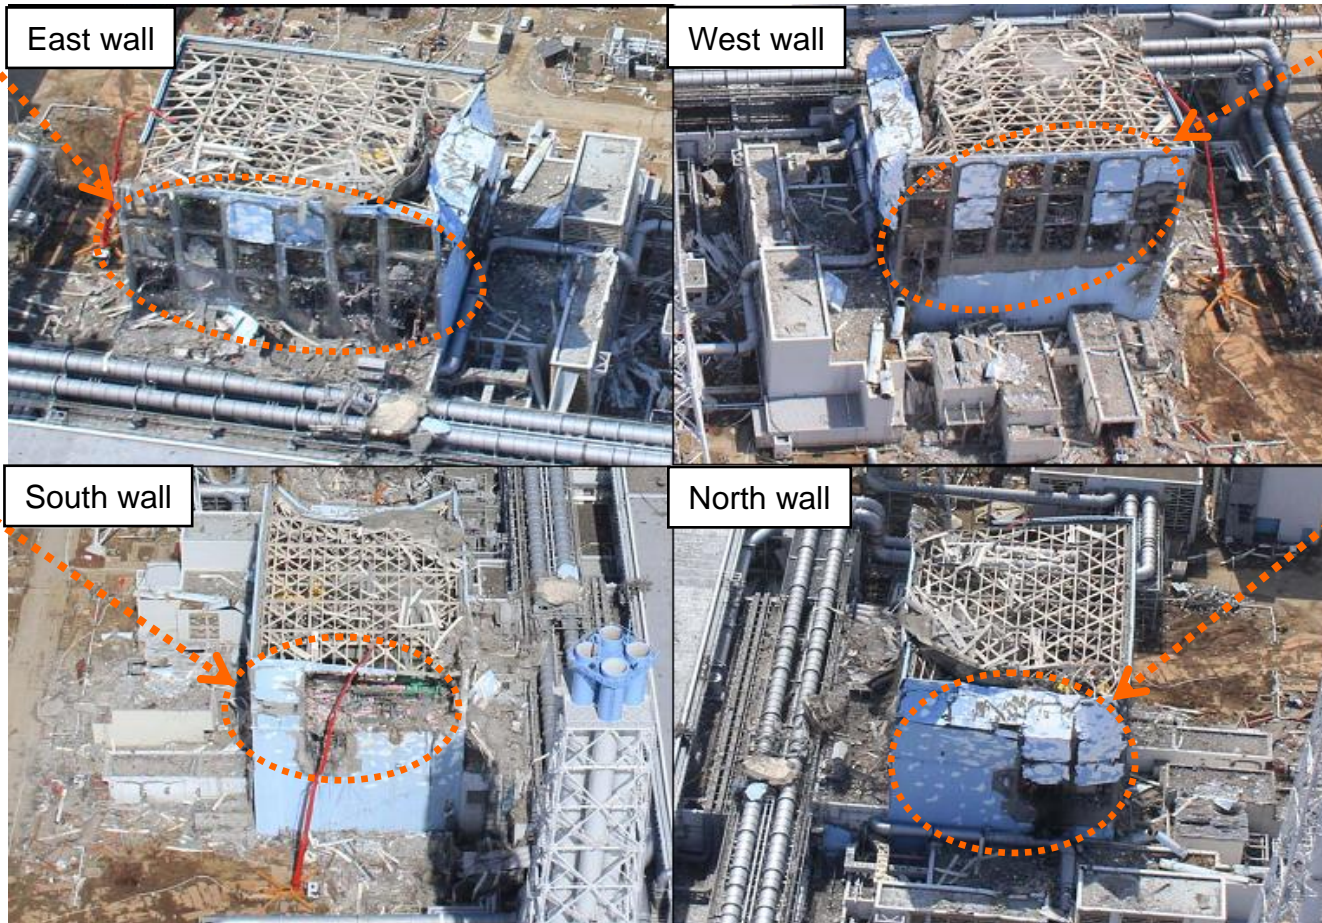
- All walls of 5th floor were damaged, and walls of 4th and 3rd floor were partially damaged.
- While walls of reinforced concrete were damaged broadly, some of the roof truss and pillars maintained their form and remain.

Almost all walls of 5th floor were damaged.
All walls of 4th floor were damaged.

Walls and pillars of 5th floor were damaged except for the west side.
Only one wall of 4th floor was damaged.

Almost all walls of 5th floor were damaged.
All walls of 4th floor were damaged.
North side wall of 3rd floor was partially damaged.

Walls of 5th floor were partially damaged.
West side walls of 4th floor were severely damaged.
West side walls of 3rd floor was damaged.

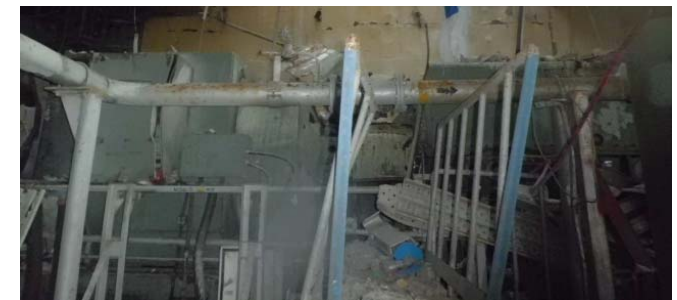
PLR MG set (on 8th Nov. 2011)

- Hydrogen from the reactor
 - The Unit 4 was under refueling outage and all fuels were in the SFP.
 - There is no possibility of the hydrogen generation by water-zirconium reaction.
- Hydrogen from the SFP
 - Fuel damage was not confirmed in observation of the fuel in the SFP with camera.
 - Possibility of hydrogen generation in the SFP due to water-zirconium reaction and radiolysis of water must be very low.
- Turbine oil of PLR MG set
 - No high temperature area in R/B except for the inside of D/W.

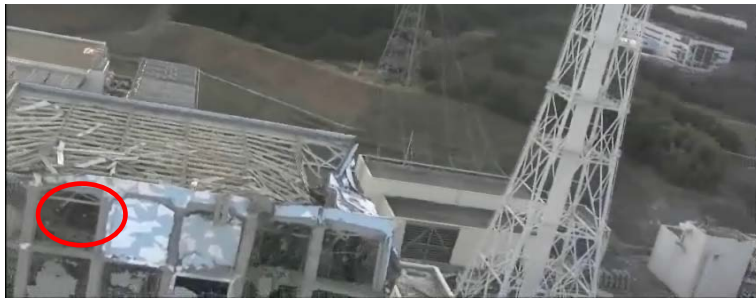
- All fuels were in the SFP, and Unit 4 SFP had the largest heat load in Fukushima-daiichi 7SFPs.
- It was confirmed that the water level in the SFP was adequate enough. By subsequent analysis, it turned out that the water of the reactor well flowed into the SFP through the pool gate.
- The picture in the SFP and the results of nuclide analysis of the pool water confirmed that there was no damage in the fuel.

The surface of the water that was confirmed from a helicopter (Photo from the east, 16th May, 2011)

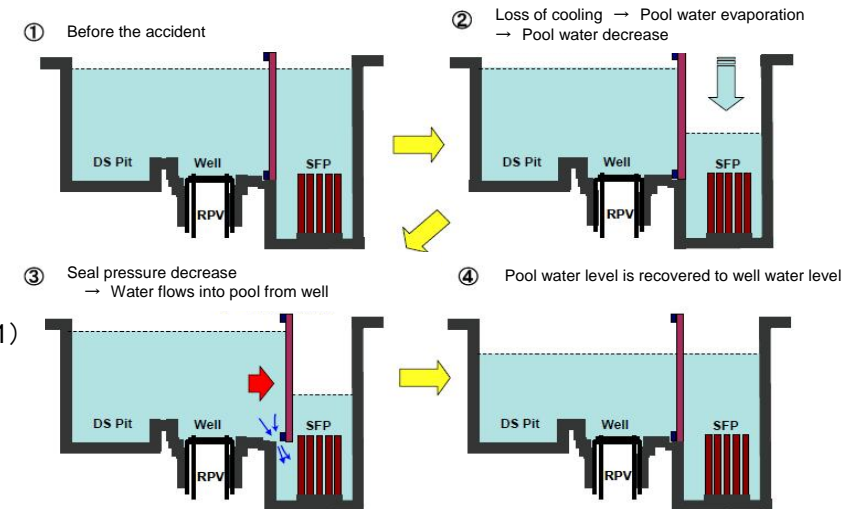
The mechanism of water flow from the pool gate

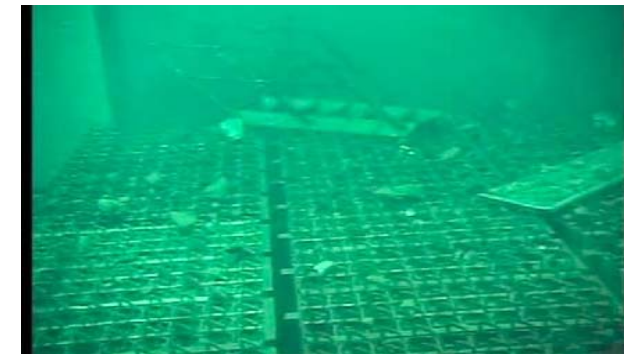
The situation in the SFP

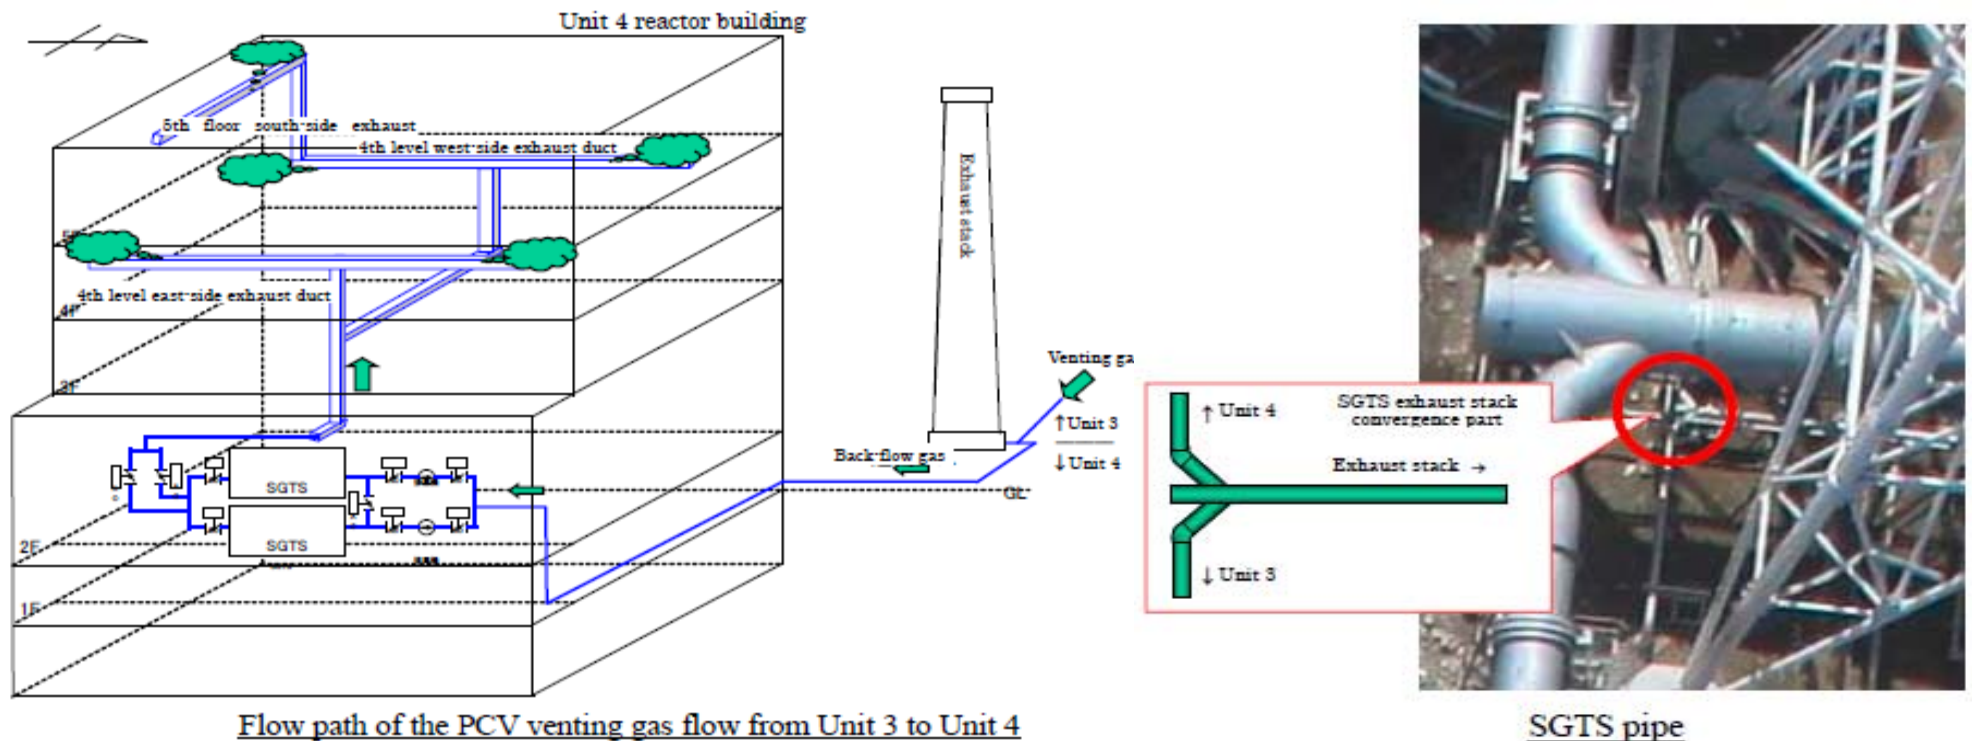
The SGTS exhaust pipe of Unit 4 joins the Unit 3 exhaust pipe at the main exhaust stack convergence part.

→ It is presumed that the PCV ventilation gas from Unit 3 flowed into the Unit 4 R/B through the SGTS piping.

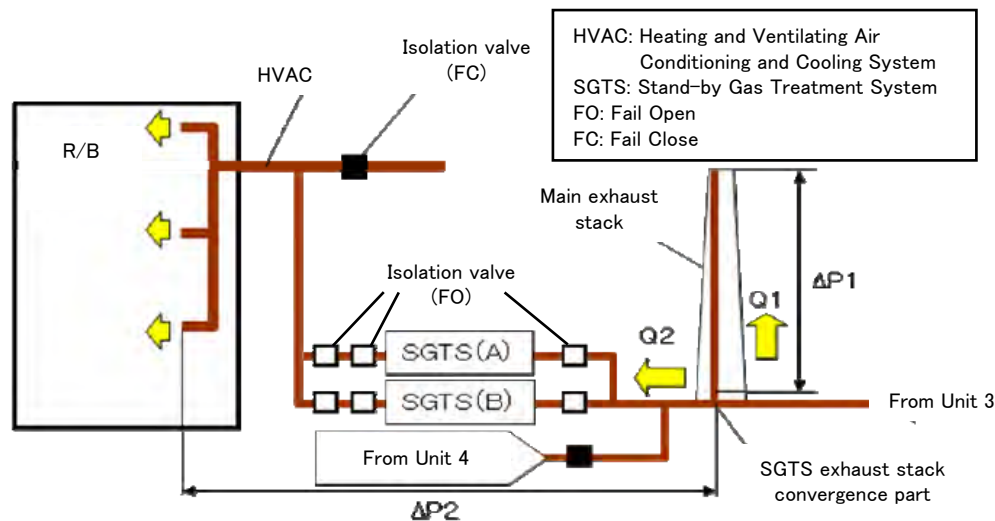
- About the inflow rate to Unit 4 of the Unit 3 PCV ventilation gas, rough estimation of the amount of hydrogen inflow to Unit 4 was carried out based on pressure loss calculation etc.

➡ The quantity which flows into Unit 4 R/B is estimated as about 40 percent of the quantity emitted from the main exhaust stack.

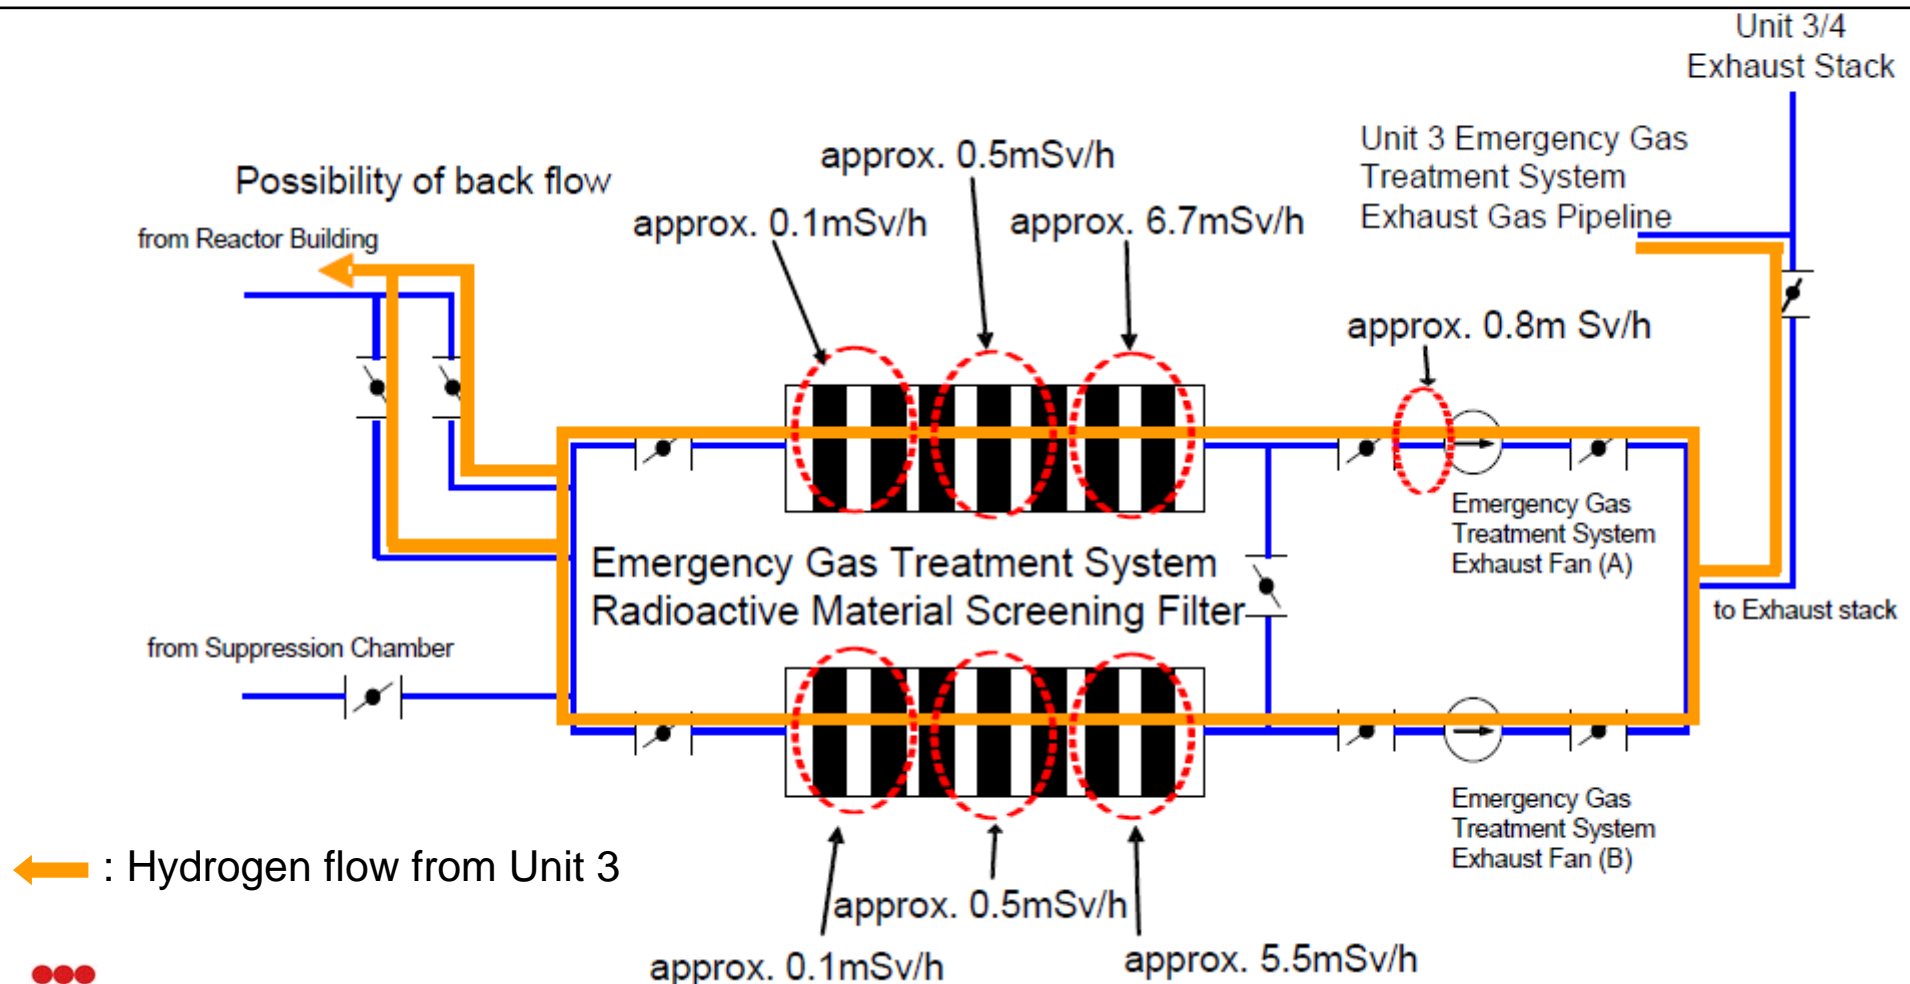
- After measuring the radiation dose of the Unit 4 SGTS filters, it was found that the radiation dose level of the downstream filter was higher than those of the upstream filters.
- This fact is well corresponding to the presumed mechanism of the explosion.

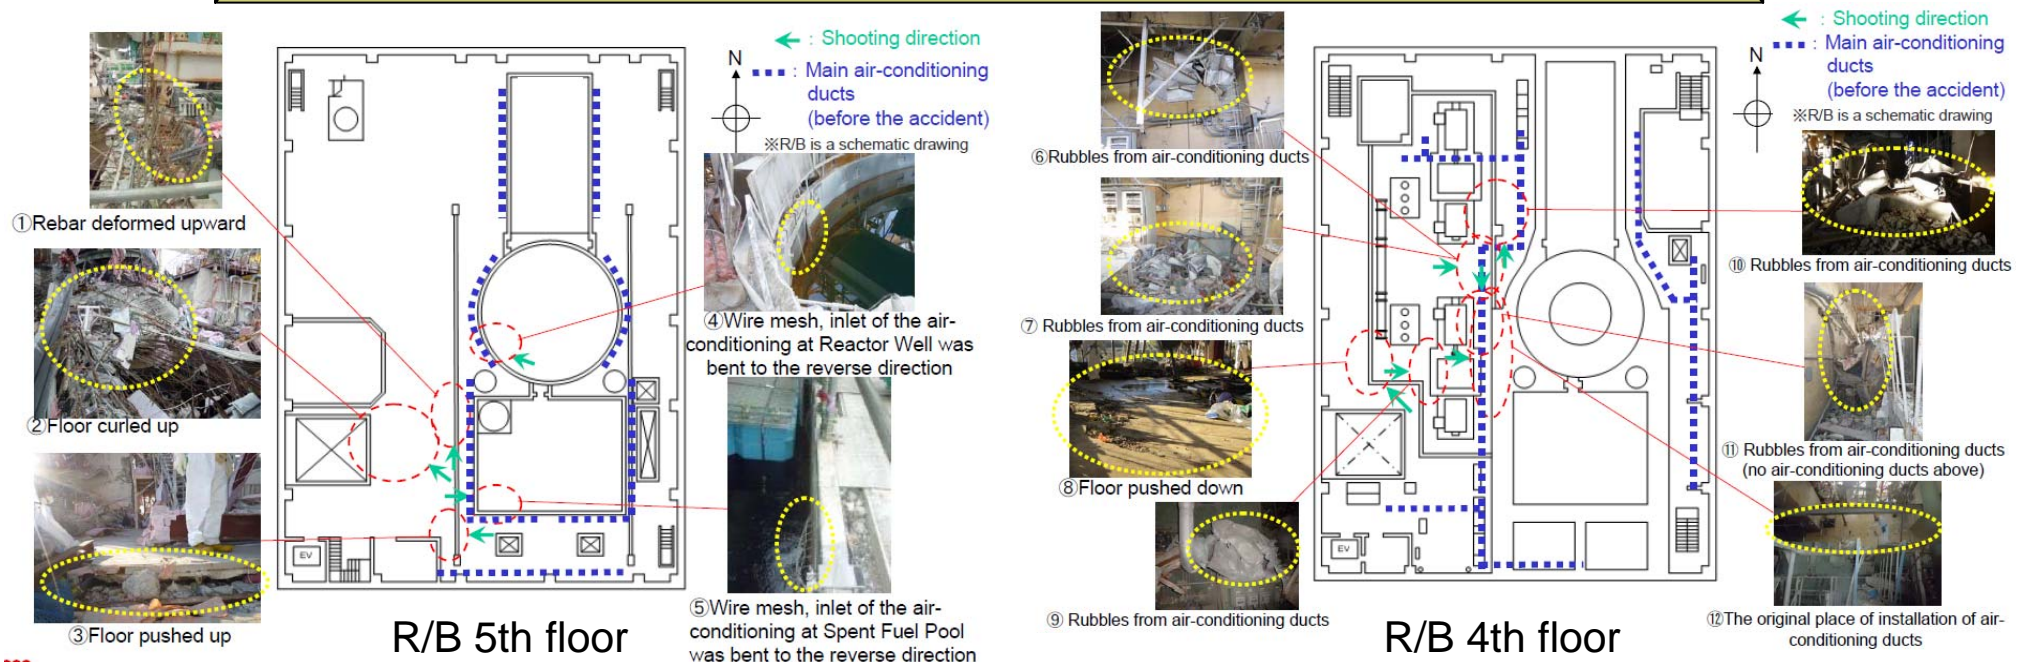
- The floor surface of the 5th floor was pushed up. (②、③)
- The floor surface of the 4th floor was pushed down. (⑧)
- Wire meshes of ventilation inlet were bent to the reverse direction. (④、⑤)
- On the 4th floor, exhaust ducts are missing and there exist many rubbles which seems to be the wrecks of the ducts. (⑥、⑦、⑨～⑫)

It is presumed that the main pressure was generated near the exhaust duct of the 4th floor of R/B.

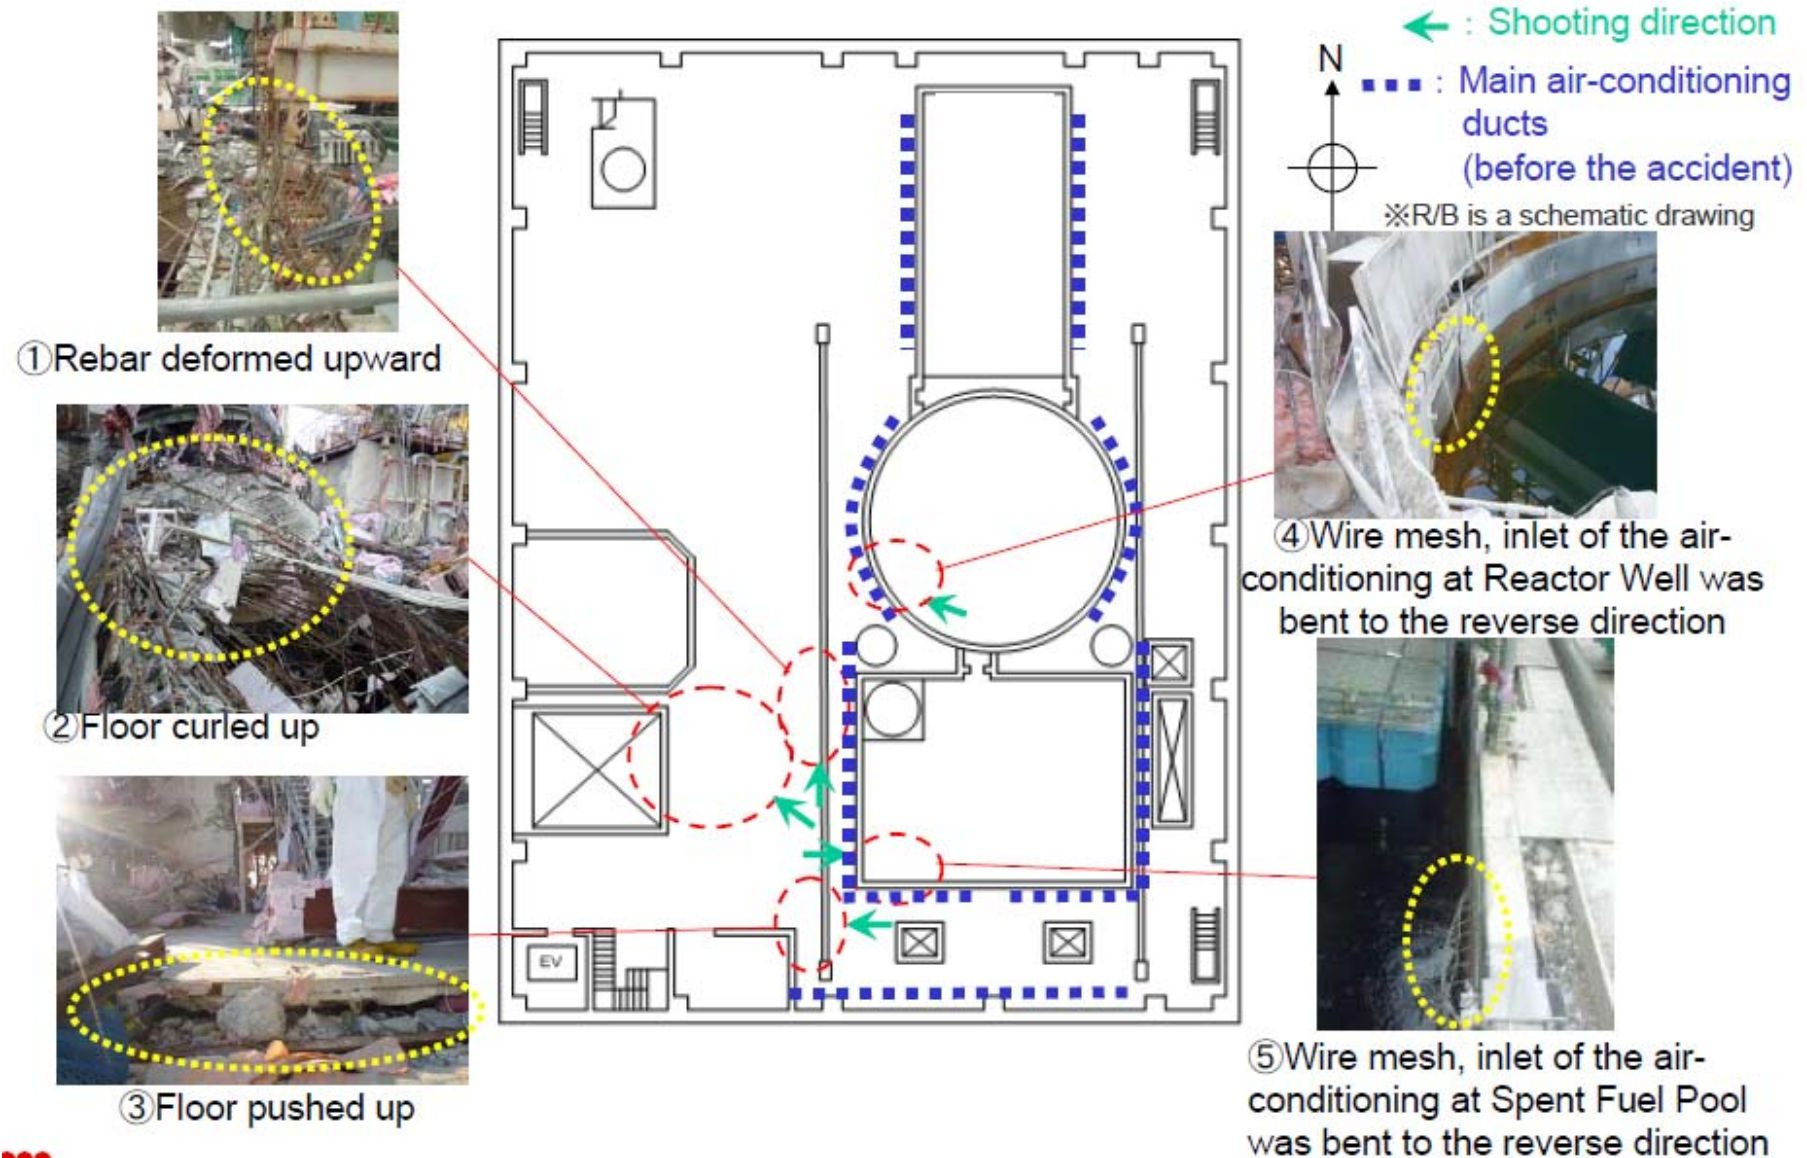
Observation results of the Unit 4 R/B (5F)

- It was likely that the explosion at Unit 4 occurred mainly on the fourth floor of the Reactor Building because (i) the floor on the fifth floor was pushed up and the floor on the fourth floor was pushed down and (ii) wire meshes attached to inlets of the air-conditioning on the fifth floor were bent to the reverse direction of the normal air flow.
- On the fourth floor of the Reactor Building, as there were no air-conditioning ducts at the original place of installation and instead, numerous rubbles presumably from air-conditioning ducts were scattered, it was possible that the explosion occurred around the air-conditioning ducts.
