Results and Current Evaluation from Inspection of Water Intake Power Cable Trench at Fukushima Daiichi Nuclear Power Station Unit 2

July 29, 2013 Tokyo Electric Power Company

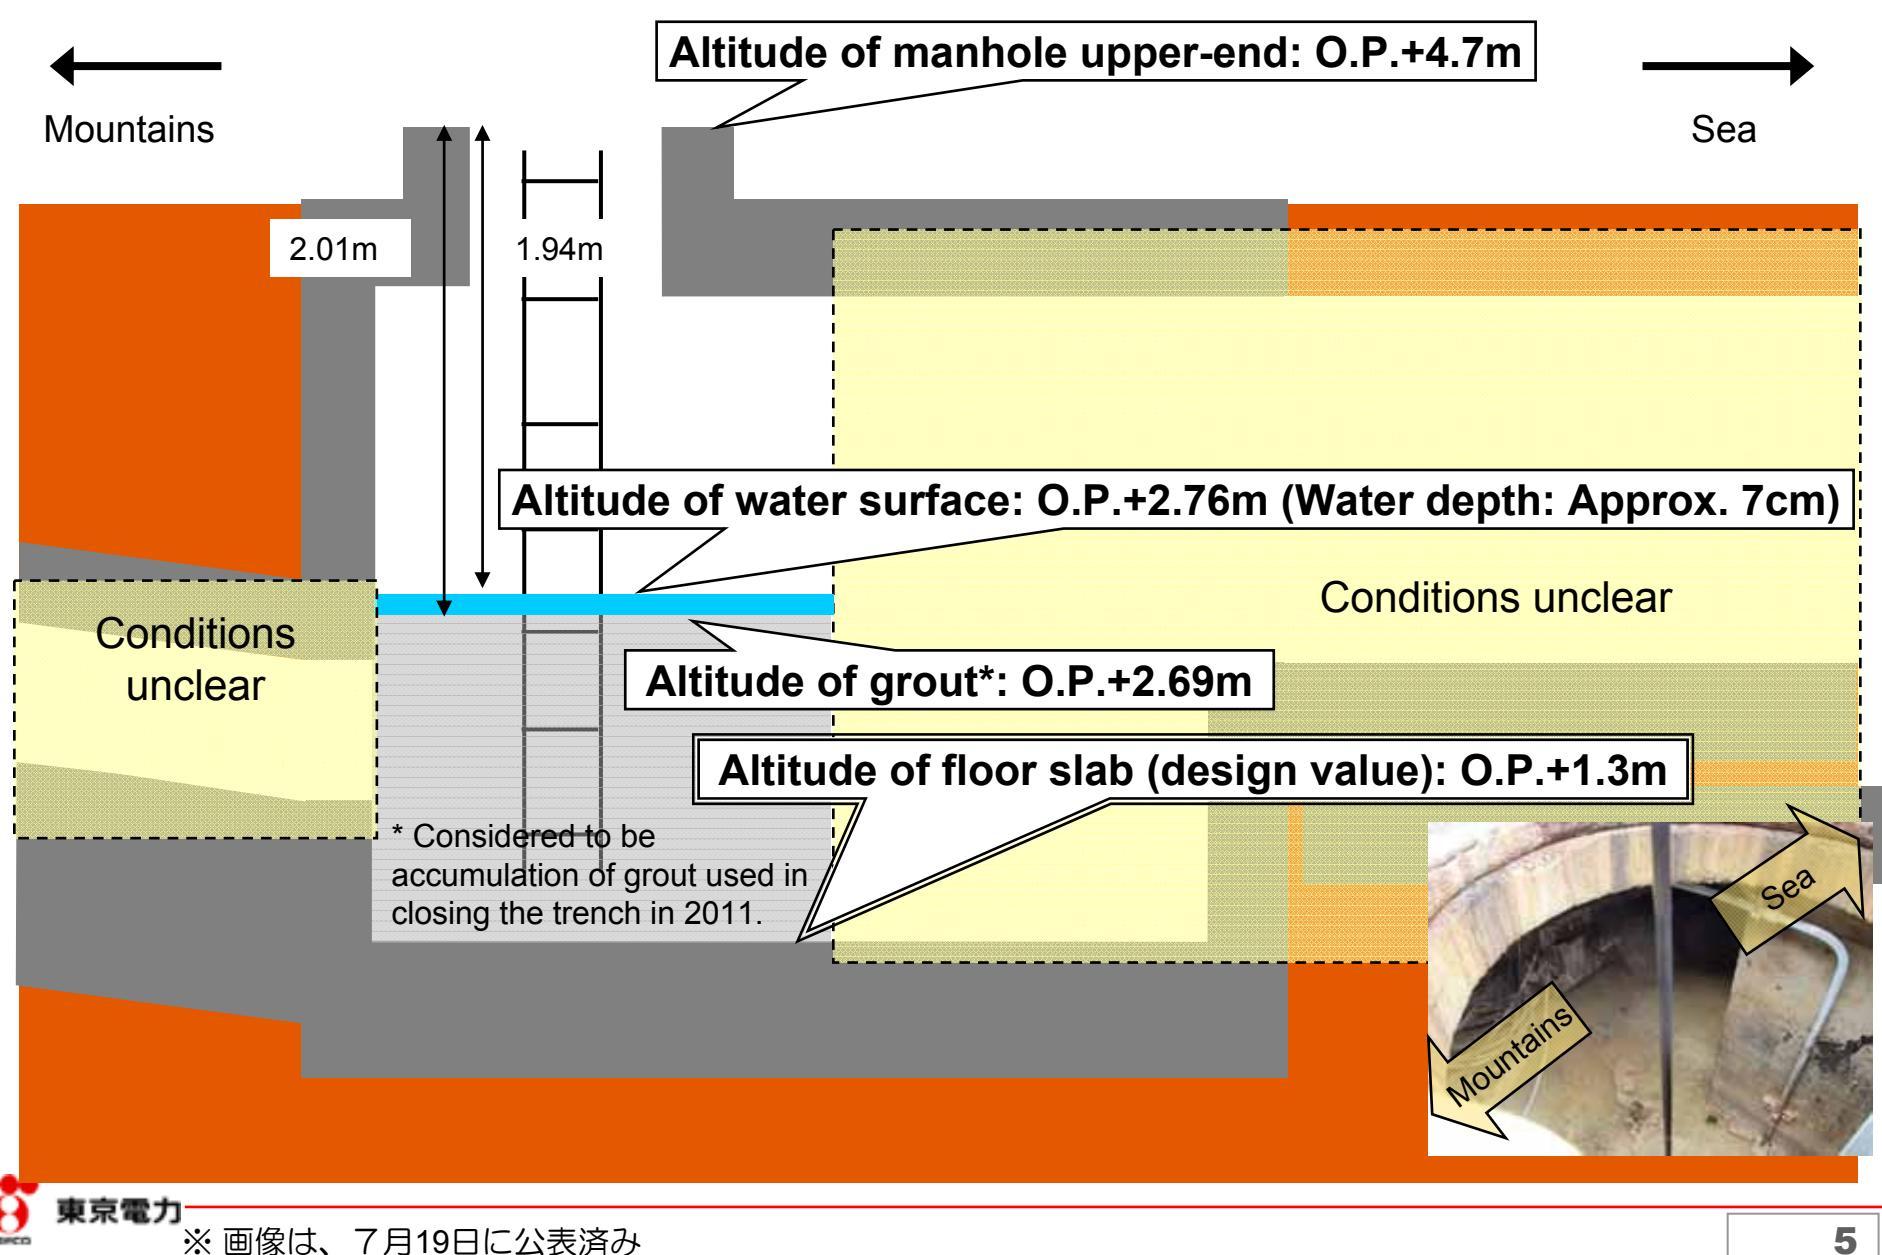
< Reference > [Unit 2 B-2] Conditions of Water Intake Power Cable Trench Interior (Illustration)

[Unit 2 B-2] Unit 2 water intake power cable trench

Sampling date	Chloride	Cs134	Cs137	All β	H-3
	(ppm)	(Bq/cm³)	(Bq/cm³)	(Bq/cm³)	(Bq/cm³)
July 17, 2013	70	1.2×10⁴	2.4×10⁴	2.3 × 104	1.2 × 10 ²

Water level measurement date	Water level ^{*1}	Reference: Water level of Unit 2 vertical shaft A ^{*2}
July 17, 2013	OP.2760mm (water depth: approx. 70mm)	OP.3196mm

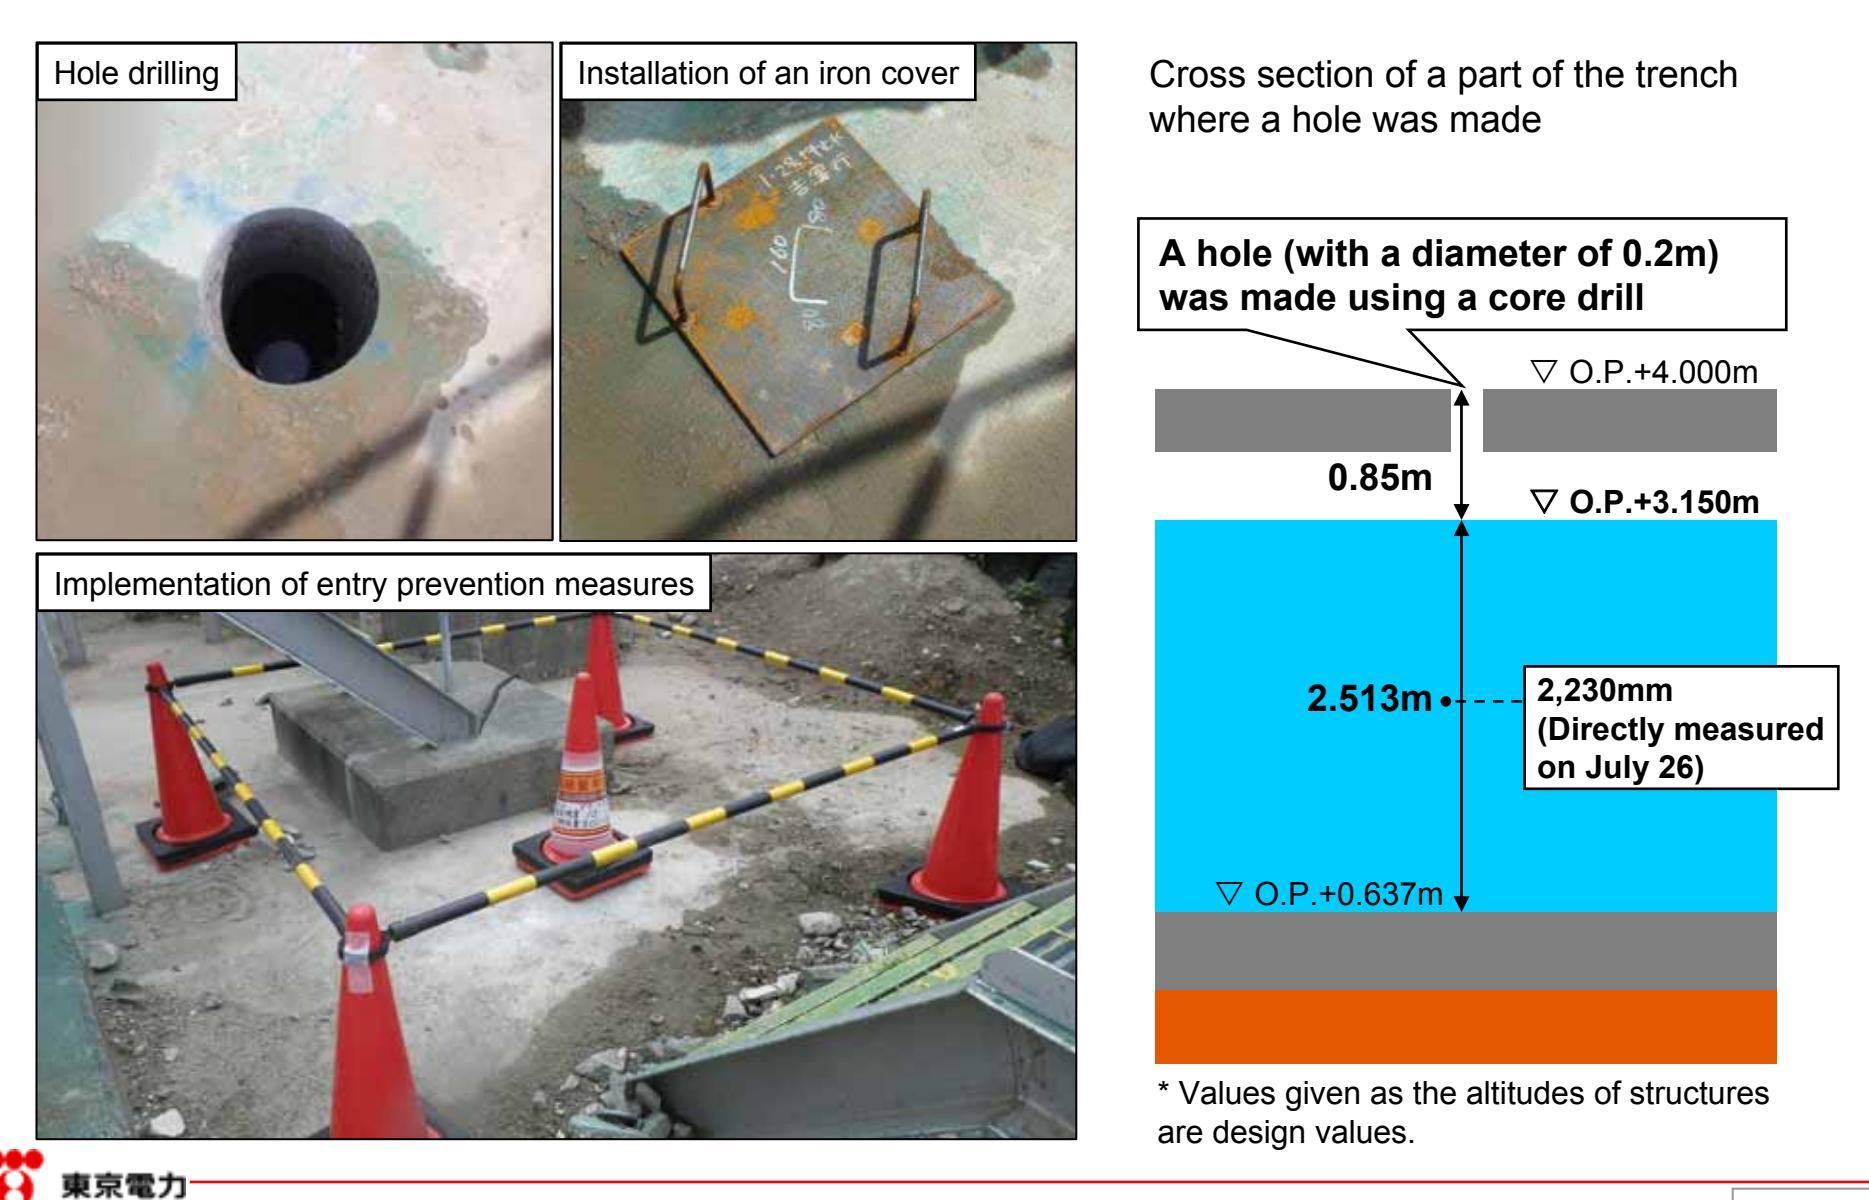
< Reference > [Unit 2 B1-1] Conditions of Water Intake Power Cable Trench (Seawater Pipe Foundation)

[Unit 2 B-1-1] Unit 2 water intake power cable trench (seawater pipe foundation)

Sampling date	Chloride	Cs134	Cs137	ΑΙΙ β	H-3
	(ppm)	(Bq/cm³)	(Bq/cm³)	(Bq/cm³)	(Bq/cm³)
July 26, 2013	8,000	7.5×10⁵	1.6 × 10 ⁶	7.5×10⁵	8.7 × 10 ³

Water level measurement date	Water level*3	Reference: Water level of Unit 2 vertical shaft A*4
July 23, 2013	OP.3150mm	OP.3083mm
July 26, 2013	OP.3150mm	OP.3302mm

Evaluation item	Communication with the Unit 2 seawater pipe trench	Water retained inside the trench
[Unit 2 B-1-1] Unit 2 water intake power cable trench (seawater pipe foundation)	 There seems to be <u>no communication</u> with the seawater pipe trench [Reason] No association has been found between water level changes in this trench and the Unit 2 vertical shaft A. 	 It seems that <u>contaminated water that flowed into</u> <u>the trench immediately after the accident has been</u> <u>retained as it was.</u> [Reasons] The Cs-137 density is in the order of the 6th power of ten (Bq/cm³) as in the case of contaminated water that flowed into the trench immediately after the accident.
[Unit 2 B-2] Unit 2 water intake power cable trench	 There seems to be <u>no communication</u> with the seawater pipe trench [Reason] The trench has a lower water level than the Unit 2 vertical shaft A. 	 The water level has been found unchanged. There is a possibility that water retained there (water depth as of July 19: approx. 7cm) may be residual water since the grout closure immediately after the accident, and <u>the possibility of water having flowed out of the trench is unclear</u>. Rainwater, etc. seems to have flowed into the trench. [Reason] Chloride concentration, cesium densities, etc are low (indicating the possibility of dilution with rainwater)

In order to confirm whether water has flowed out of the trench, measurement of water levels (confirmation of increases and decreases of water levels) is needed.
