<Reference> Area with the coating done in front of the water intake.

(On the side of Unit 1 to 4) Coating area: Approx. 34,000m<sup>2</sup>/ Construction period: 2012.3.14 to 5.11. (On the side of Unit 5 & 6) Coating area: Approx. 38,600m<sup>2</sup> / Construction period: 2012.5.16 to 7.05.

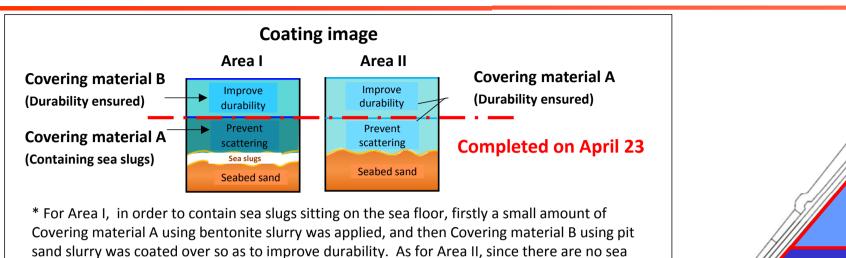
Coating done in 2012

slugs exist, only Covering material B was applied.

<sup>\*</sup> Open ditch of water intake has sea slugs, therefore, covering material with bentonite slurry was applied to make it duplex coating.

The thickness of the coating is planned to be checked through bathymetry. And based on the data taken, additional coating will be performed to strengthen durability if necessary.
