Workshop for technical catalog study regarding the development of equipment to remove fuel debris for decommissioning of Fukushima Daiichi Nuclear Power Station, Tokyo Electric Power Company 1

# Current Status and Needs for Technical Findings

February 24, 2012

Tokyo Electric Power Company

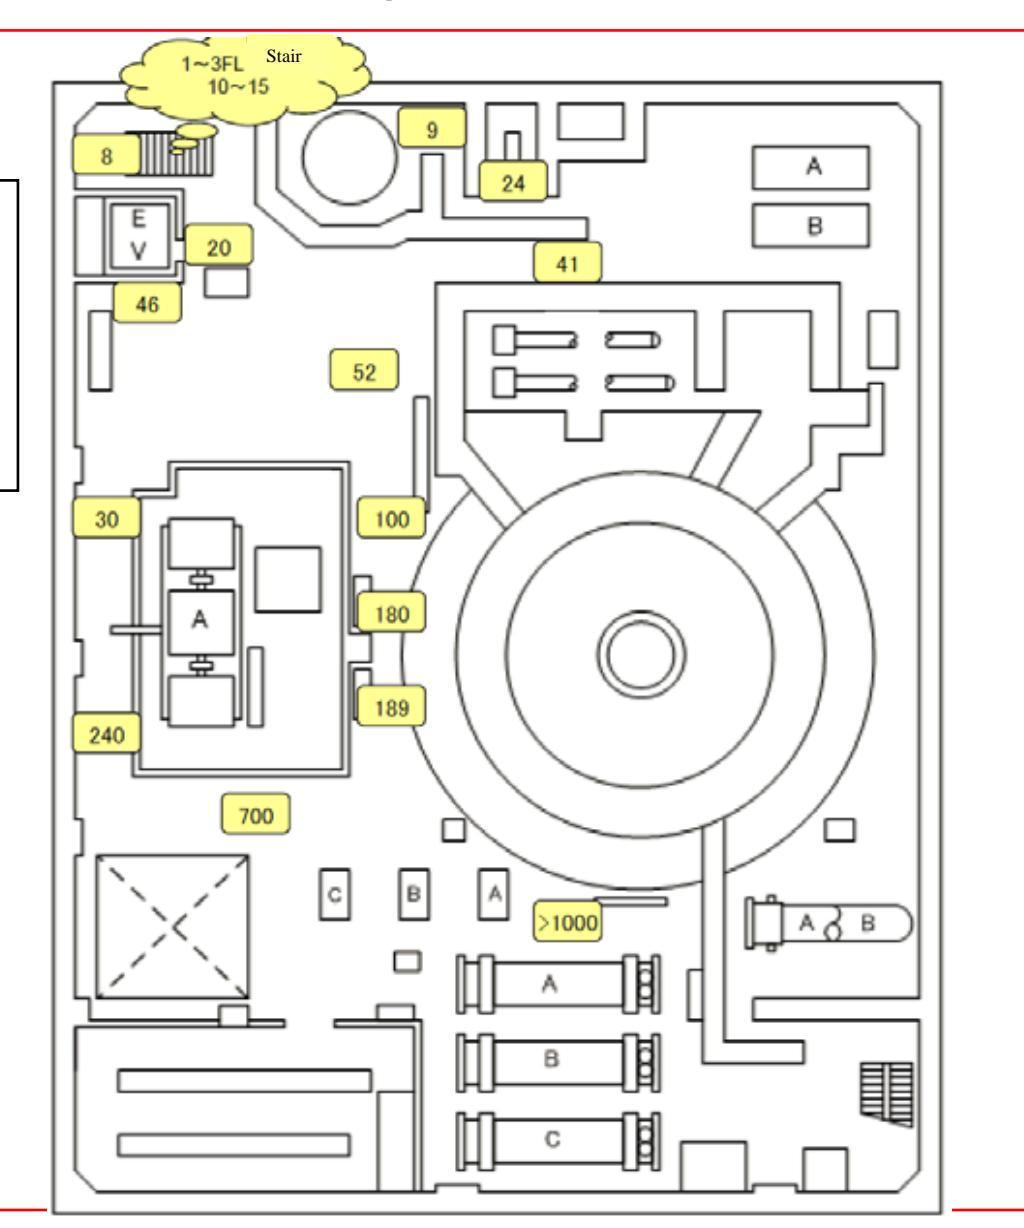
#### Airborne radiation rate of reactor building (2<sup>nd</sup> floor, Unit 1)

➢Around several tens – several hundreds mSv/h at aisle

➢More than 1000mSv/h at high radiation areas

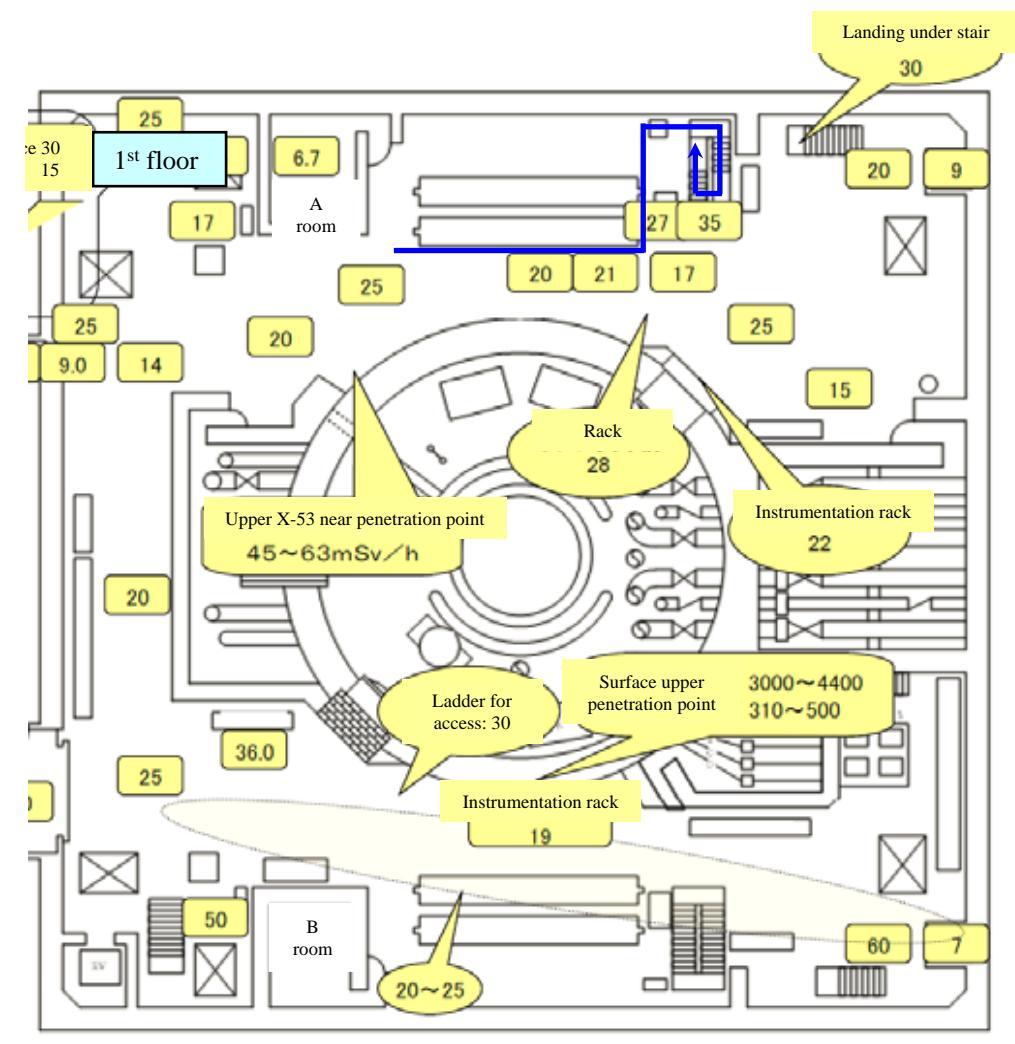
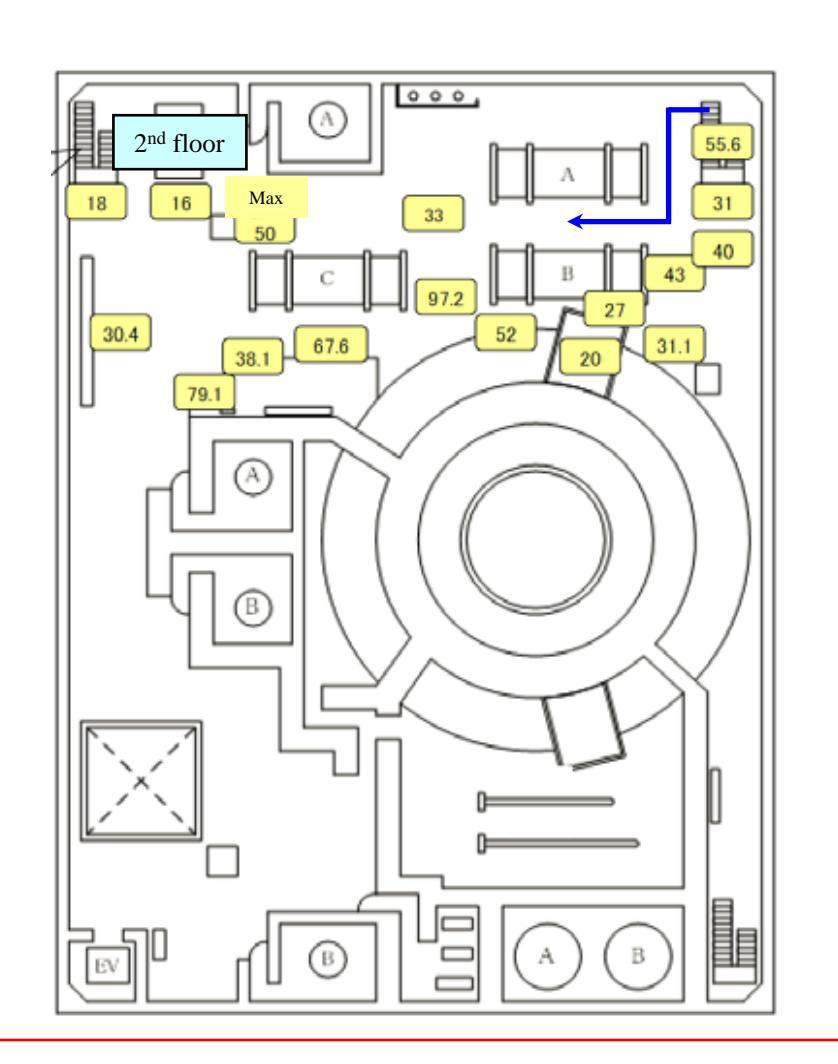
[Image by Quince] Overcoming of the difference  $1^{st}$  floor ~ Stair ~  $2^{nd}$  floor

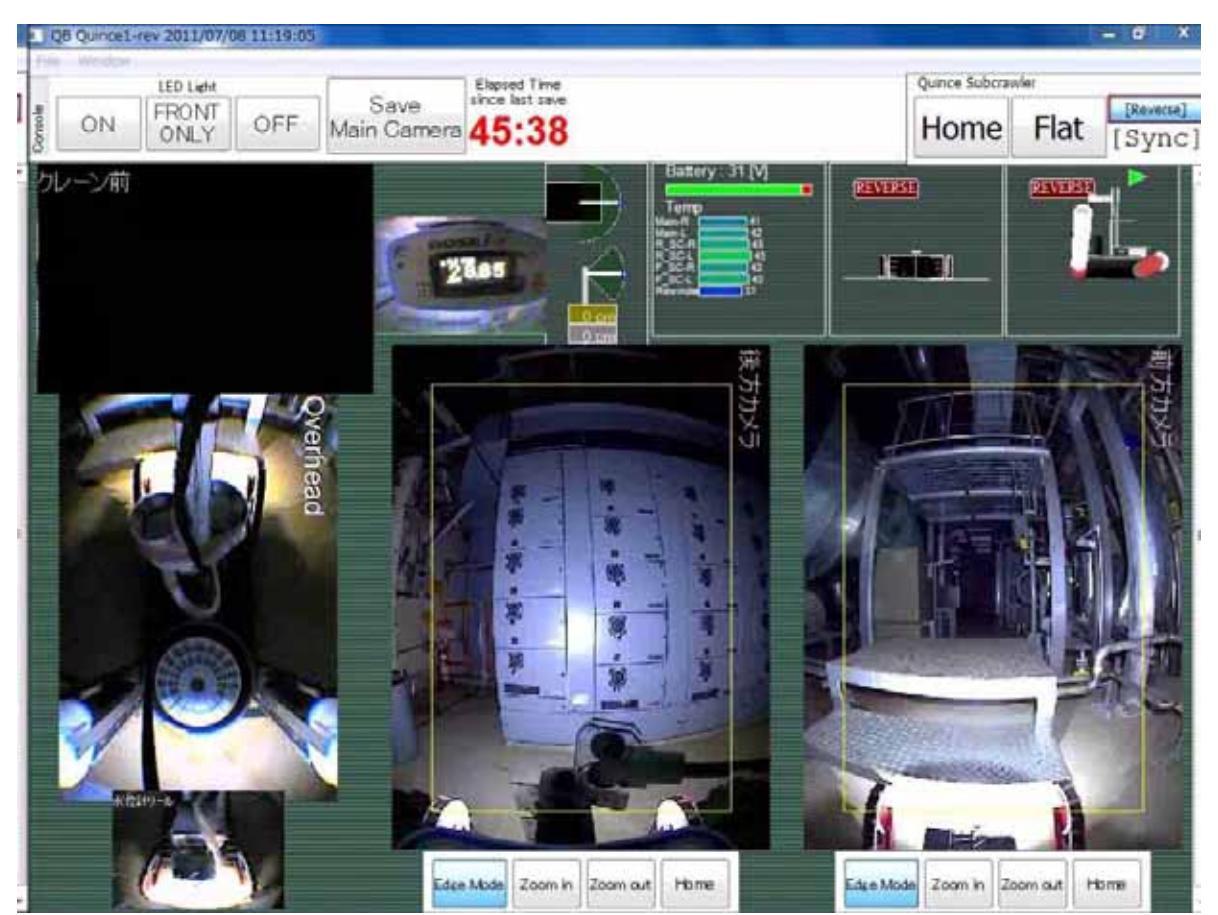
# Status of inside reactor buildings (Unit 2)

[Image by Quince] Overcoming of the difference 1<sup>st</sup> floor ~ Stair ~ 2<sup>nd</sup> floor

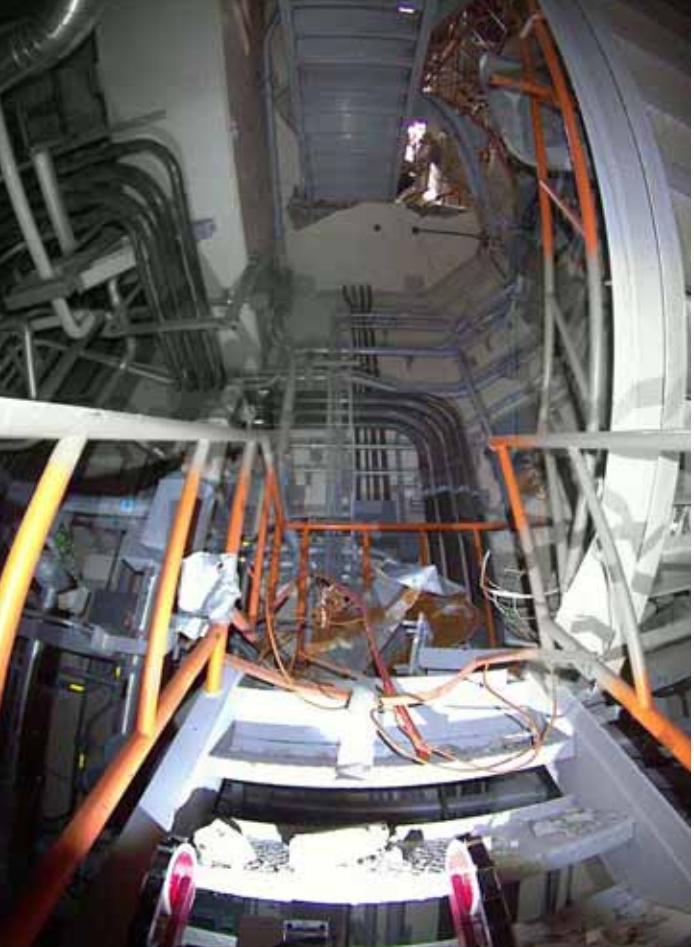
### Status of inside reactor buildings (Unit 3)

(Image by Quince) Overcoming of the difference 2<sup>nd</sup> floor ~ Stair ~ 3<sup>rd</sup> floor, stair is hardly passable

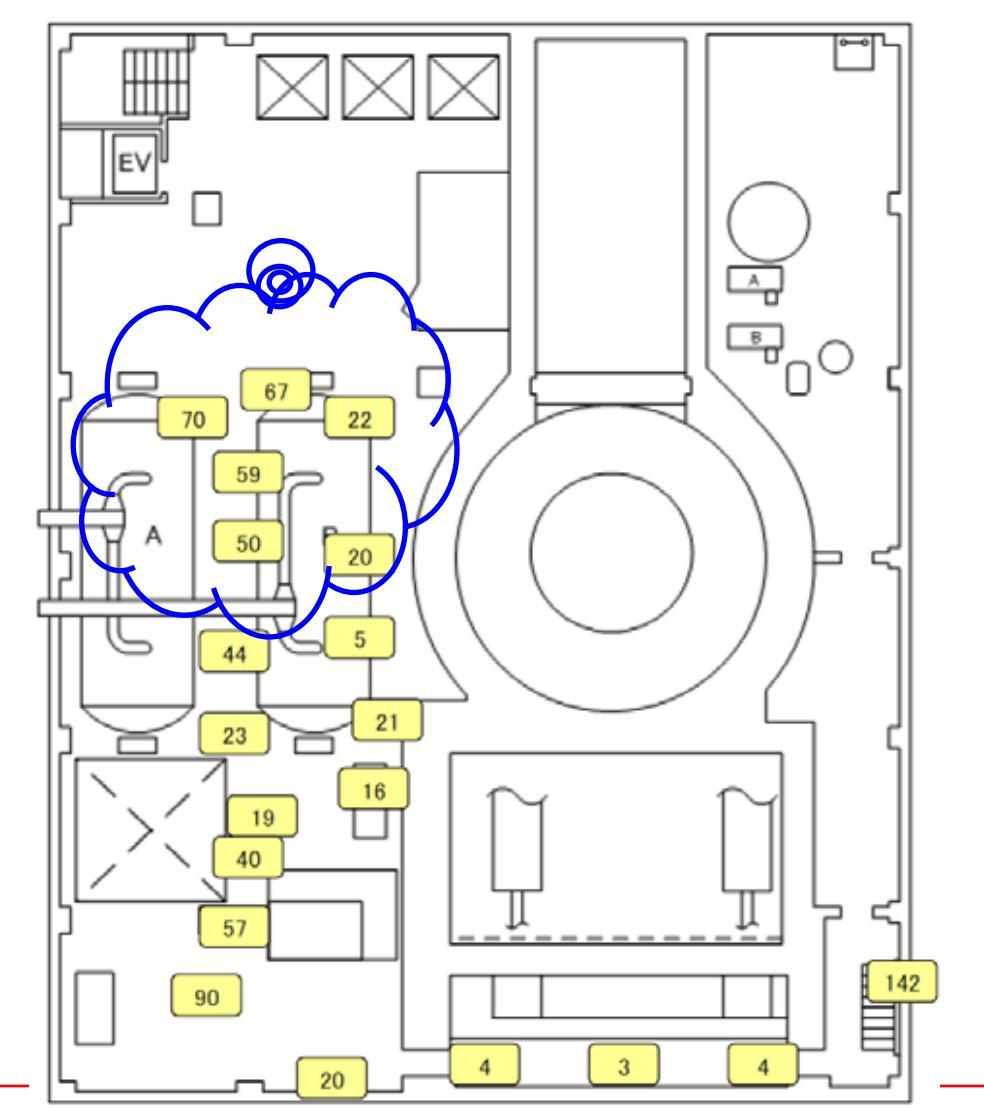
### Debris are scattered around isolation condenser

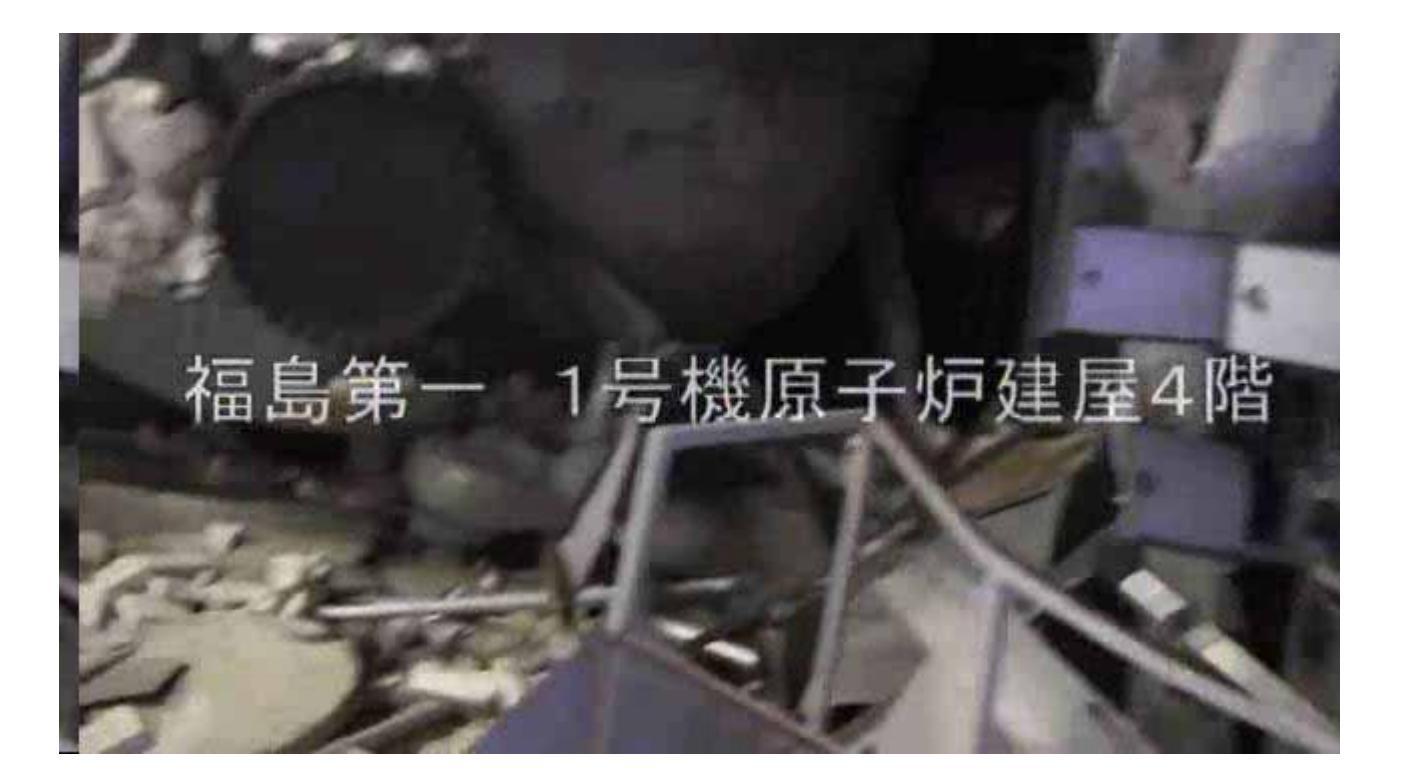
## Status of inside reactor buildings (Unit 1)

Debris are scattered around isolation condenser on 4<sup>th</sup> floor
