Seismic Data from the Unit 3 Reactor Building

February 25, 2021

Tokyo Electric Power Company Holdings Inc.

Background and steps to be taken going forward (1/2)

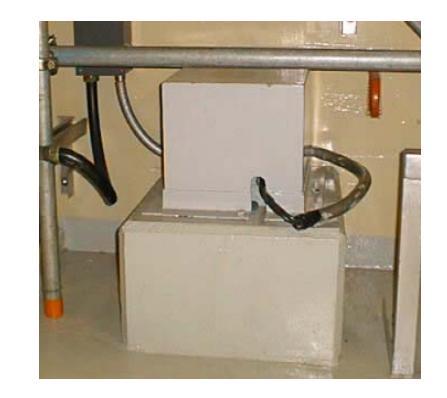
× Simple standalone seismometers that use solar panels for power and send data via wireless transmission were employed

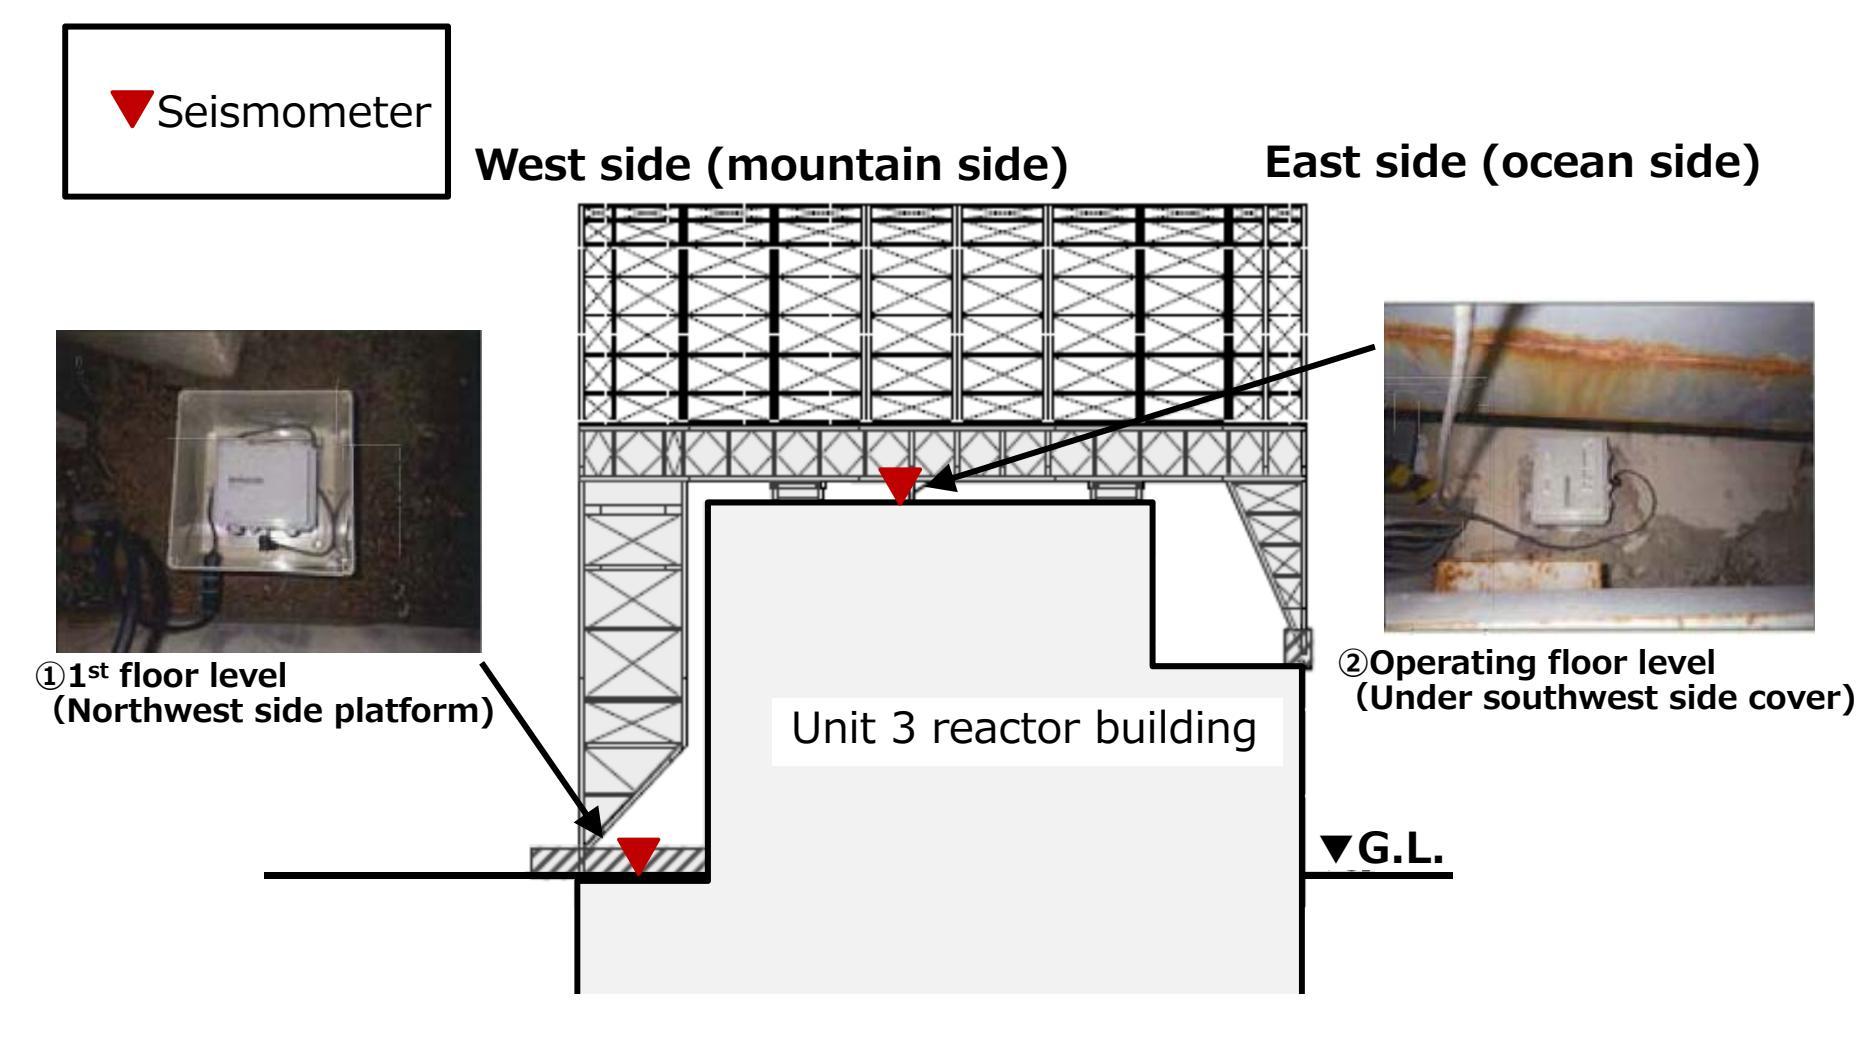
Seismometer installation locations

- OAfter the seismometers were put into use, seismic data was obtained without issue until June 2020, and we started to deliberate how to use the data in order to analyze degradation trends. However, even though a rain cover had been installed, the seismometer installed on the first floor level (outside of the west side platform) become water-logged from rain water and malfunctioned on July 3.

- ODuring this time, the other seismometer (on the operating floor) started to show noise and missing data in its wave patterns on October 13, so an investigation to ascertain the cause was commenced.

OThe results of a detailed investigation into the seismometer that was recording noise revealed a nonconformance with the circuit board, so we began comparing past test data to investigate the possibility of the seismometer being affected by radiation. (January-February 2021)

A total of two seismometers were installed, one on the first floor level and one on the operating floor level of the Unit 3 reactor building

OThe aforementioned seismometers will be repaired and we will begin recording data again during March. Along with implementing measures to prevent the recurrence of malfunctions caused by rain, such as building a new foundation (raising the elevation), we will also prepare for malfunctions by having spare units on hand.
