# 1. Overview of test waterproofing (steel tubes/steel sheet piles)

Changes over time in the temperature of temperature measurement tubes 150-7S, and peripheral temperature measuring tubes (Surface layer excerpt)

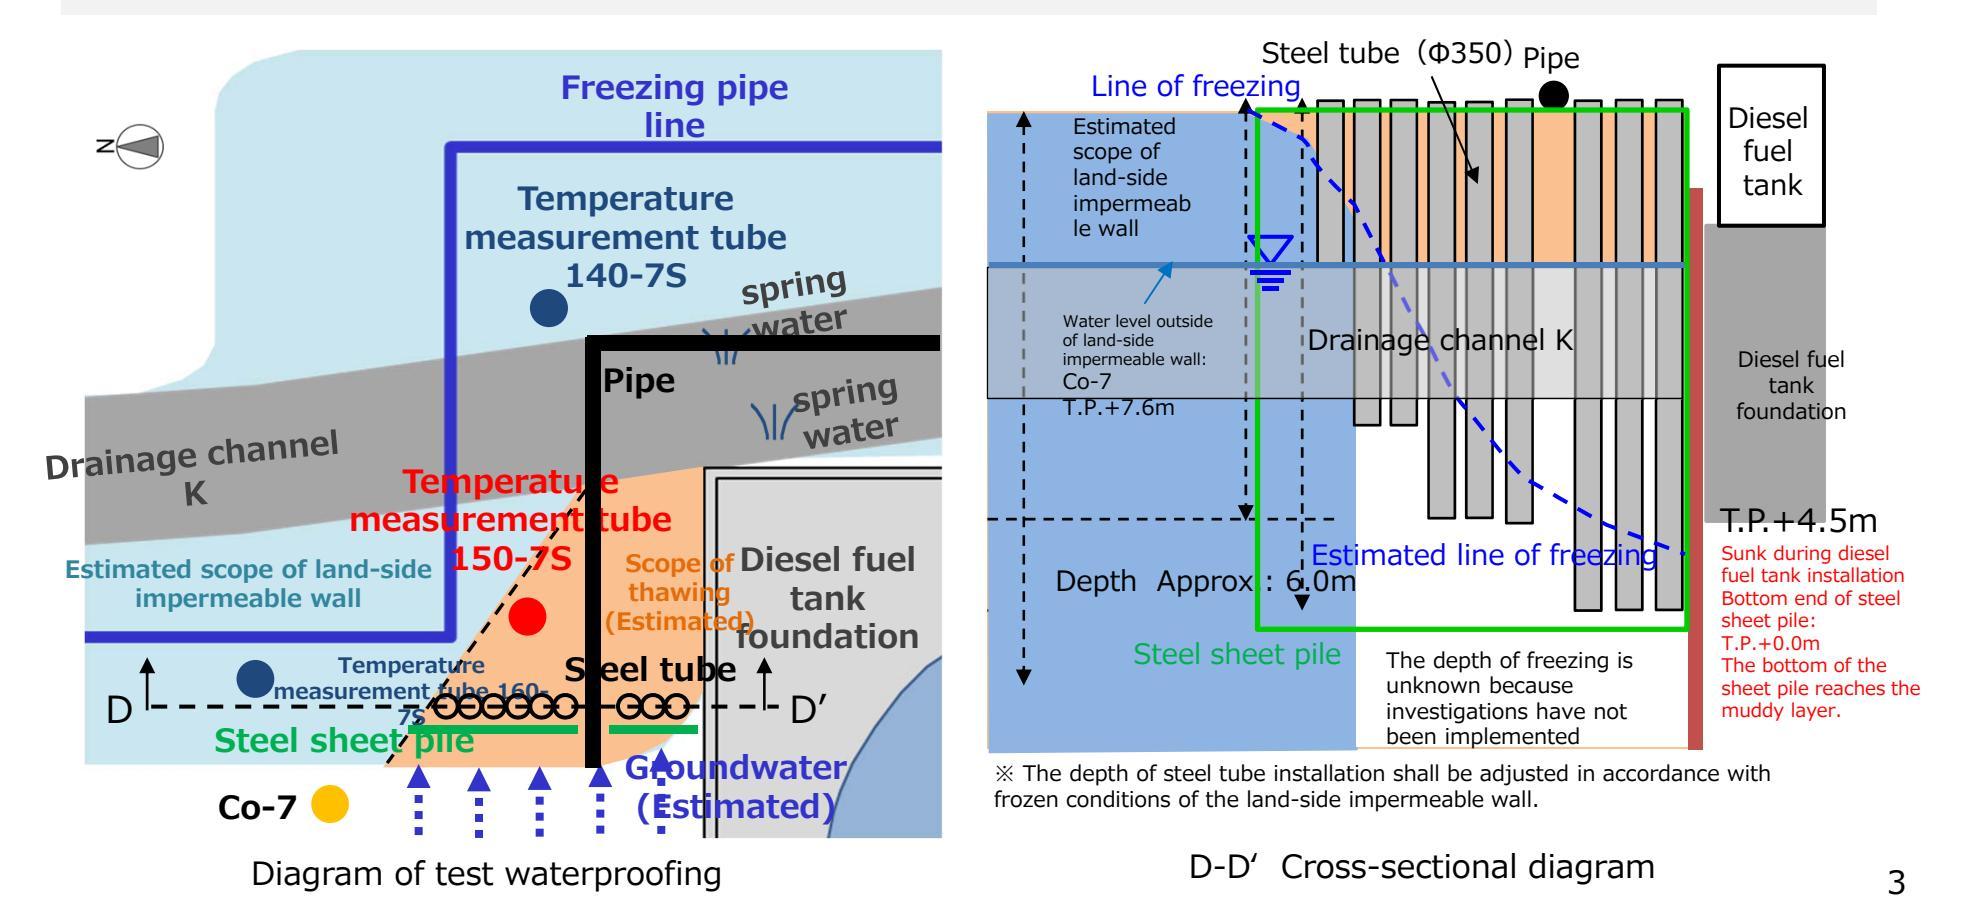
- The impermeability of the land-side impermeable wall is being maintained, but steel tubes will be installed on the mountain side of temperature measurement tube 150-7S in order to prevent the flow groundwater which is thought to be thawing a portion of the land-side impermeable wall.
- During the test waterproofing period temperature measurement tube measurements shall be monitored (refer to the following page for monitoring targets and frequency) in order to ascertain the impact of waterproofing. If it is determined that waterproofing needs to be improved, steel sheet piles will be installed on the mountain side of the steel tubes.

(To buried pipes were found when confirming the location of steel sheet piles already sunk near the diesel fuel tank. In order to avoid these pipes, the number of steel tubes that will be inserted has been changed to eight, which differs from the plan announced on November 25.)

- Eight steel pipes shall be installed on the mountain side of temperature measurement tube 150-7S in order to prevent the flow of groundwater that is thought to be thawing a portion of the land-side impermeable wall.

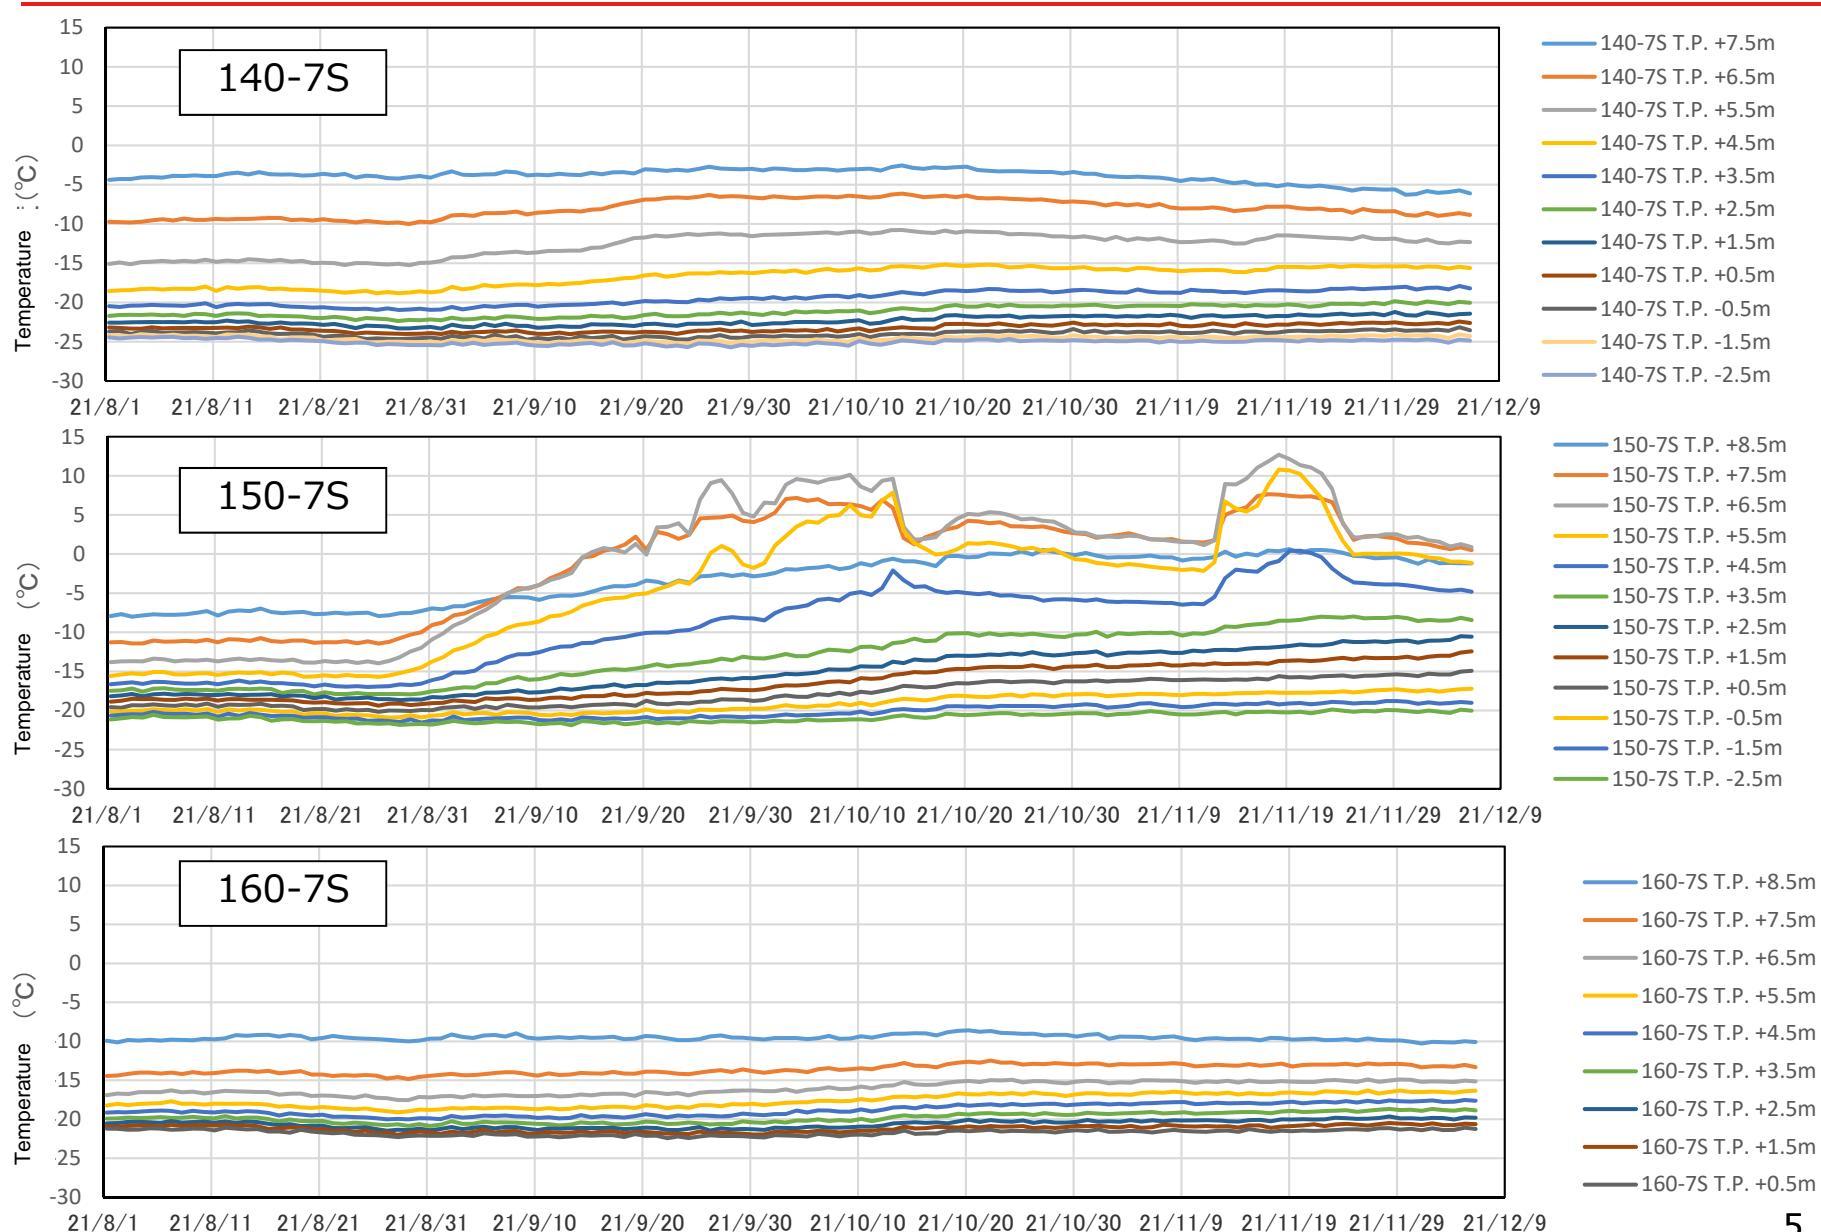
On October 13, it was observed that in localized areas 3m below the ground (around 1.0m~4.0m below the ground surface) temperatures measured by temperature measurement tube 150-7S near the intersection of drainage channel K (downstream side) continued to exceed 0° C

- Furthermore, in light of the discovery of spring water during the investigation of the inside of drainage channel K on November 2 and 3, it is hypothesized that ground water flowing into drainage channel K may have caused some portions of the land-side impermeable wall (frozen-soil wall) to thaw, thereby causing the increase in temperature measured by temperature measurement tube 150-7S.
- Therefore, the decision was made to temporarily waterproof the area outside temperature measurement tube 150-7 at the beginning of December in order to prevent the flow of groundwater and watch for changes in temperatures measured by temperature measurement tube 150-7S, as well as the conditions of ground water flowing into drainage channel K.

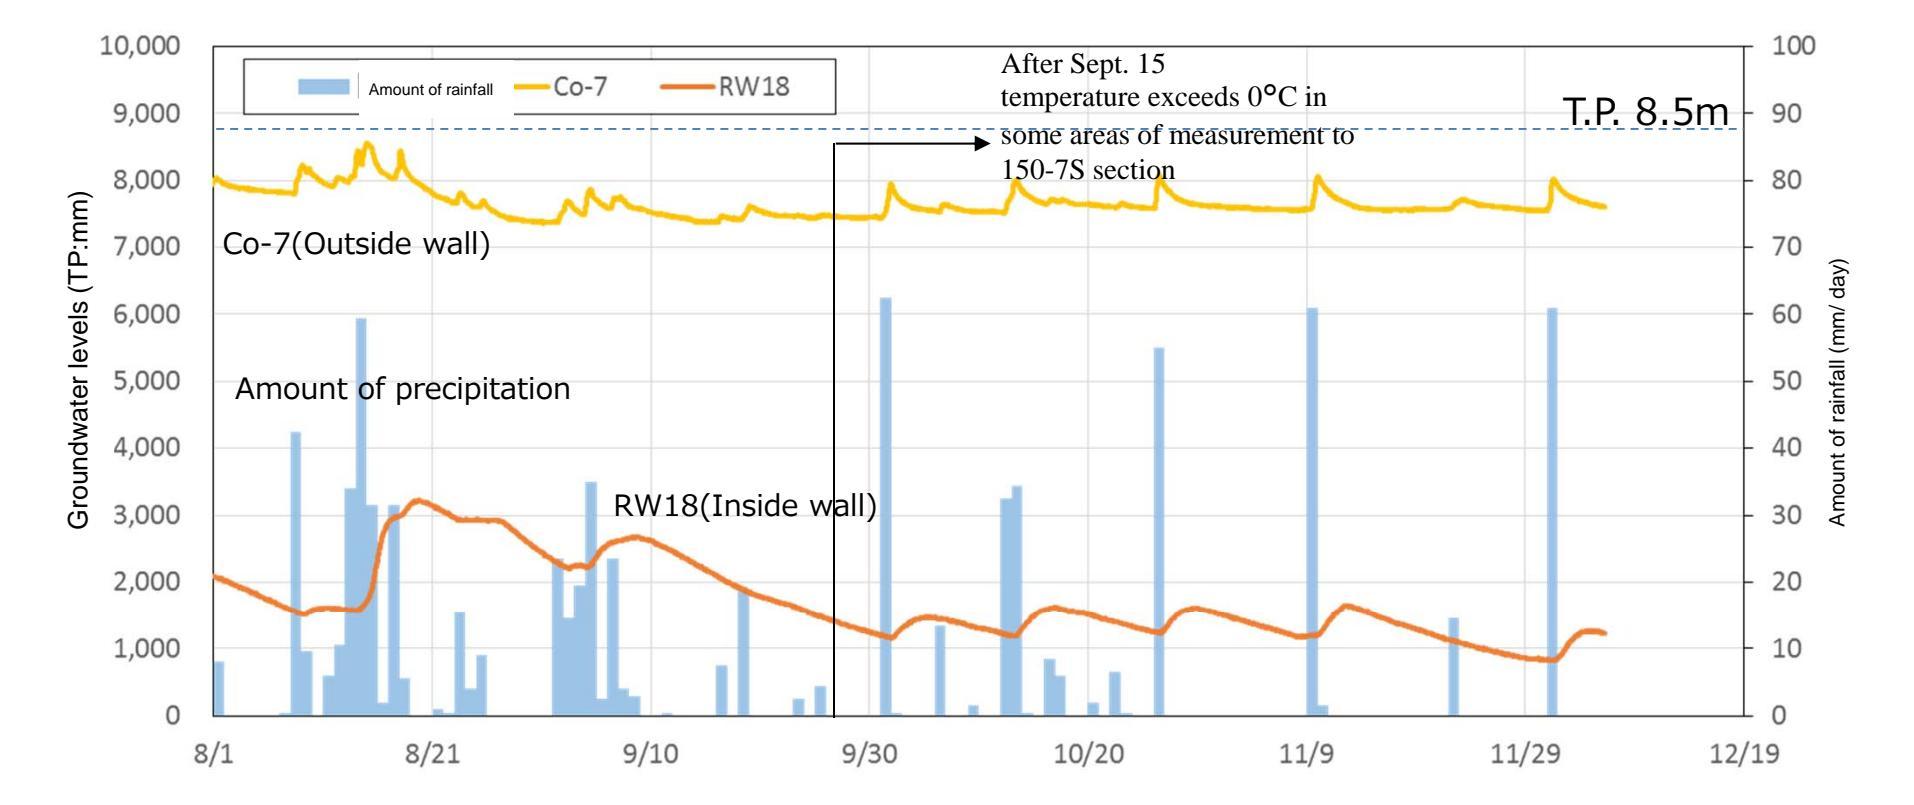
Changes in water levels inside/outside the land-side impermeable wall (frozen-soil wall) and rainfall over time

- During the waterproofing period temperature measurement tube measurements shall be monitored in order to ascertain the impact of waterproofing.
- Since the difference in water levels inside and outside the wall were being maintained, and there has been no change in the amount of water being pumped up by subdrains, it was determined that this is not having an impact on the impermeability of the land-side impermeable wall.

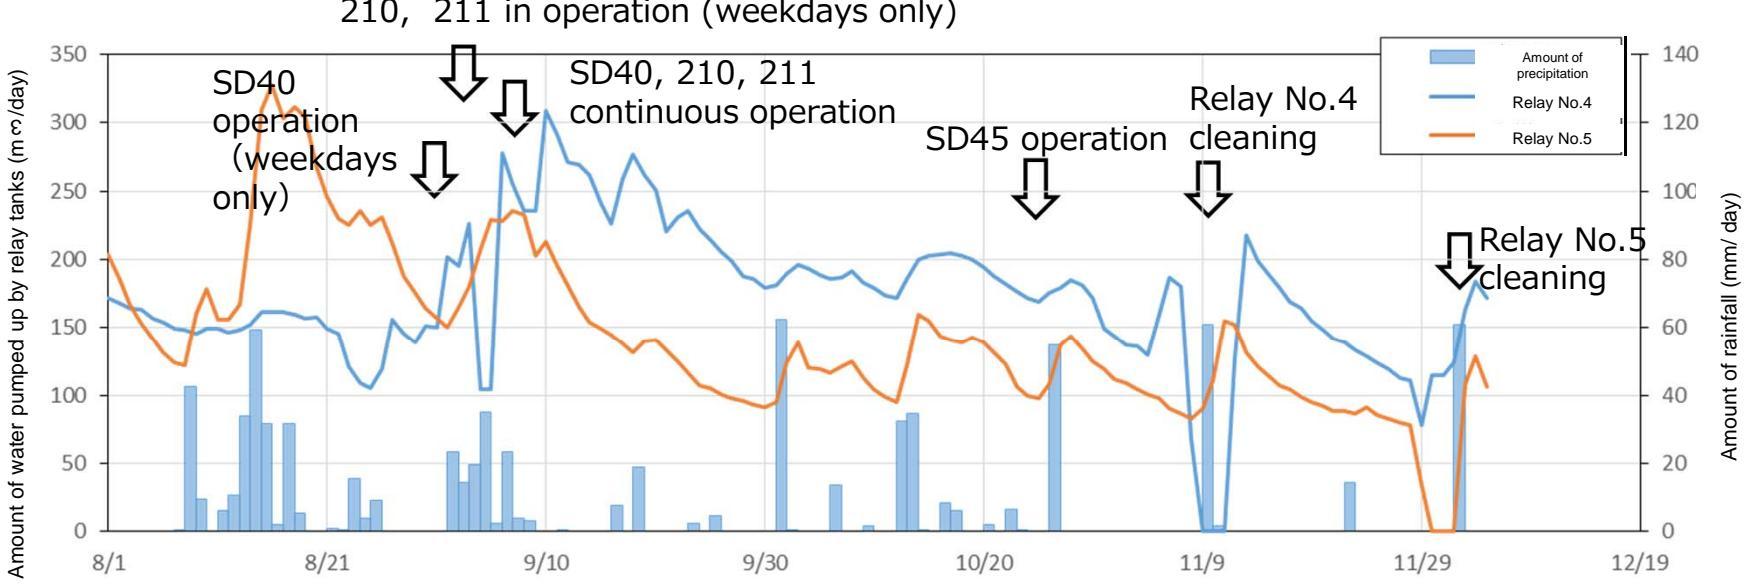
The relationship between the amount of water pumped up by subdrains No. 4, No.5 relay tanks and the amount of precipitation

Throughout the construction period, the amount > of water being pumped up including operation status will be monitoring
