Reference February 2, 2017 Tokyo Electric Power Company Holdings, Inc.

Pre-investigation results of the area inside the pedestal for the Unit 2 Primary Containment Vessel Investigation at Fukushima Daiichi Nuclear Power Station (examination results of digital images)

# 1. Current conditions of Unit 2 Primary Containment Vessel (PCV)

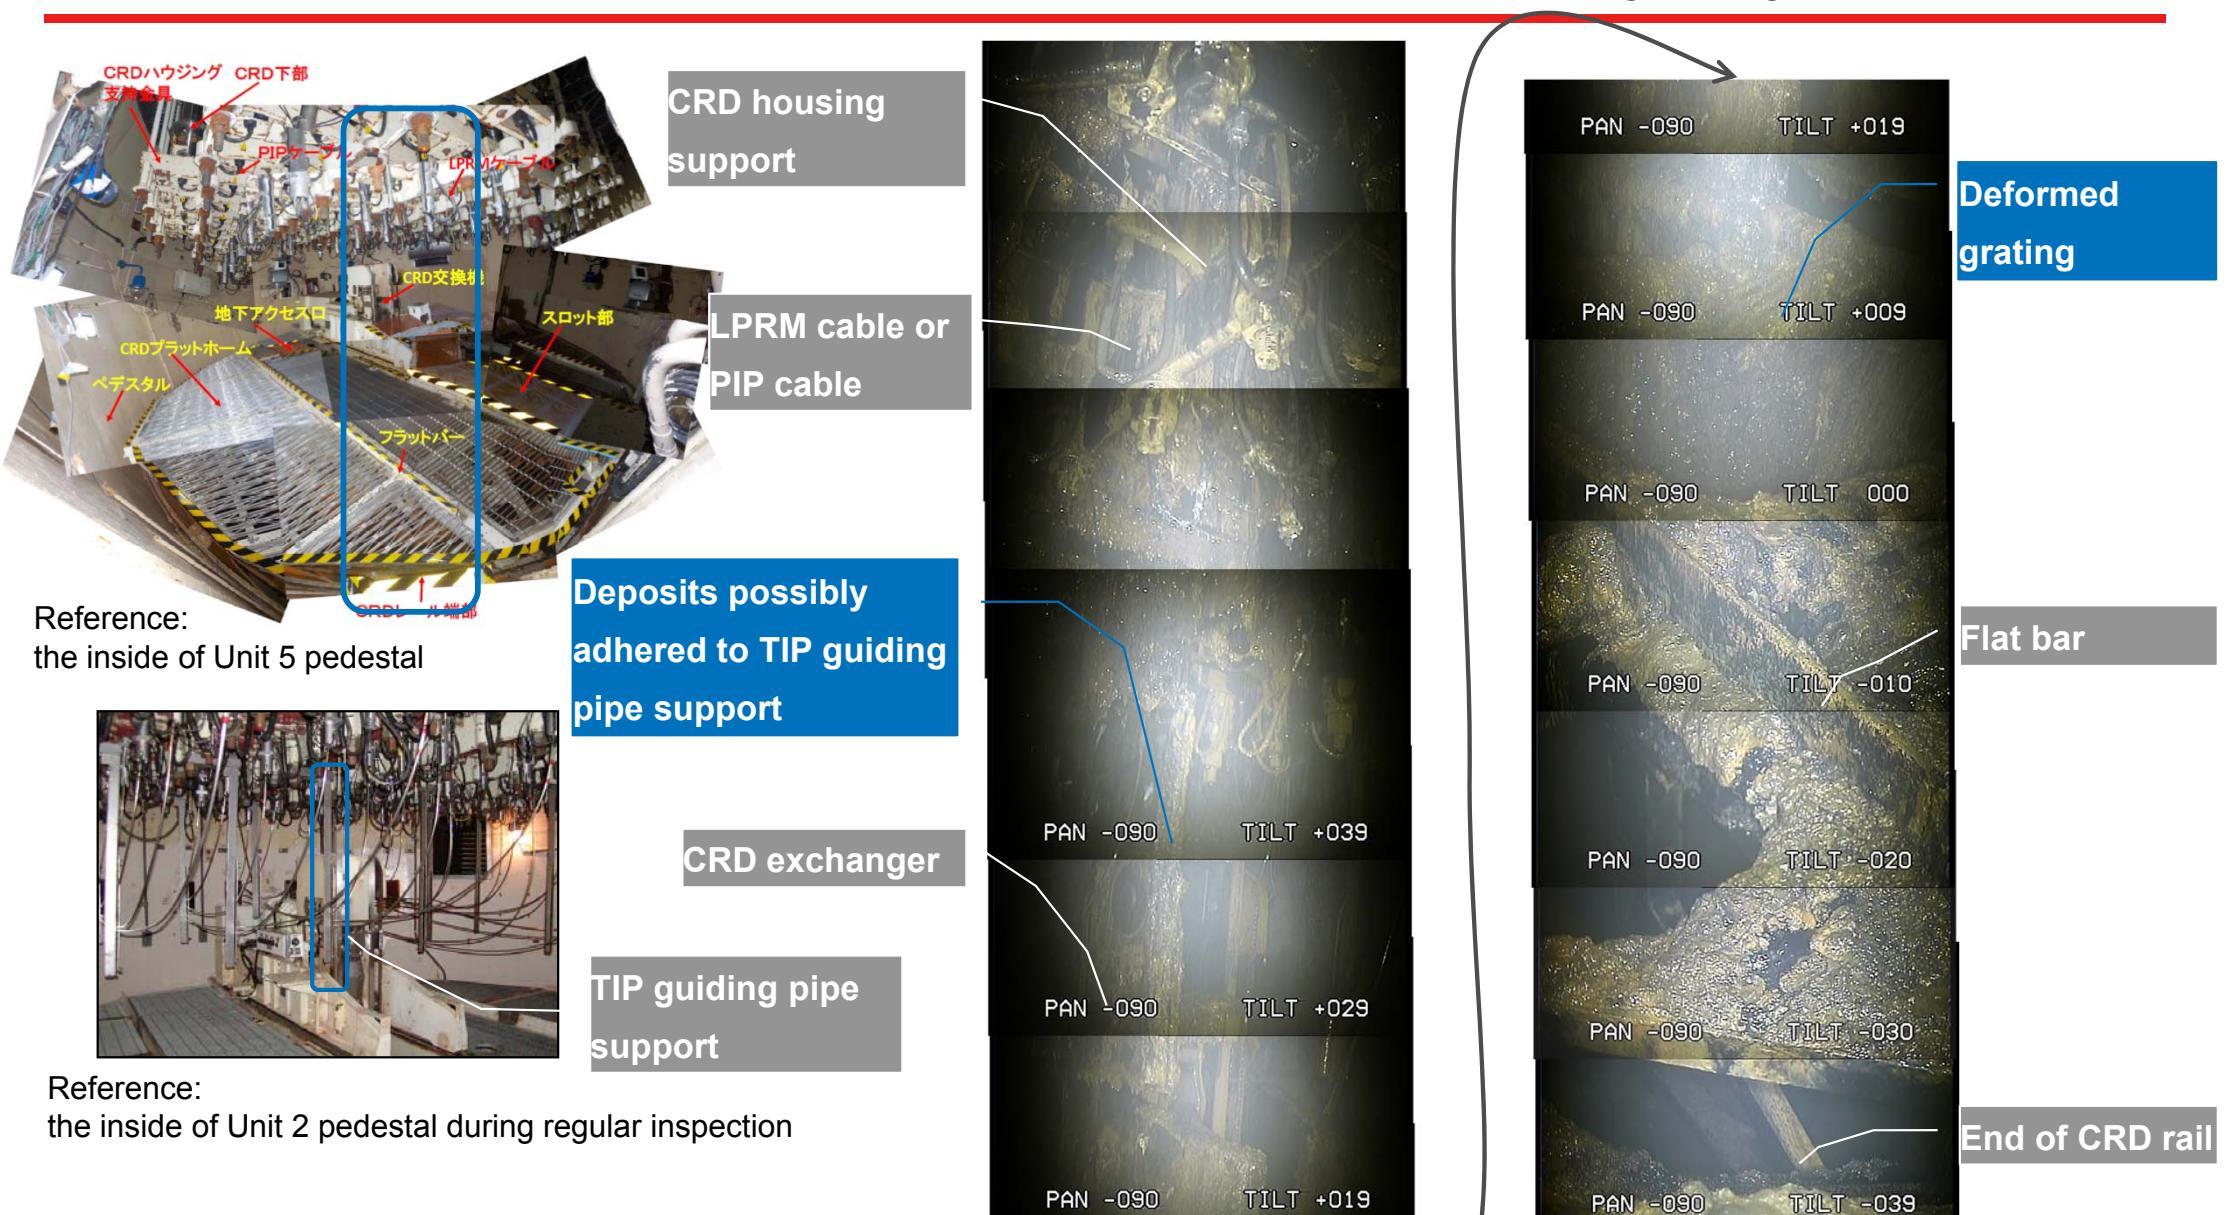
### 4-1. Pre-investigation results for the area inside the pedestal

LPRM (Local Power Range Monitor) measures flux levels of neutron inside the reactor core.

TIP (Traversing In-Core Probe System) proofs LPRM.

PIP (Position Indicator Probe) detects positions of Control Rods.

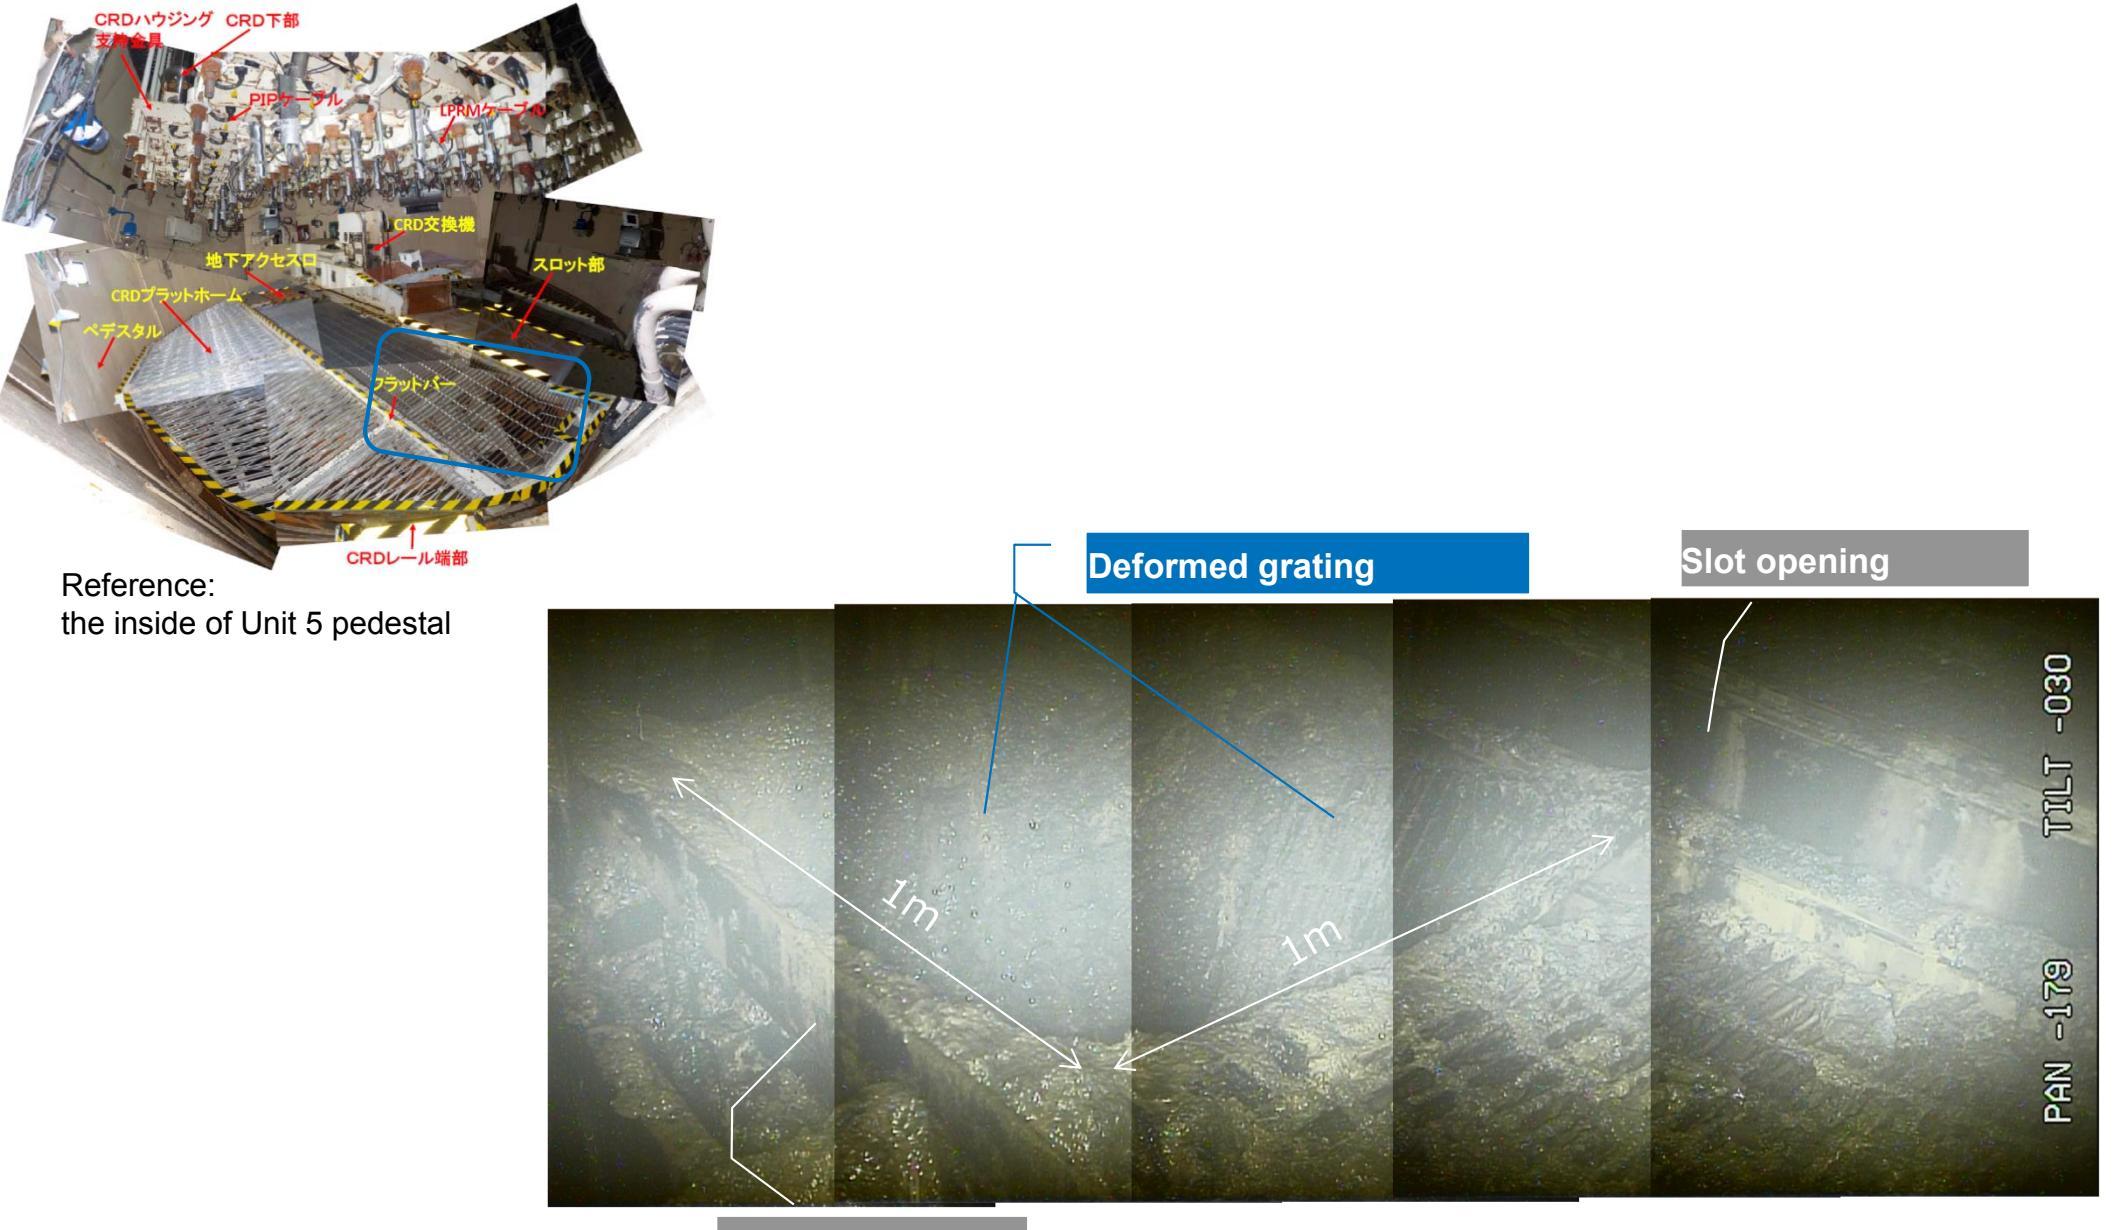
4-2. Pre-investigation results for the area inside the pedestal (examination results of digital images) **TEPCO**

Flat bar

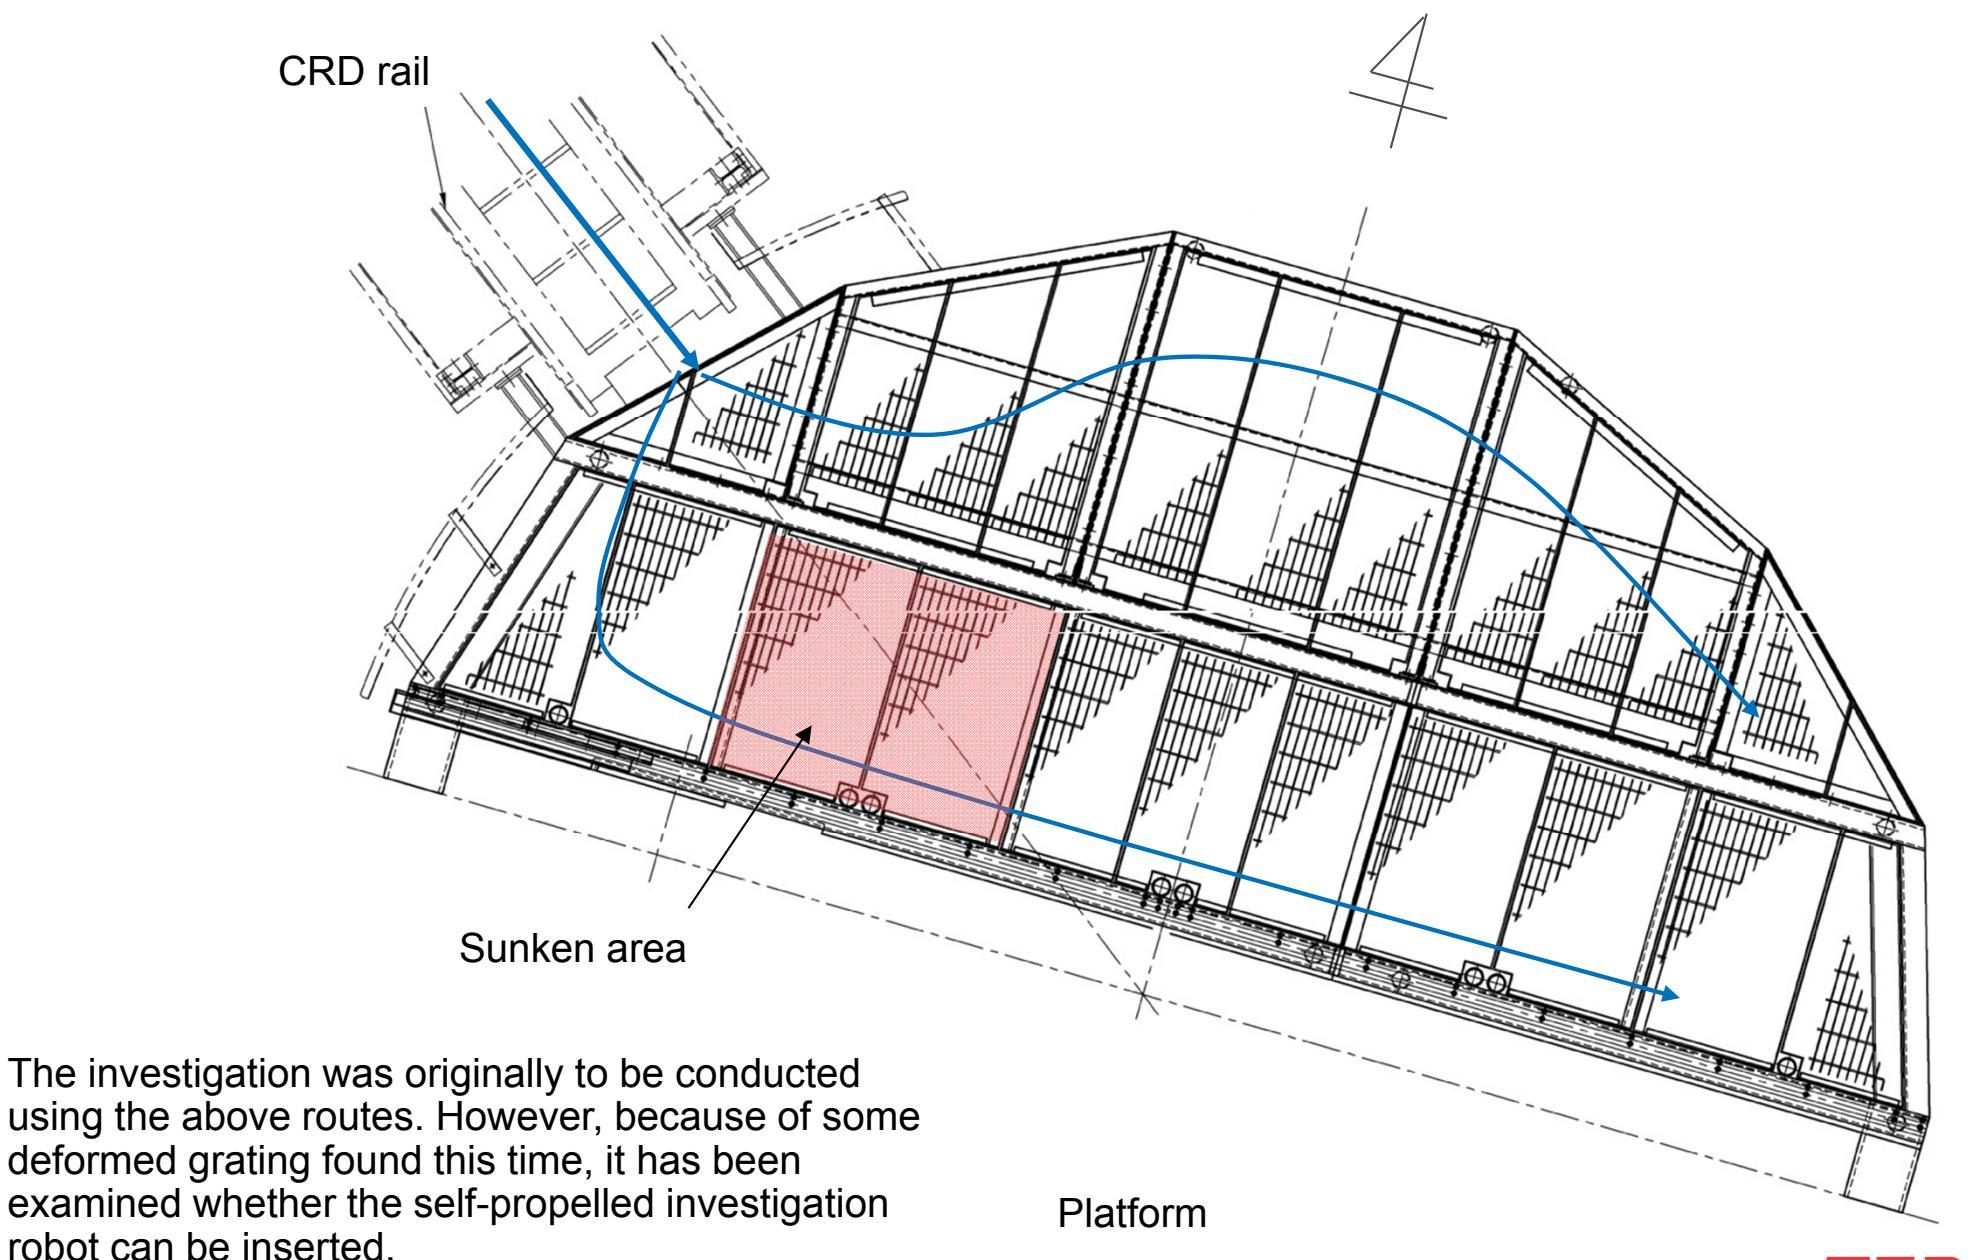
#### 5. Expected investigation routes for the self-propelled Scorpion robot

- To determine whether the obstacle removal robot and the self-propelled investigation robot can be inserted inside the pedestal, we examined digital images obtained from the pre-investigation conducted on January 30 and found detailed conditions inside the pedestal.
  - Some deposits possibly adhered to TIP guiding pipe support
  - > A part of the grating sunken in at the center of the pedestal
- Based of the conditions inside the pedestal found this time, we will proceed with the examination on whether to insert the obstacle removal robot and the self-propelled investigation robot.
