ALPS Treated Water Discharge Status Update

November 30, 2023

Tokyo Electric Power Company Holdings, Inc.

-
- 1 . Performance of the Third Discharge (P2~22)**
 - 2 . Reviewing the first three discharges and plans for future discharges (P23~31)**

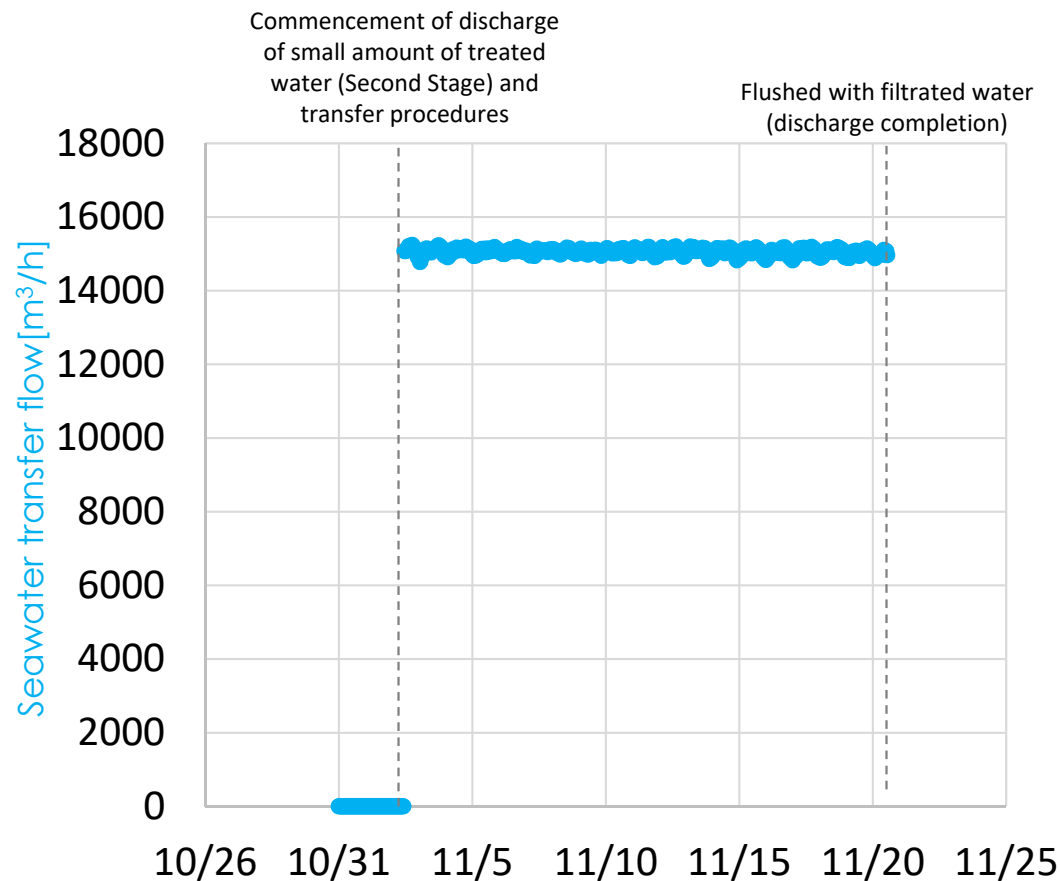
■ We were able to operate ALPS treated water transfer systems and seawater systems without issue.

ALPS treated water transfer flow and total transfer volume of ALPS treated water

Seawater transfer flow

*1 : The flowmeters are reduplicate, so the higher of the figures from both meters was used.

*2 : Total for systems A and B

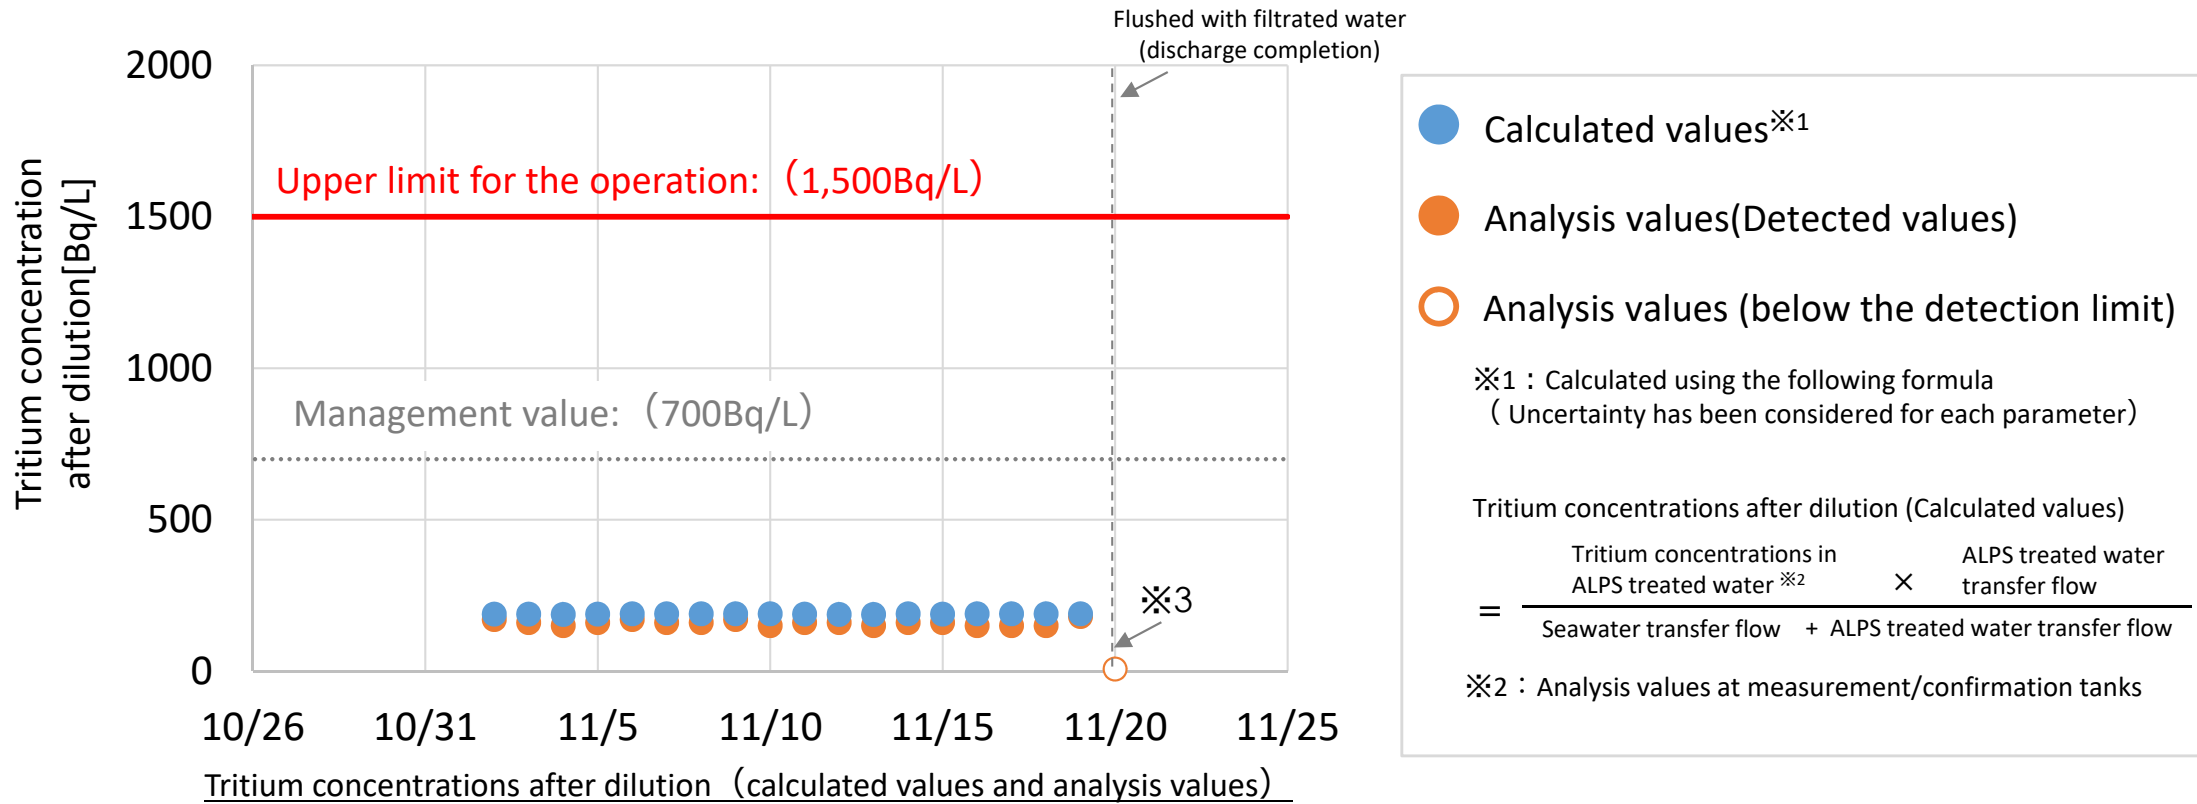
- During the discharge period, water was sampled daily from the seawater pipe to analyze tritium concentrations.
⇒ Confirmed to be less than the upper limit for the operation: 1,500Bq/liter
- Furthermore, on November 20, the ALPS treated water transfer pipe was flushed with an amount of filtrated water that exceeds the volume of the pipe and samples were taken afterwards. An analysis of these samples showed no detection (ND; concentrations of radioactive substances were below detection limit) thereby confirming that the water inside the ALPS treated water transfer pipe had been flushed with filtrated water.

11/2	11/3~11/19	11/20
Calculated value: Time of data acquisition	14:00	7:00	—
Analysis value: Time of specimen sampling	14:13	7:00~10:00	11:54

※3 : No calculated values since the pipes were flushed out with filtrated water.

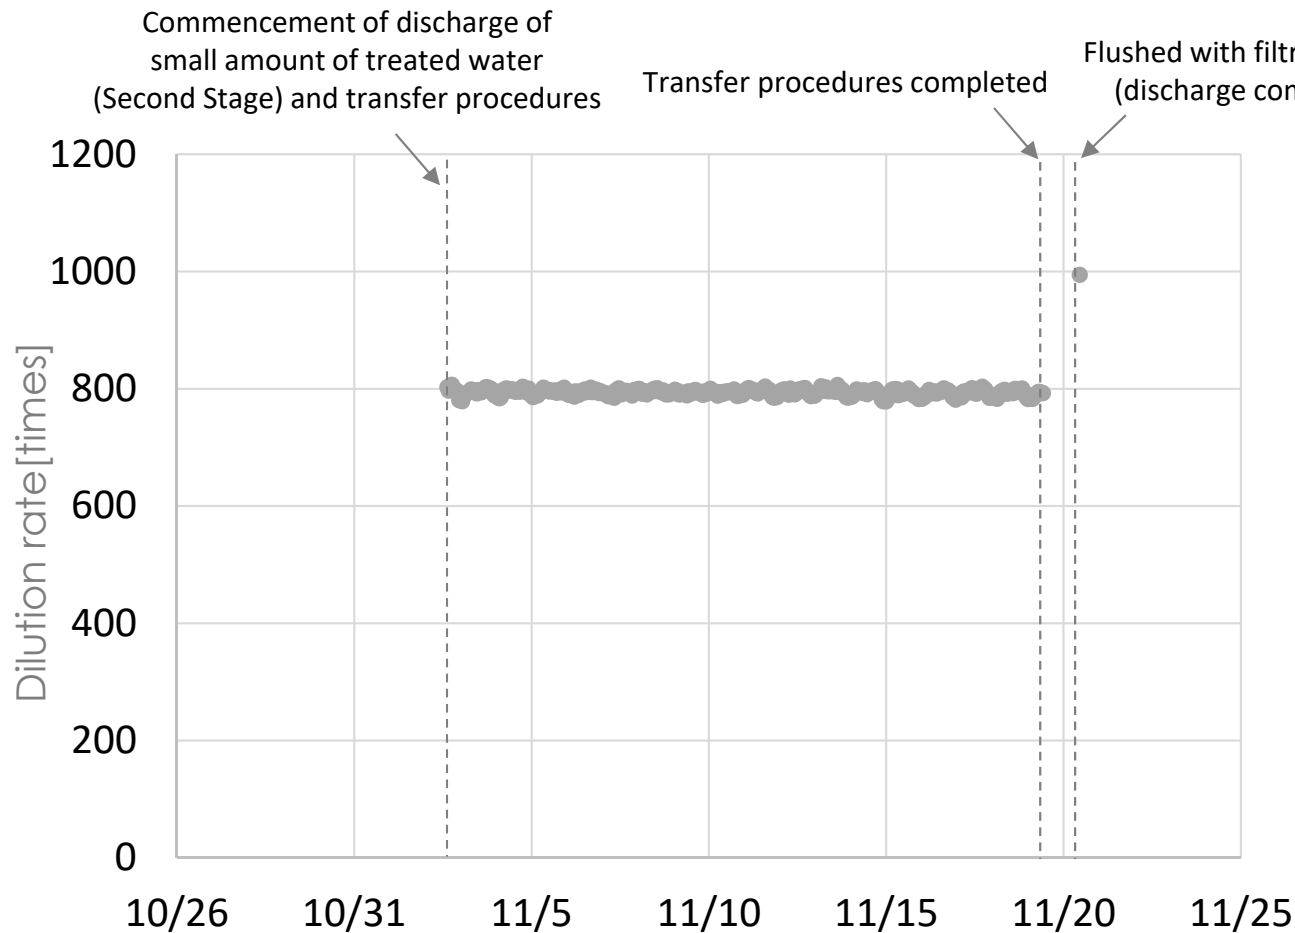
Dilution rate of ALPS treated water

- The dilution rate has always been kept at over 100 times during the discharge.

● Dilution rate^{※1}

$$\text{Dilution rate} = \frac{\text{Seawater flow rate}^{\text{※2}} + \text{ALPS treated water flow rate}^{\text{※3}}}{\text{ALPS treated water flow rate}^{\text{※3}}}$$

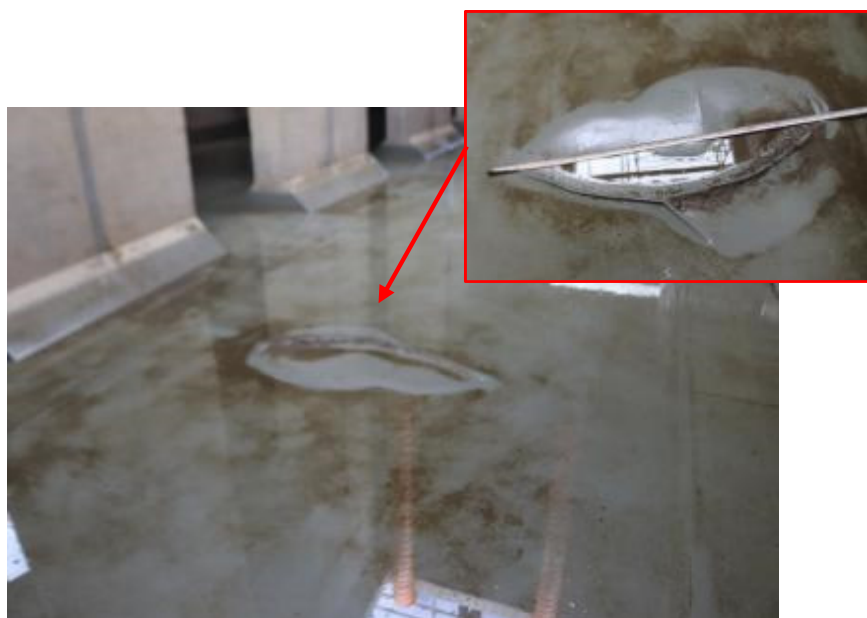
Waterproof coating bubbles

To address the bubbling of the waterproof coating inside the storage, the following repairs will be implemented in order to engage in preventative maintenance.

Locations to be repaired	Repair method
Bubbles over 10cm in width*	①Cut the bubbles to drain the rainwater underneath the waterproof coating that caused the bubbles ②Install a temporary weir around the cut area, treat the surface and apply waterproof coating(Polyurea)
Wall panel joints	①Cut through the caulking between joints where rainwater is expected to accumulate to drain rainwater ②Caulk the cut area after the drainage is completed (Highly weather resistant one-component polyurethane)

*As a result of the inspection, bubbles that are either narrow or wider than 10cm but are deemed not to require repairs, will be subject to follow-up observations.

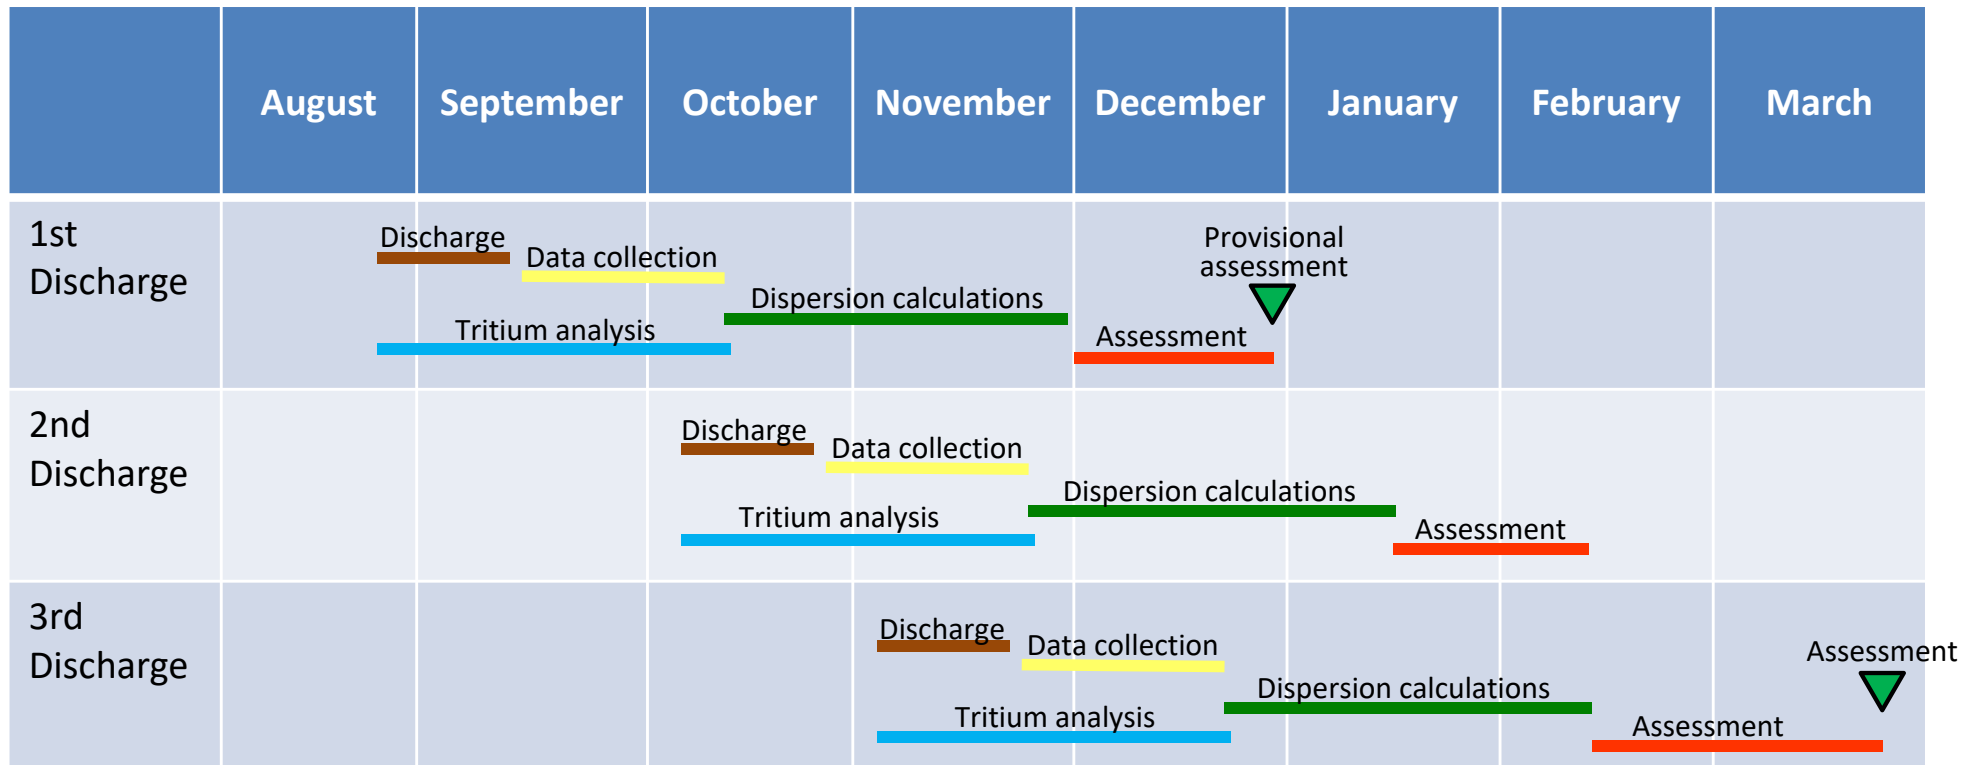
2-3. Dispersion simulation review schedule

- Analyzing the tritium concentrations in seawater sampled during the discharge takes approximately one month.
- And, it takes approximately one month after that to obtain the meteorological/marine meteorological data because reanalysis needs to be conducted.
- Dispersion calculations and assessment will be conducted thereafter, so the total process from the completion of discharge until assessment will take approximately three months.
- A provisional assessment of the 1st discharge will be released in December, and an assessment of all three discharges will be released at the end of March next year.

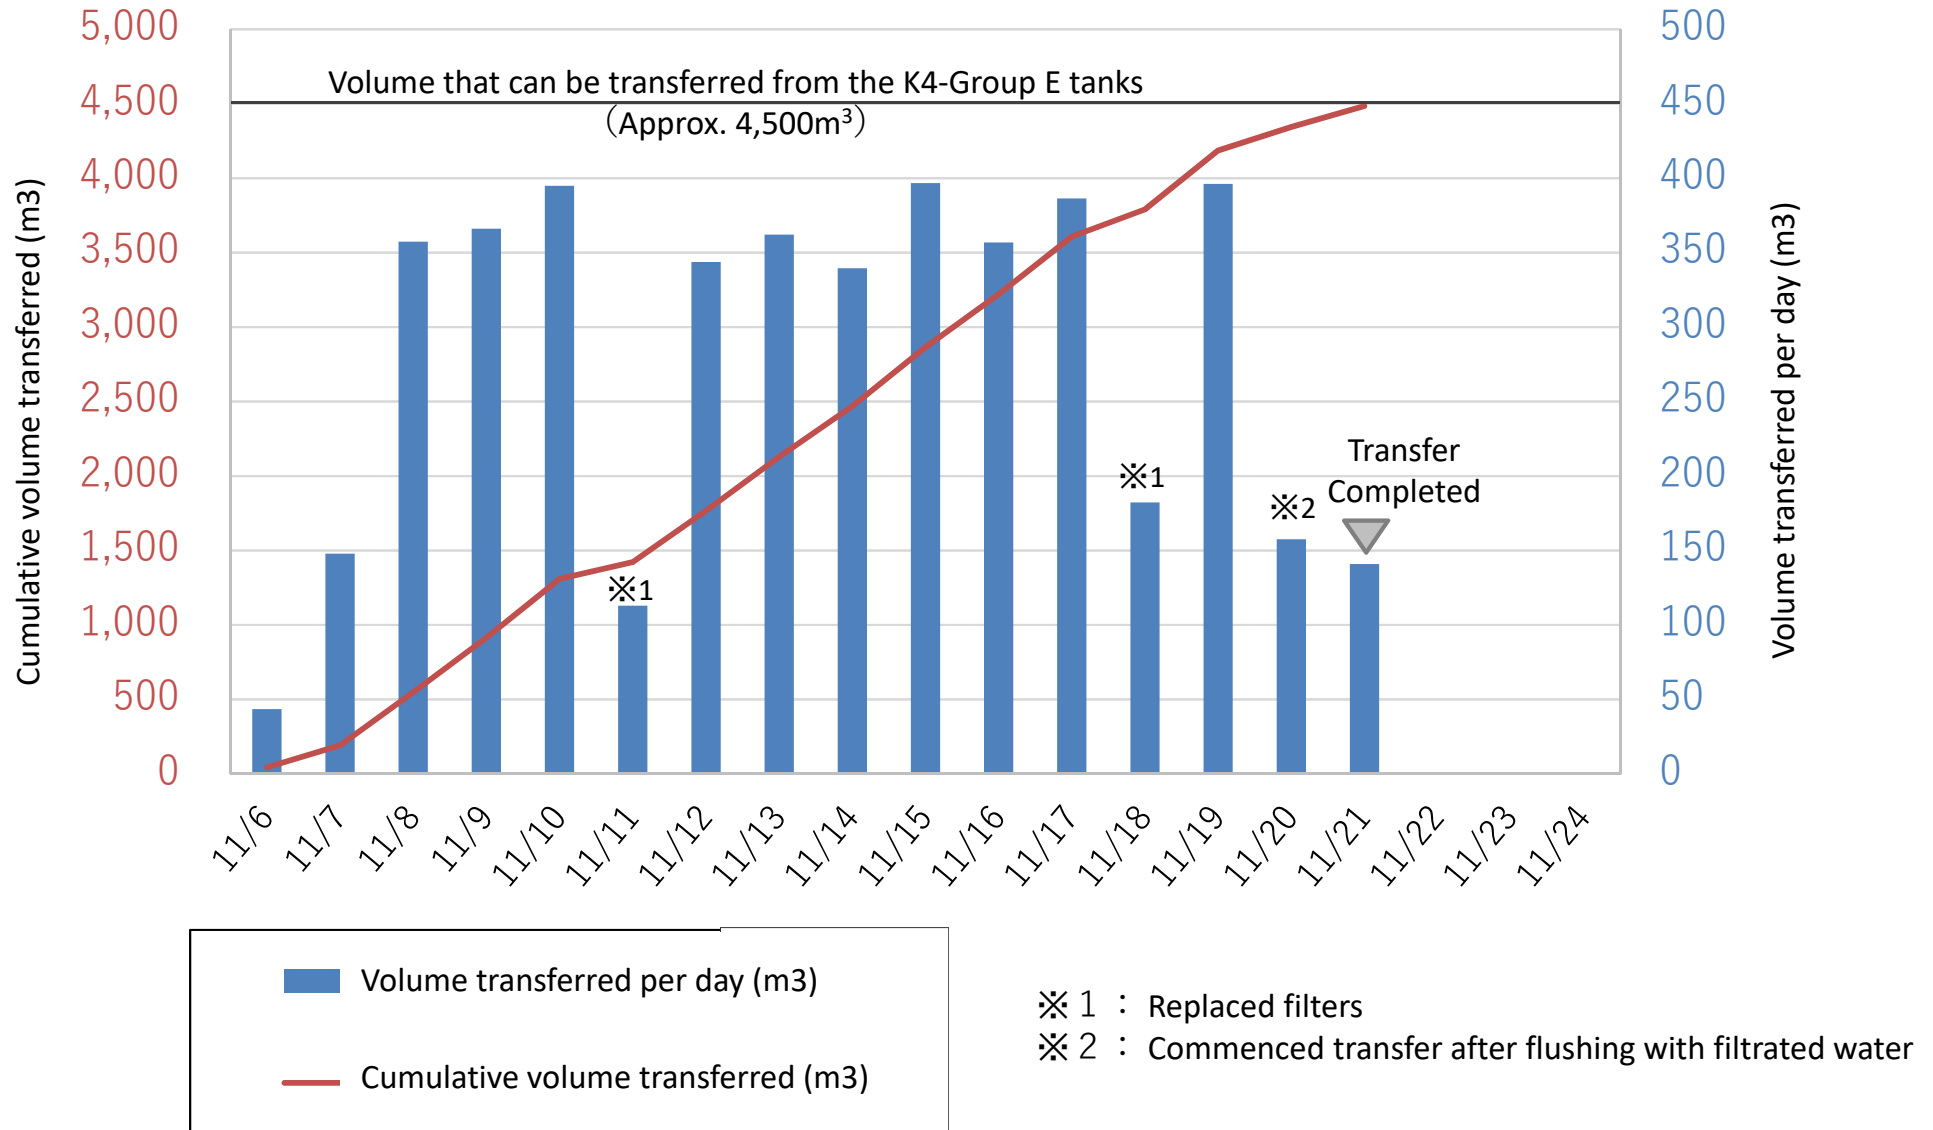
[Reference] Water transfer record for K4 tank group E in preparation for the fourth discharge

- In preparation for the 4th discharge of ALPS treated water into the sea, ALPS treated water will be transferred from tank group E in K4 area and tank group A in K3 area to measurement/confirmation tank group B.
- To transfer the water, temporary equipment including hoses, pumps and filters will be installed as shown in the following diagram. This water transfer will be conducted upon implementing leak countermeasures, such as using dual-layered hoses, etc.
