# Fukushima Daiichi Nuclear Power Station

## Completion of the Dismantling of the D1 tank E Area

< Reference document >  
J u n e 1 5 , 2 0 2 6  
Tokyo Electric Power Company Holdings, Inc.  
Fukushima Daiichi Decontamination &  
Decommissioning Engineering Company

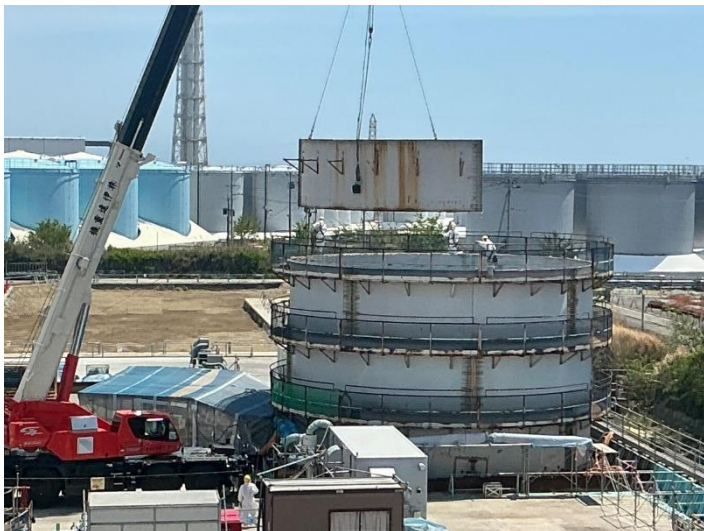
Dismantling of D1 tank in E area (May 12, 2026)

- The inside of the tank was cleaned and decontaminated after which dismantling began on May 12, 2026, and was completed on June 15, 2026.
- Standardization<sup>※</sup> of the dismantling process, which took place over the course of flanged tank dismantling, and the introduction of technology, such as laser decontamination, enabled the highly contaminated tanks to be dismantled safely.

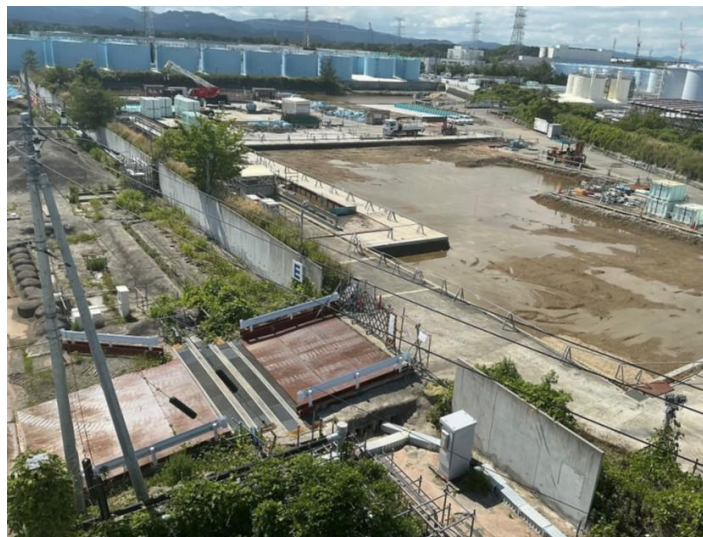
After dismantling D1 tank in E area (June 15, 2026)

- Dismantling of the D1 tank in E area was completed on June 15.
- This marks the completion of the dismantling of all 334 flanged tanks used to store contaminated water for approximately 11 years since the accident which began in May 2015.
- We will continue to prioritize safety as we move carefully forward with the decommissioning work of the Fukushima Daiichi Nuclear Power Station in order to reduce risk.

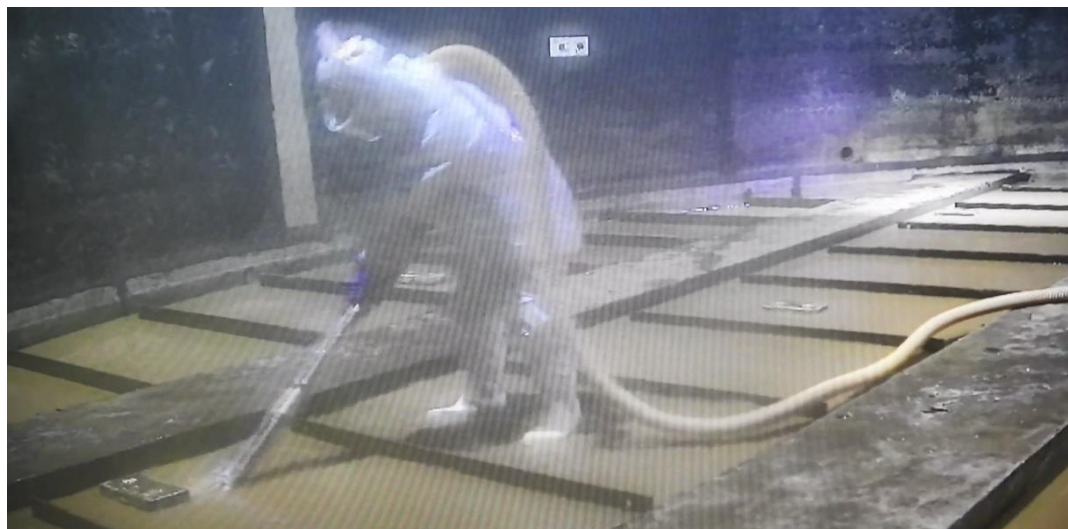
Cleaning the inside of tank D1 in E area (December 24, 2025)

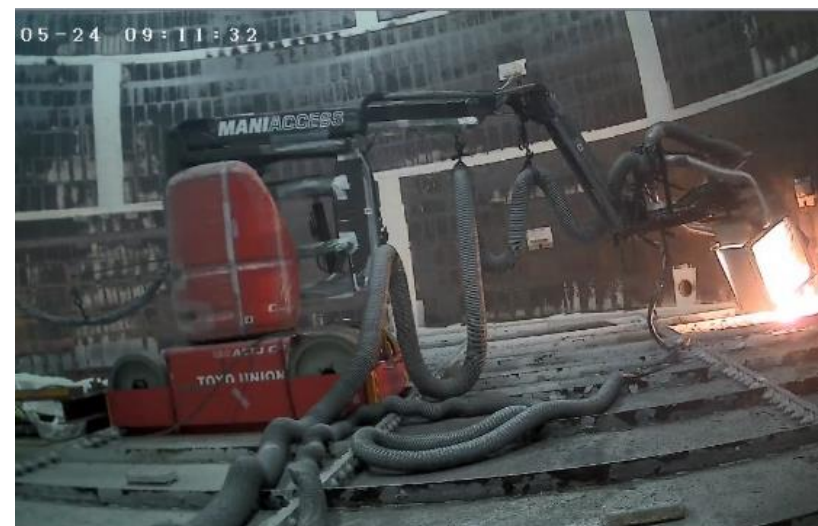
Using lasers to decontaminate a tank in E area (May 24, 2022)

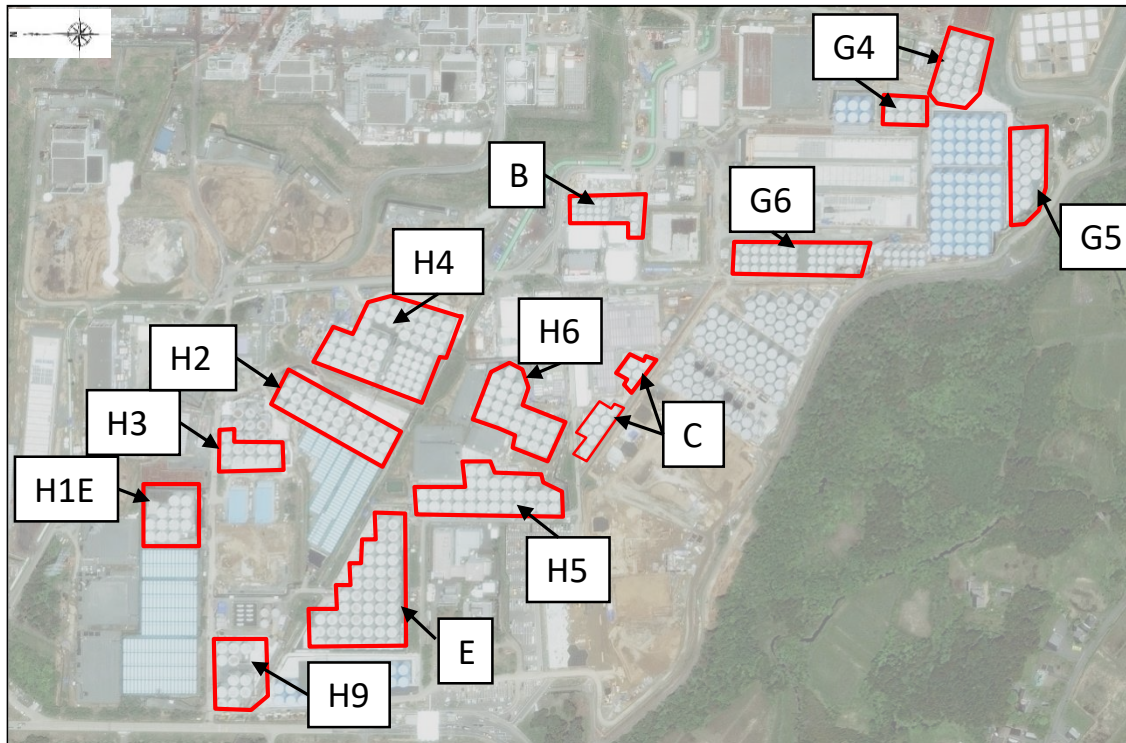
Flanged tank areas subject to dismantling (2017)

- After the accident occurred, 334 flanged tanks<sup>※</sup> were erected and used to store contaminated water from Units 1~4. As a result of leakage from some of these tanks, the decision was made to replace them with more reliable, welded tanks, so dismantling began in May 2015.  
※Flanged tanks, such as the existing ALPS sample tanks, are present within the site, and these are not included in the plan.
