Sampling Results Regarding the Water Leak at the Tanks in the H4 area and the B area in Fukushima Daiichi Nuclear Power Station (South Water Outlet, Drainage Channel)

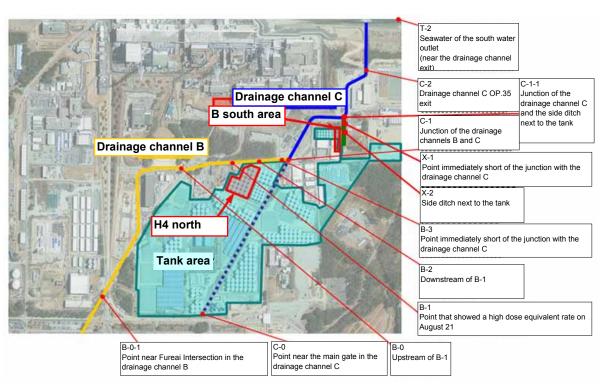
-							Unit: Bq/L
	Seawater of the	water outletJunction of the drainage channels B and Cuge channeland C	Side ditch next to the tank (X-2)	Side ditch next to the tank (point immediately short of the junction with the drainage channel C) (X-1)	Junction of the drainage channel C and the side ditch	Sampling points of the inside of drainage channel B					
						Point that showed a high dose equivalent rate on August 21 (B-1)		Point immediately short of the junction with the drainage channel C (B-3)		date in the drainage	Drainage channel C
Date of Sampling	Oct 20, 2013	Oct 20, 2013	Oct 20, 2013	Oct 20, 2013	Oct 20, 2013	Oct 20, 2013	Oct 20, 2013	Oct 20, 2013	Oct 20, 2013	Oct 20, 2013	Oct 20, 2013
Time of sampling	9:48 AM	10:21 AM	10:02 AM	10:07 AM	10:16 AM	* Note 4	* Note 4	10:26 AM Note 4	10:33 AM	10:39 AM	9:55 AM
Cs-134(Approx. 2 years)	ND(1.1)	ND(19)	21	44	ND(18)	* Note 4	* Note 4	70 Note 4	ND(18)	ND(18)	ND(19)

Cs-137(Approx.30 years)	ND(1.3)	ND(26)	70	100	ND(26)	* Note 4	* Note 4	160 Note 4	ND(26)	ND(26)	ND(26)
All β	ND(20)	54	1,200	1,600	78	* Note 4	* Note 4	9,800 Note 4	14	ND(13)	59

Note 1: Approx. 330m south from Unit 1-4 water outlet (T-2)

Note 2: Same sampling point as side ditch in front of the core warehouse sampled on August 19 (announced on August 20) and August 20 (announced on August 21)

Note 3: Water inflow location of drainage channel to the tank area

Note 4: Collection of accumulated water and cleaning of the ditch are ongoing.
