Possibility of Debris (Assumed to be the Fuel Handling Machine Mast) Sinking in the Spent Fuel Pool at Debris Removal from the Upper Part of the Unit 3 Reactor Building at Fukushima Daiichi Nuclear Power Station

February 8, 2013
Tokyo Electric Power Company

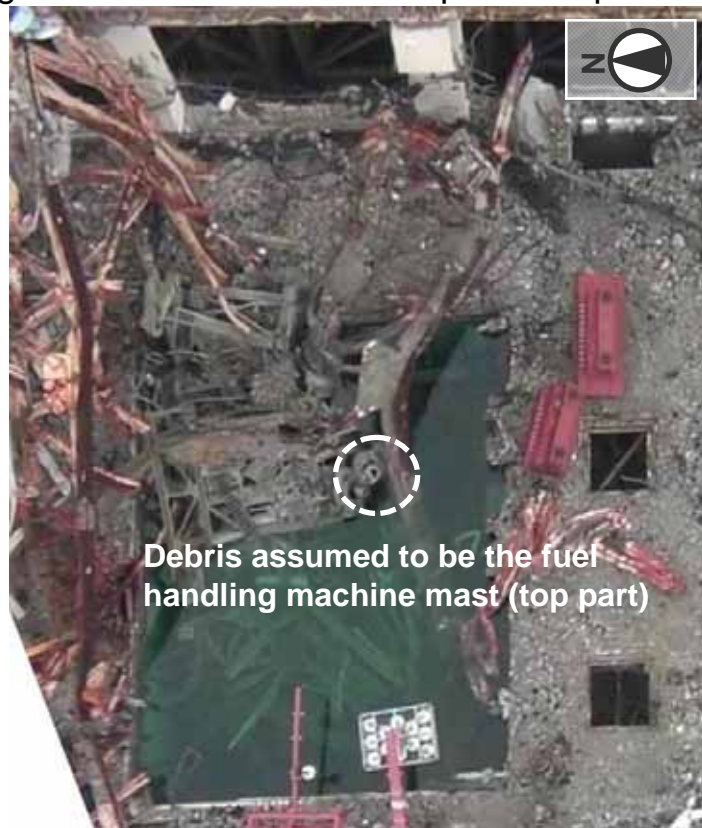
Before steel truss debris removal (Photo taken on February 4, 2013)

Debris assumed to be the fuel handling machine mast (top part)

At the steel truss debris removal from the upper part of the spent fuel pool performed on February 6, 2013, the debris assumed to be the fuel handling machine mast* which was present before the steel truss removal was found to be missing in the image taken after the removal work. On February 7, we judged that there is a possibility that the missing debris has sunk into the pool.
