Debris Removal from the Upper Part of Unit 3 Reactor Building at Fukushima Daiichi Nuclear Power Station

< Reference >
February 4, 2013
Tokyo Electric Power Company

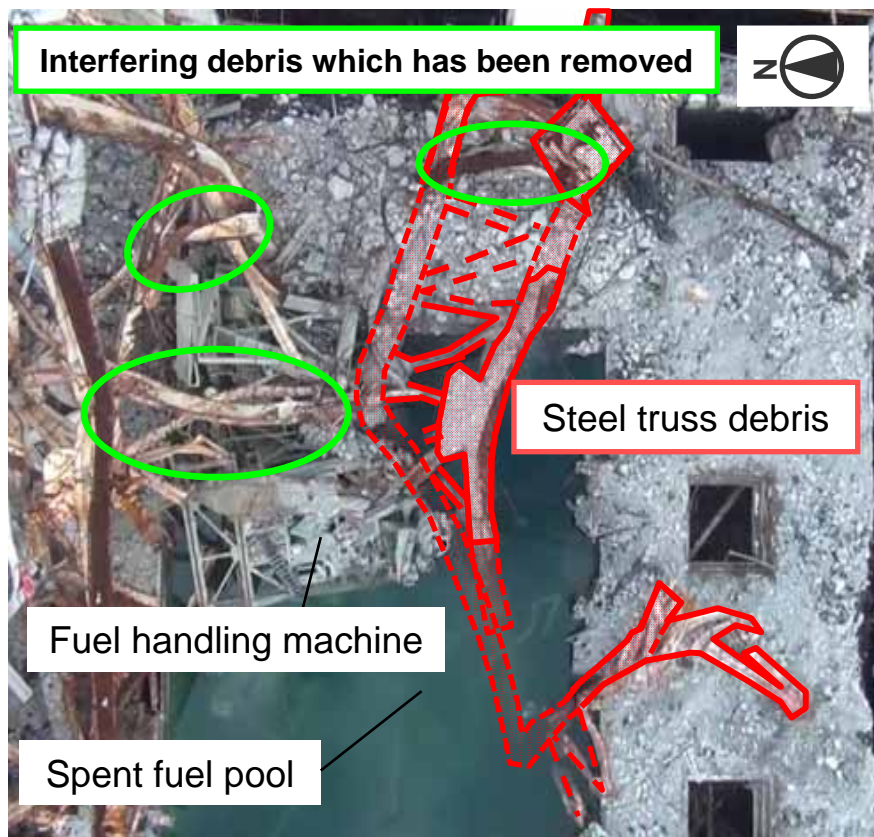
Interfering debris (Before removal)

The steel truss in the upper part of the spent fuel pool will be removed in early February. The steel beam interfering with the steel truss removal has been performed based on investigation results and completed on February 1.

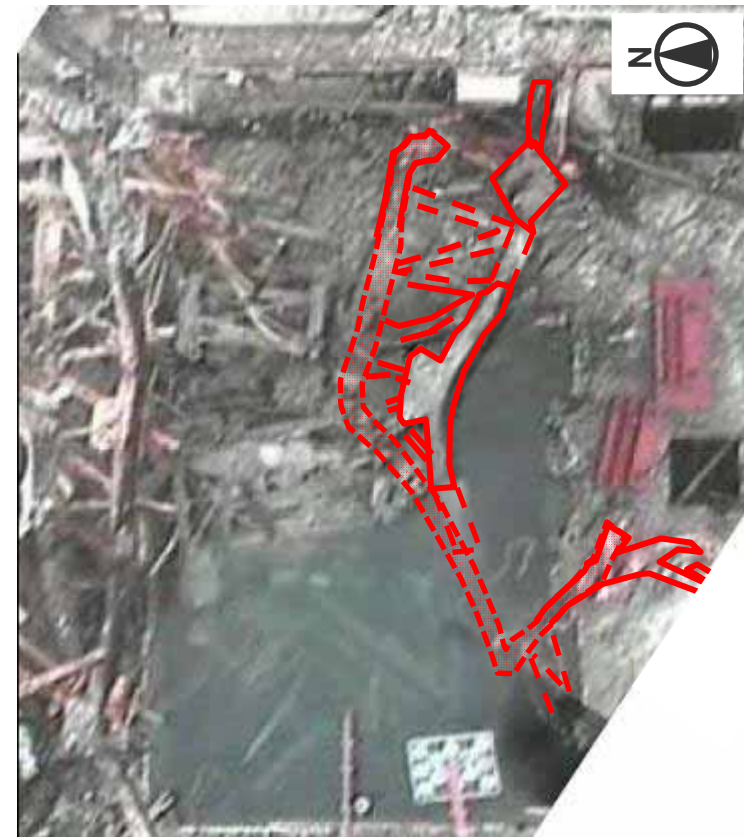
Interfering debris (After removal)

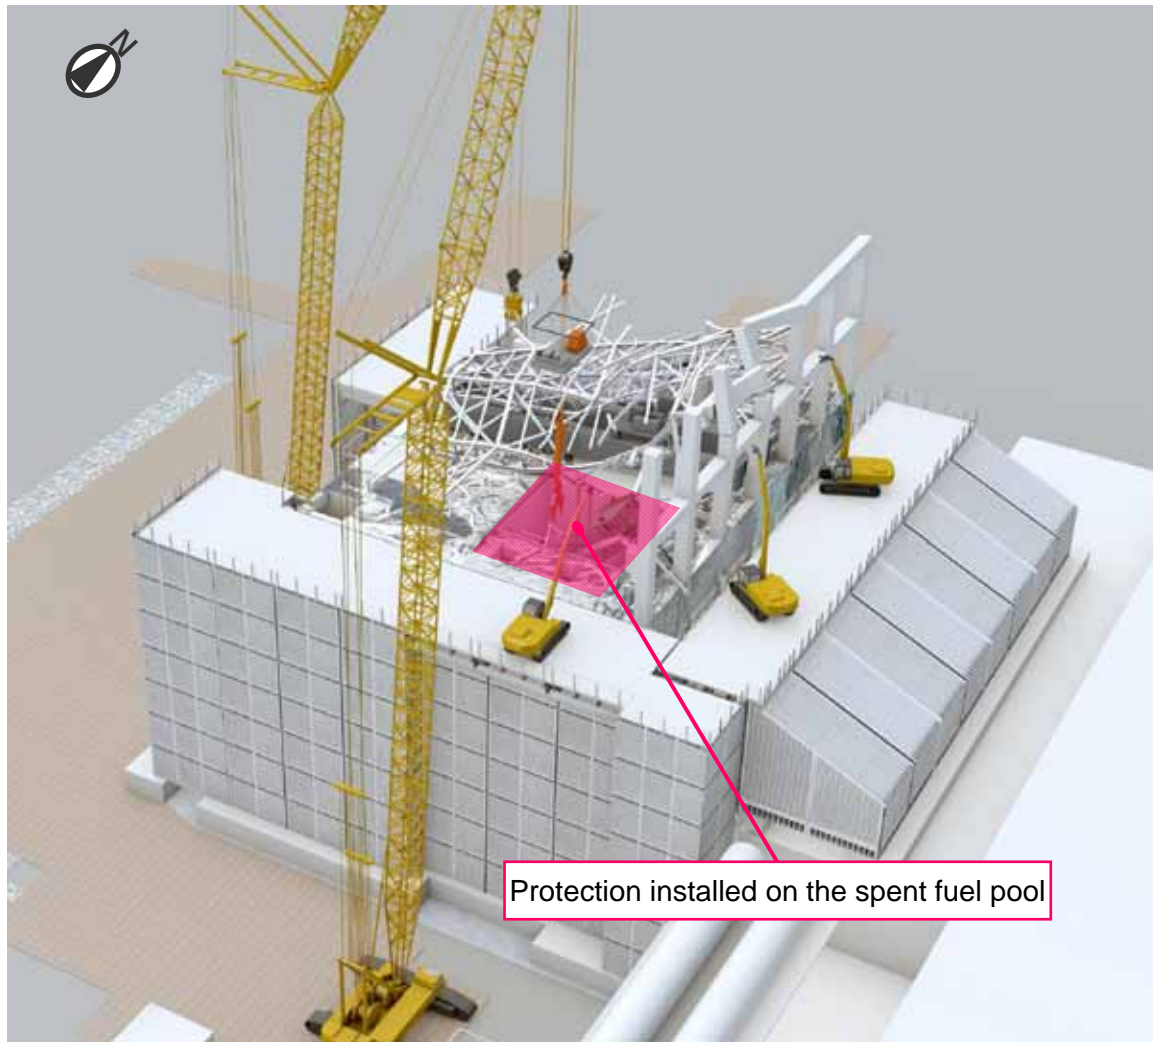
Debris removal from the upper part of the operation floor

After removing the steel truss debris, protection will be installed on the spent fuel pool and debris removal from the upper part of the operation floor will be started.

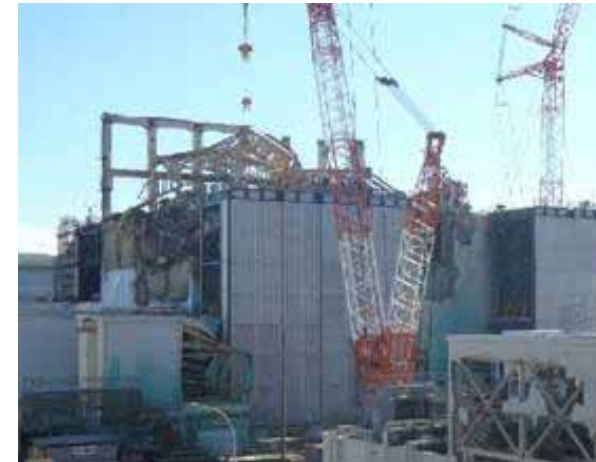
Full view of the Northwest side
(Photo taken on January 29, 2013)

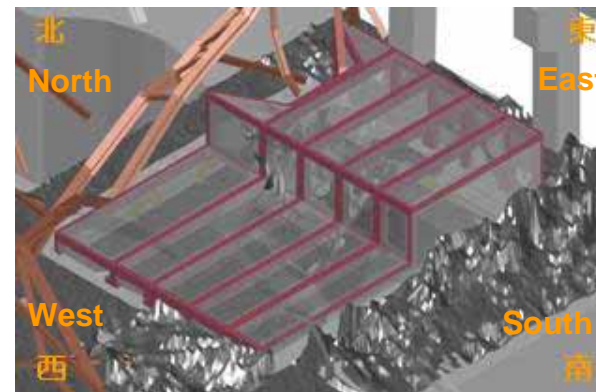
Protection installed on the spent fuel pool
