# Progress Status of the Groundwater Bypass Construction

March 27, 2013

**Tokyo Electric Power Company**

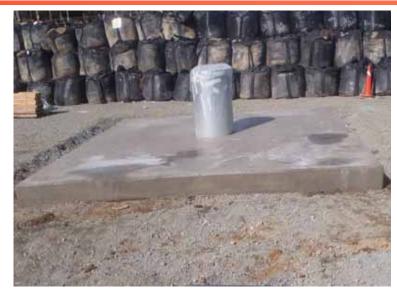
Installation of pump well No.9 (B system) completed

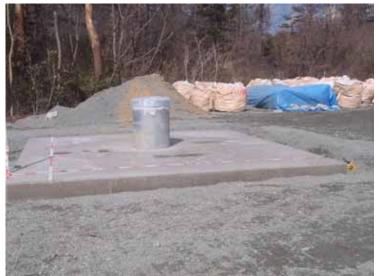
Installation of pump well No.11 (system C) completed

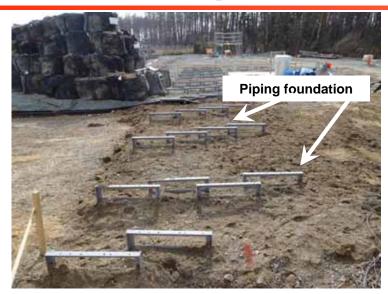
Foundation installation for piping (B system)

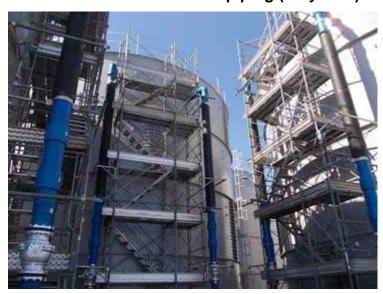
Temporary storage tank installation

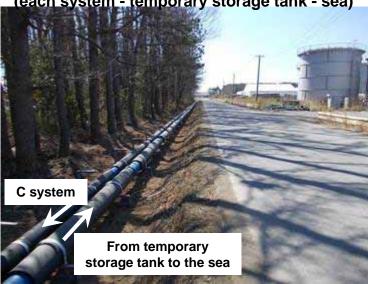
Transfer pipe installation (C system, temporary storage tank - sea)
