Cause Investigation of the Leakage

Measures to Prevent the Expansion of Contaminated Water Leakage from the Underground Reservoirs

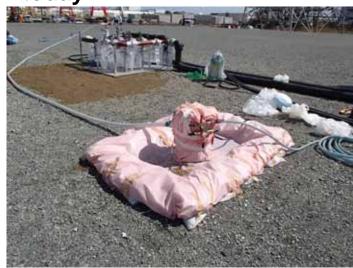
• In order to prevent the leaked water in the leakage detection holes from leaking into the ground in the surrounding area, the water in the leakage detection holes will be returned to the underground reservoirs.

Installation of the pump at underground reservoir No. iii (photo taken on April 13)

- Sampling will be conducted in all detection holes (Northeast side, Southwest side).
- Suction and transfer of the contaminated water will be conducted in all detection holes with high radioactive material densities.
