Dismantlement of Unit 1 Reactor Building Cover for Fuel Removal at Fukushima Daiichi Nuclear Power Station

May 9, 2013

Tokyo Electric Power Company

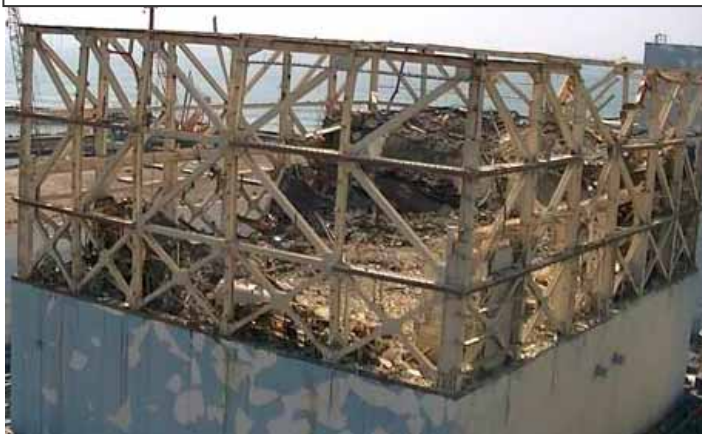
Full-view of the operation floor (northwest side)

Photo taken around June 2011

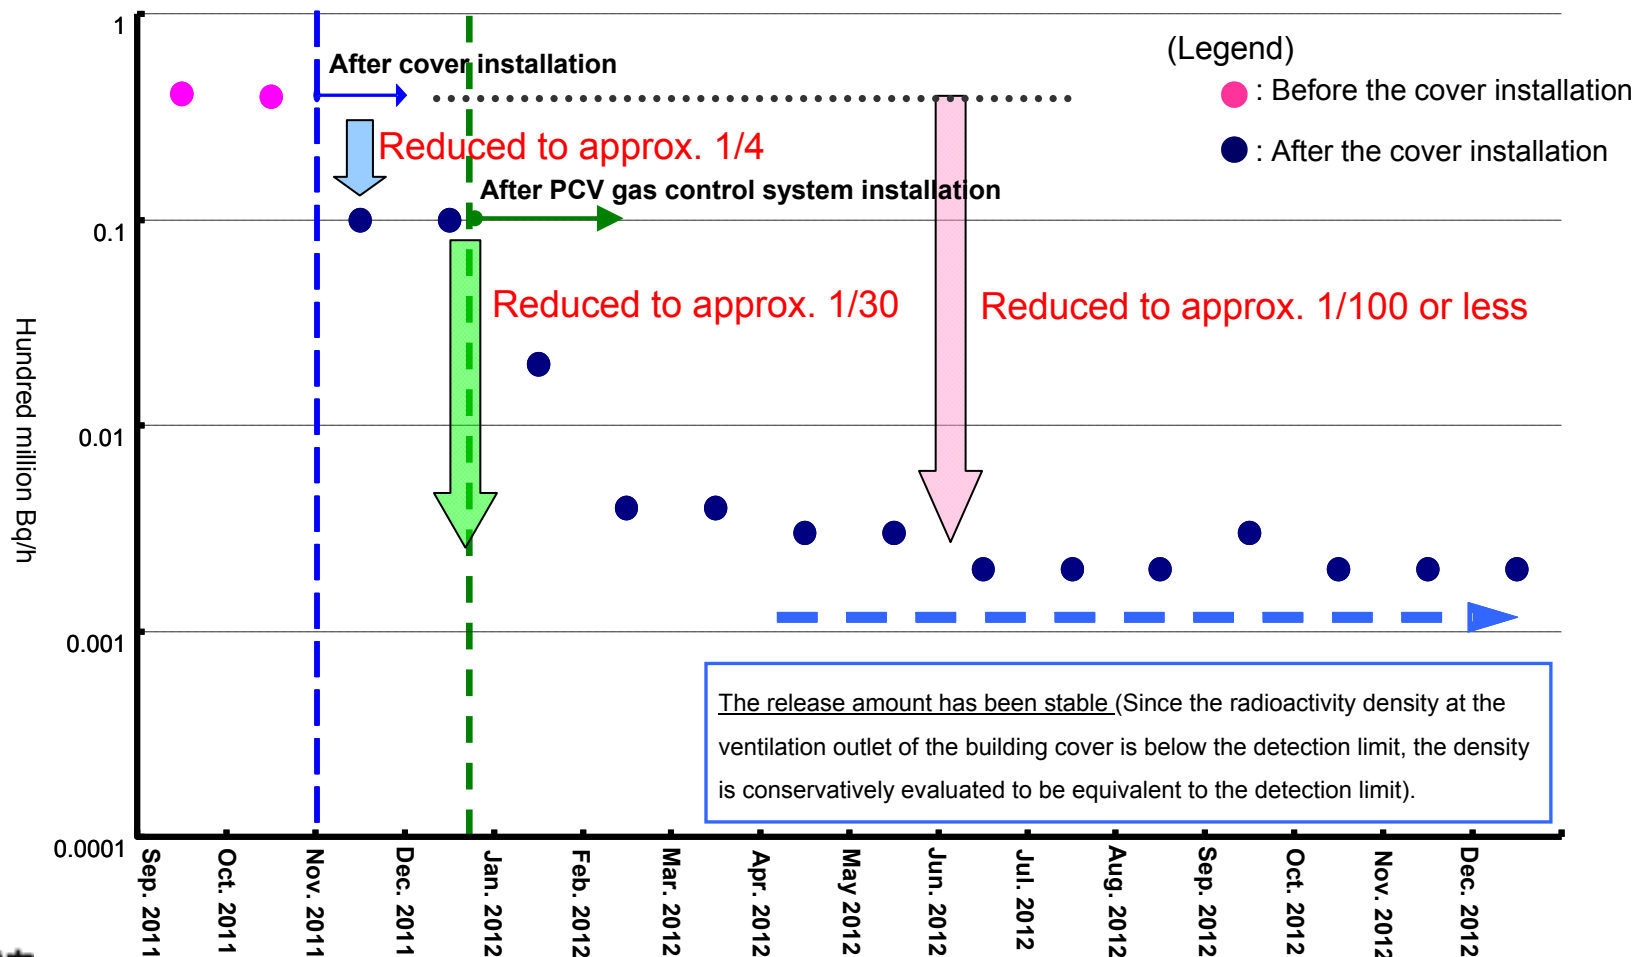
3. Current Condition of Unit 1 Reactor Building (2) (Comparison of Radioactive Release Amounts Before and After the Building Cover Installation)

- The current radioactive release amount is approx. 1/100 or less compared to before the building cover installation.
 - The release amount was reduced to approx. 1/4 as a result of building cover installation.
 - The release amount was reduced to approx. 1/30 due to the “decrease in radioactive materials released as a result of continuous reactor cooling” and the “installation of PCV gas control system”.
