About the Inappropriate Wearing of APDs that Are to Be Worn to Check Dose Levels when Wearing a Shielding Suit

<Reference Information>
June 5, 2013
Tokyo Electric Power Company

【Overview】 (The fact that was confirmed around 10:00 a.m., June 4, 2013)

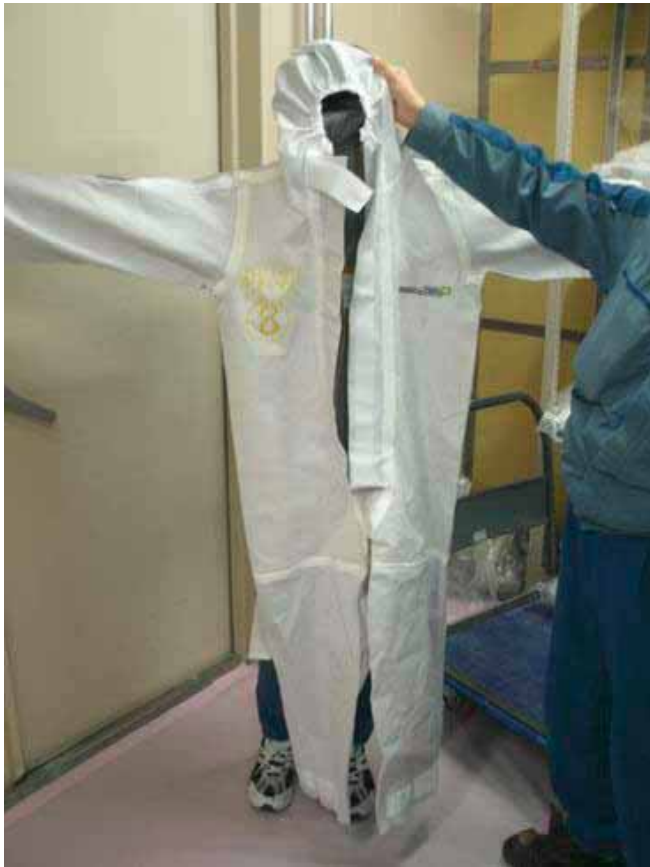
Shielding suit identical to the ones the 3 employees were wearing

○ The 3 employees were wearing **a shielding suit covering the entire body, which prevents uneven exposure**. However, our internal rules require workers wearing a shielding suit to wear an APD outside the suit in addition to wearing an APD inside the suit as a precaution.

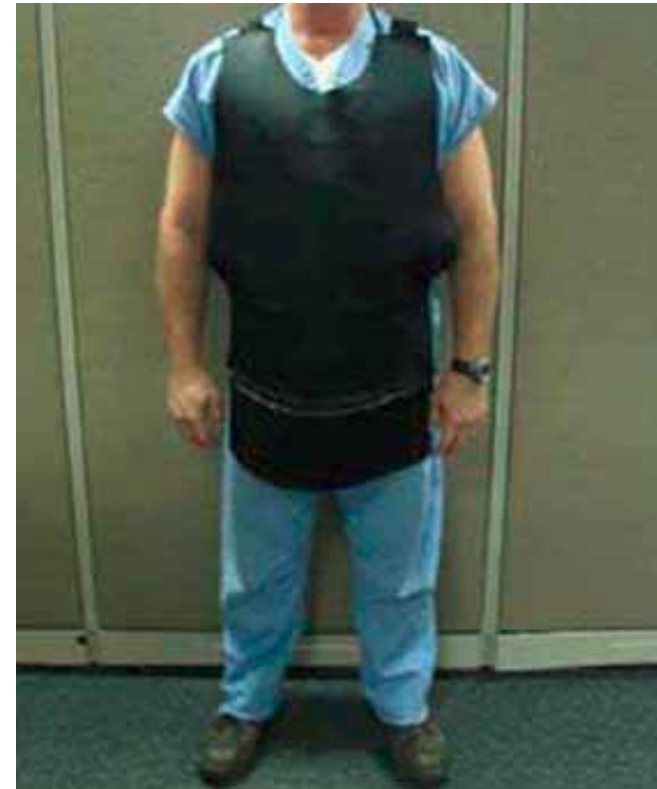
A shielding suit of a different shape

○ Depending on the shape of the suit, there can be differences in the exposure dose level between the parts of the body covered by the suit and the parts not covered by the suit (uneven exposure). To evaluate such differences, workers wearing a shielding suit are to wear a dose level checking APD inside the suit and another outside the suit around the breast area.
