Overview of the Disaster Situation and the Restoration Condition at Fukushima Daini Nuclear Power Station

June 7, 2013

Fukushima Daini Nuclear Power Station

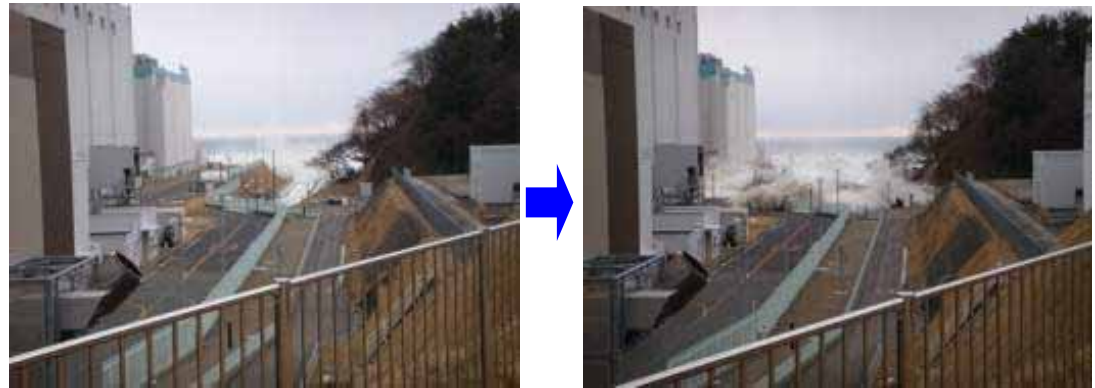
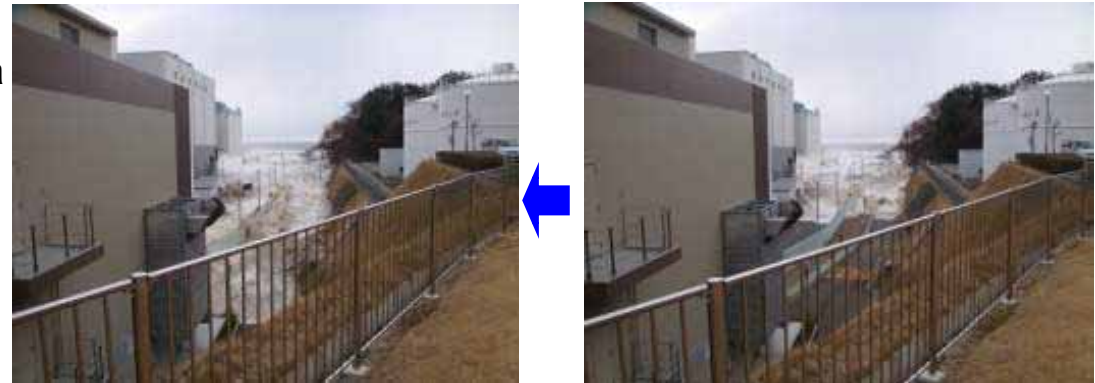
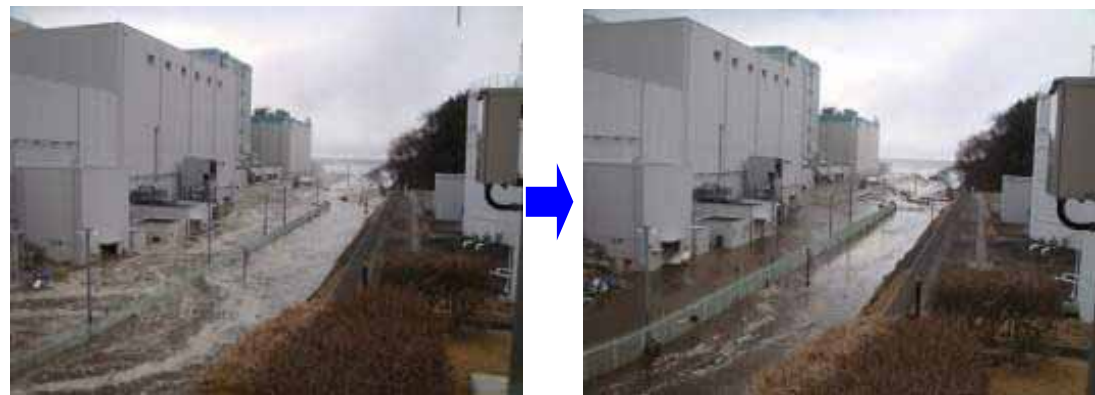
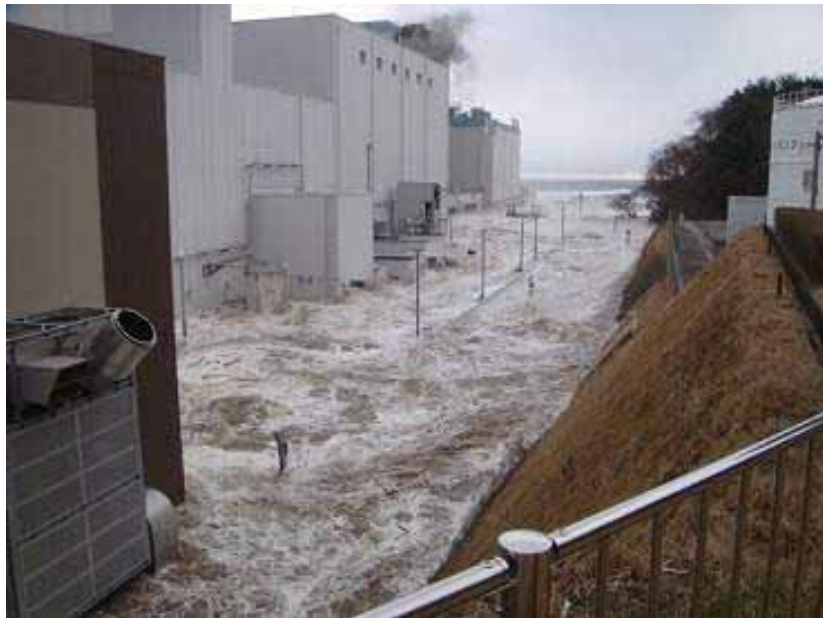
Photo taken from upland near the Main Anti-earthquake Building to Unit 1 (east side) at Fukushima Daini NPS

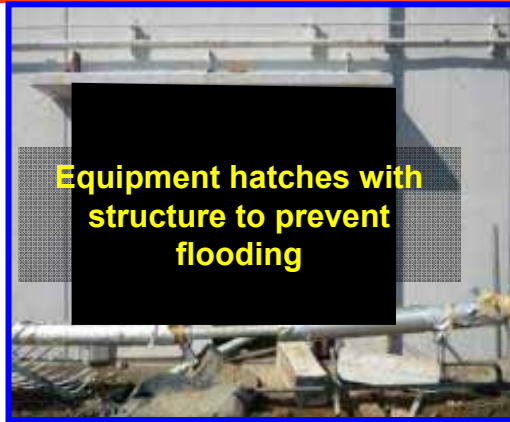
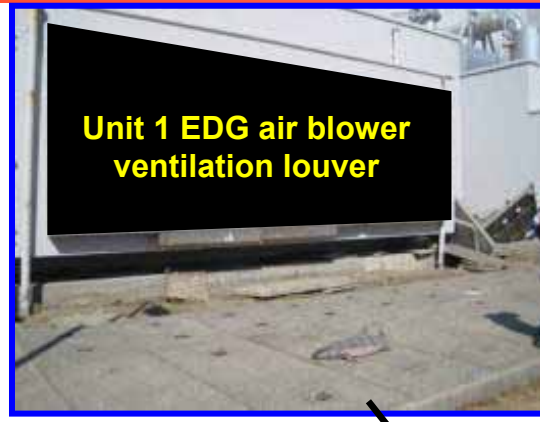
* Equipment hatches of all Units except the south heat exchanger building of Unit 3 were destroyed by the tsunami.

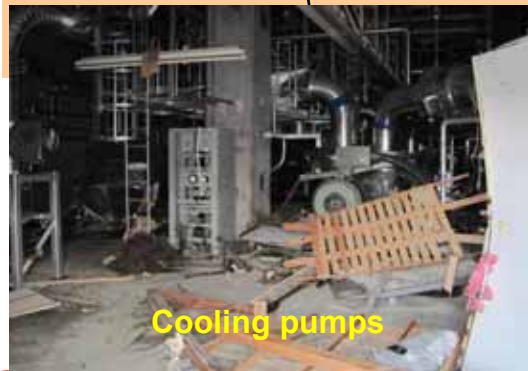
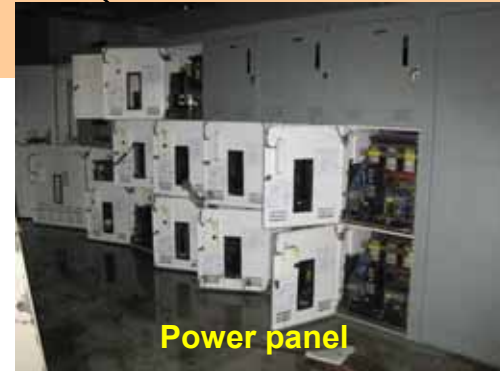
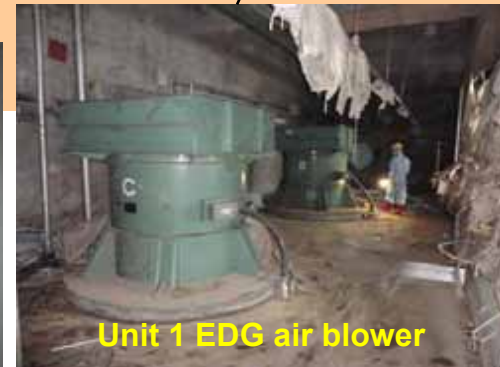
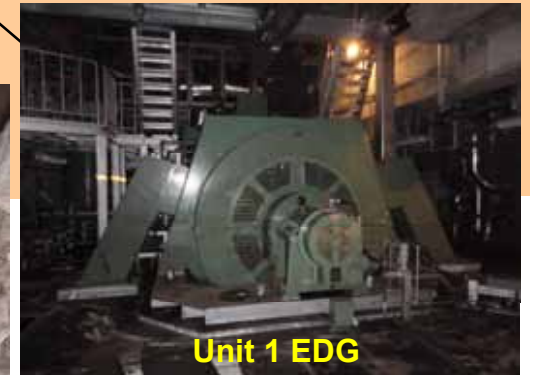
* Unit 1
Flooded to the Reactor Building through EDG ventilation louver

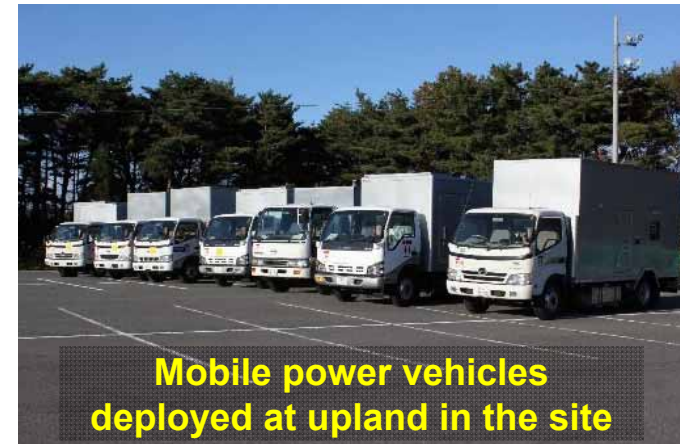
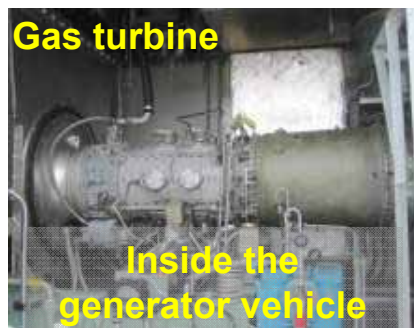
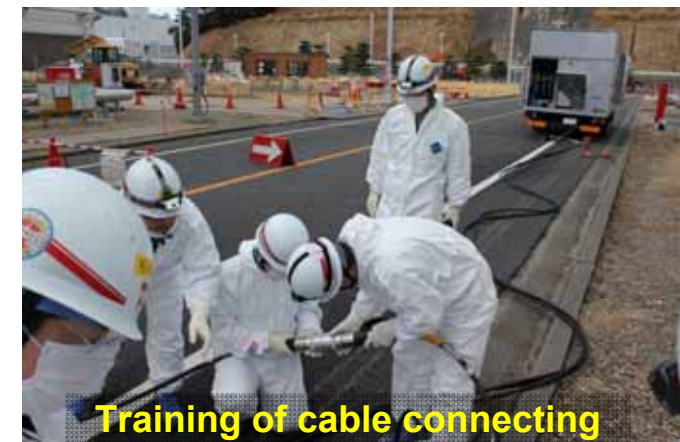
- Securement of power supply in case of emergency
 - Gas turbine generator vehicles and mobile power vehicles were deployed at upland in the site, and procedures to secure power supply was developed.

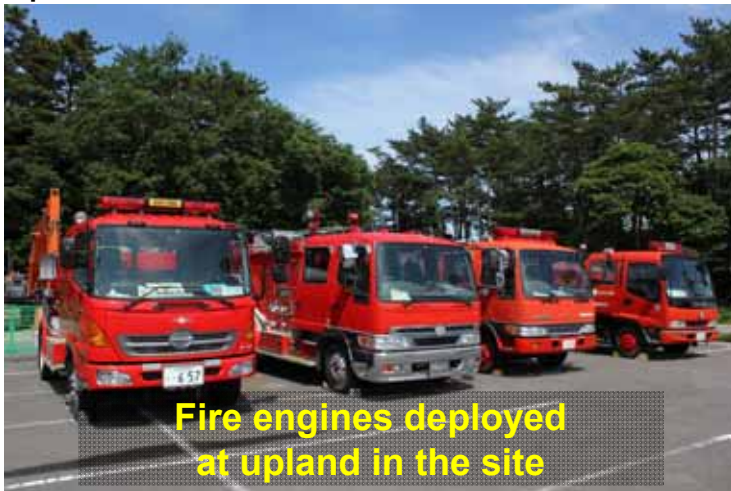
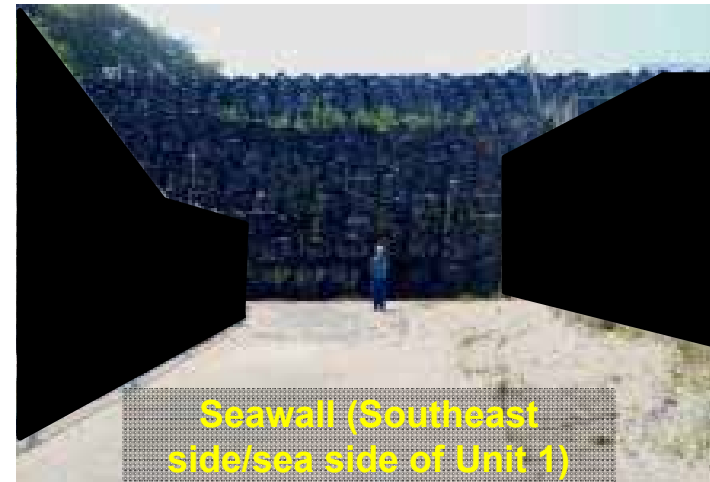
- **Securement of final heat removal function and cooling of spent fuel pool in case of emergency**
 - Fire engines were deployed at upland in the site, and procedures to perform alternative water injection were developed.
 - Procedures to operate PCV vent utilizing backup gas cylinder in case of station blackout were developed.

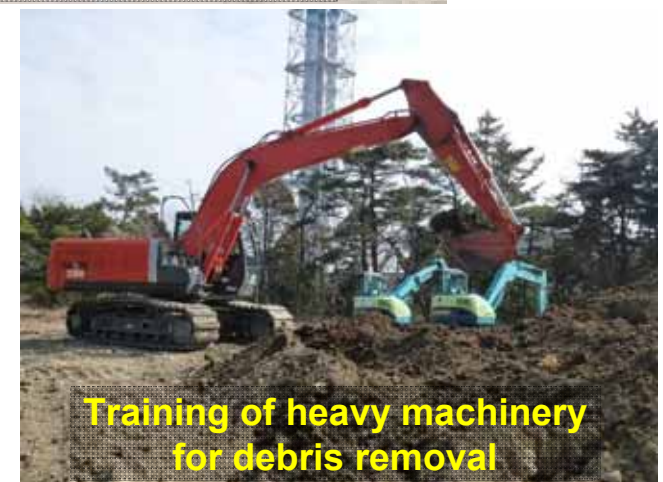
- **Prevention of water entry and implement of debris removal**
 - Water-tightness of the doors at the heat exchanger building and the Turbine Building was enhanced, and 15.4m seawall was installed.
 - Heavy machinery for debris removal, and gravels was deployed.

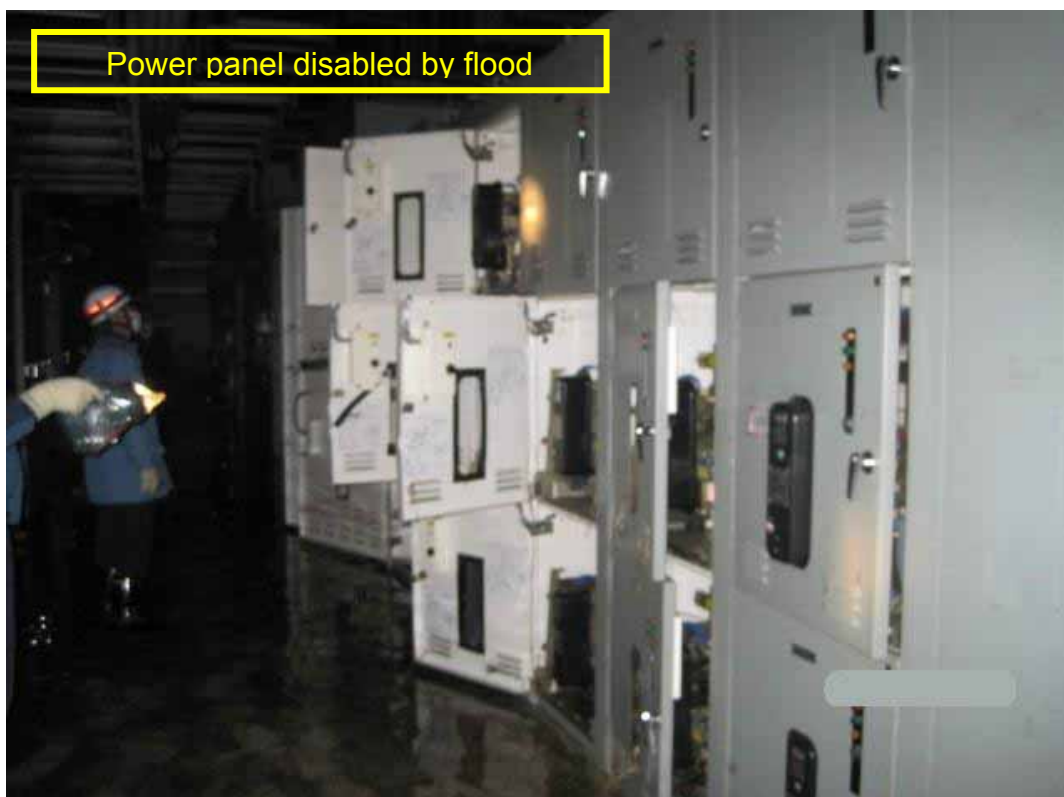
Power panel (Power center 1D-2)

(Before restoration work)

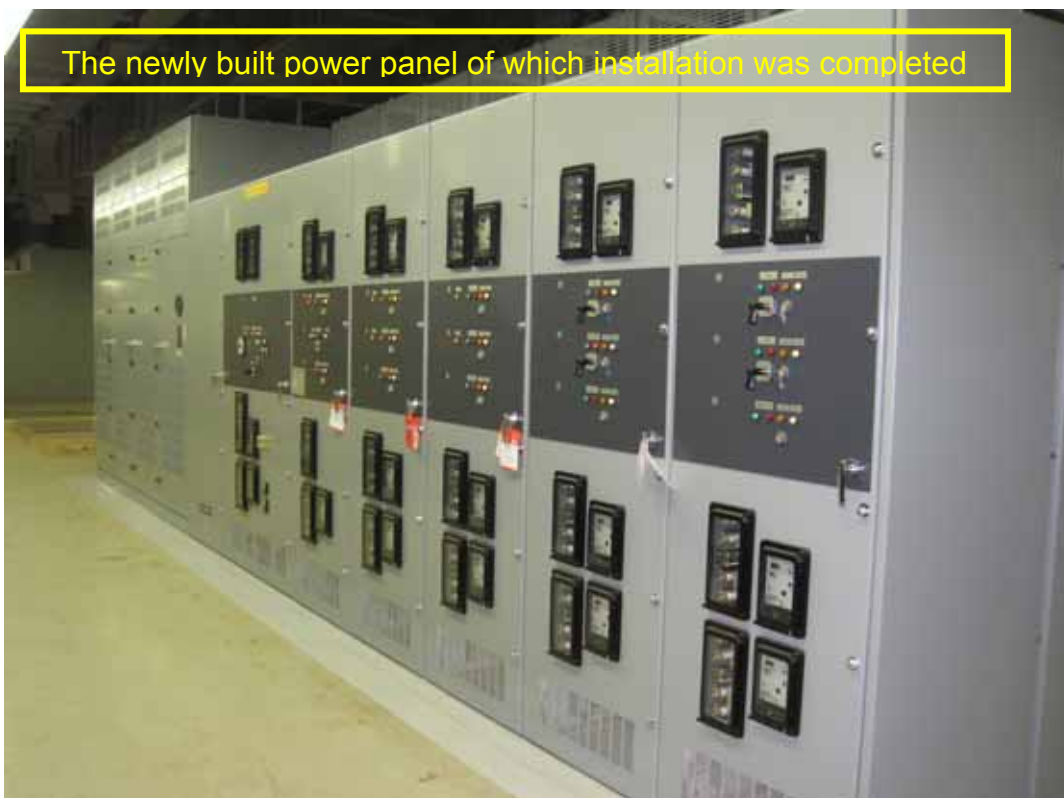
(After restoration work)

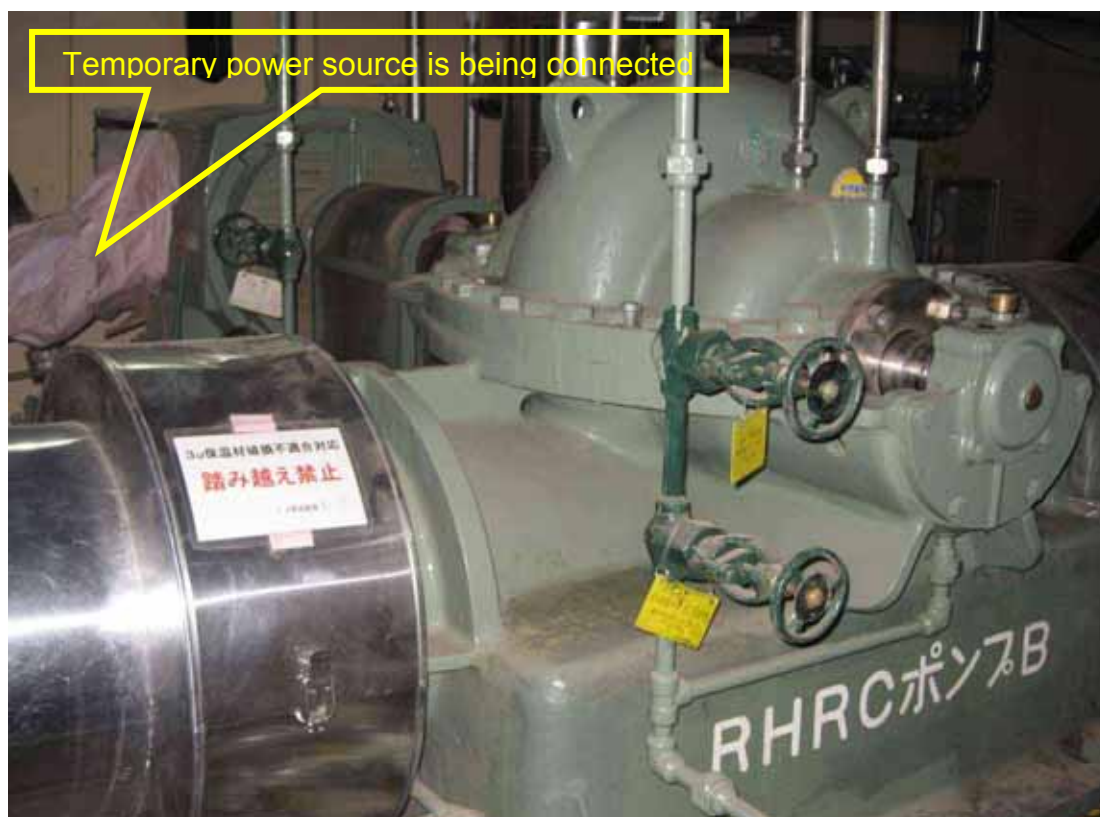
Residual heat removal cooling system pump B

(Before restoration work)

- Auxiliary cooling system pump at RHR (B) system was investigated, and electric motor which was not available was replaced.
- Power panel was replaced to a new one at Waste Treatment Building, and high pressure power vehicle and mobile transformer were deployed at the site. In addition, temporary cables were installed.
- Most of the temporary cables (total length of 9km) were installed by approx. 200 of TEPCO employees and corporate company employees in almost one day.

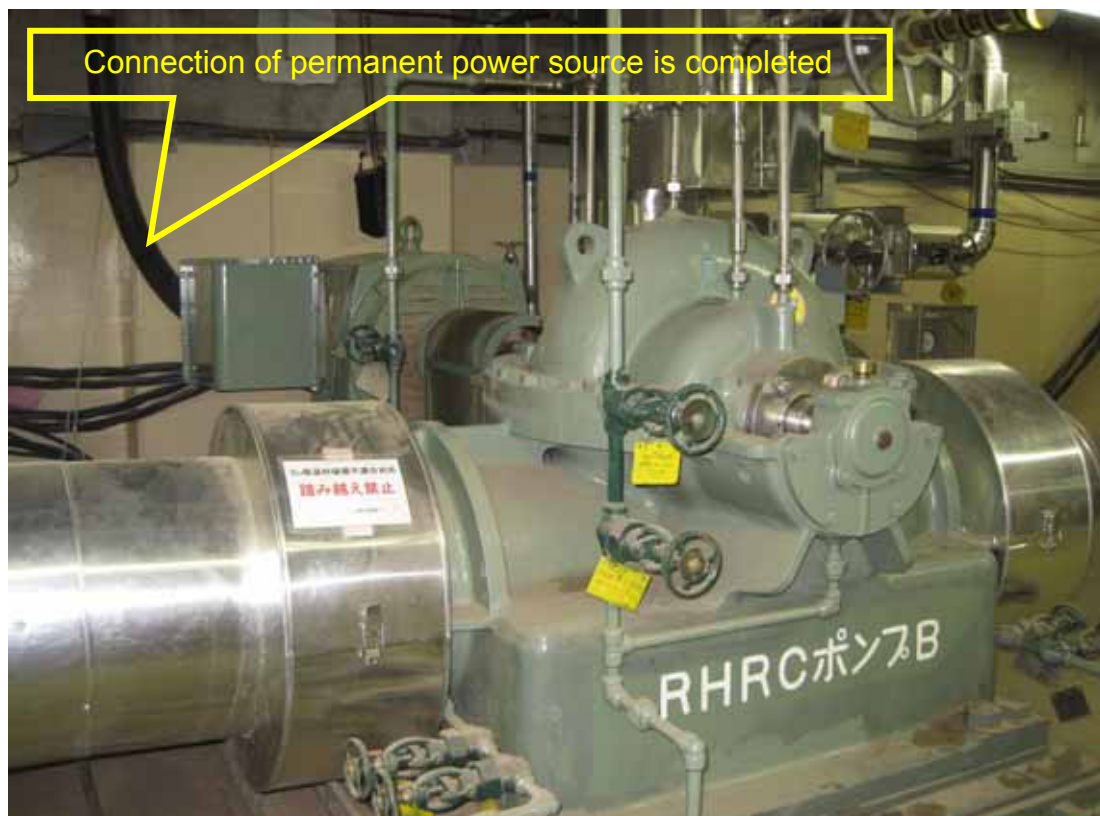
(After restoration work)

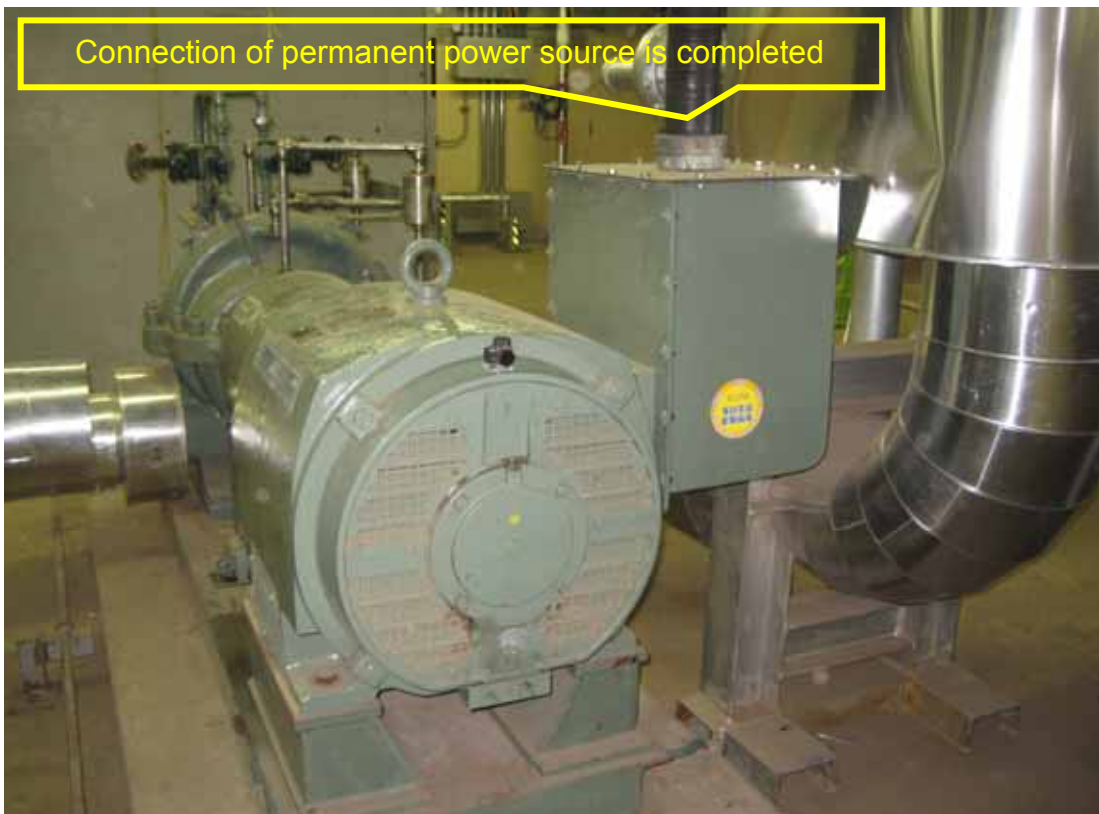
Emergency diesel generator cooling system pump B

(After restoration work)

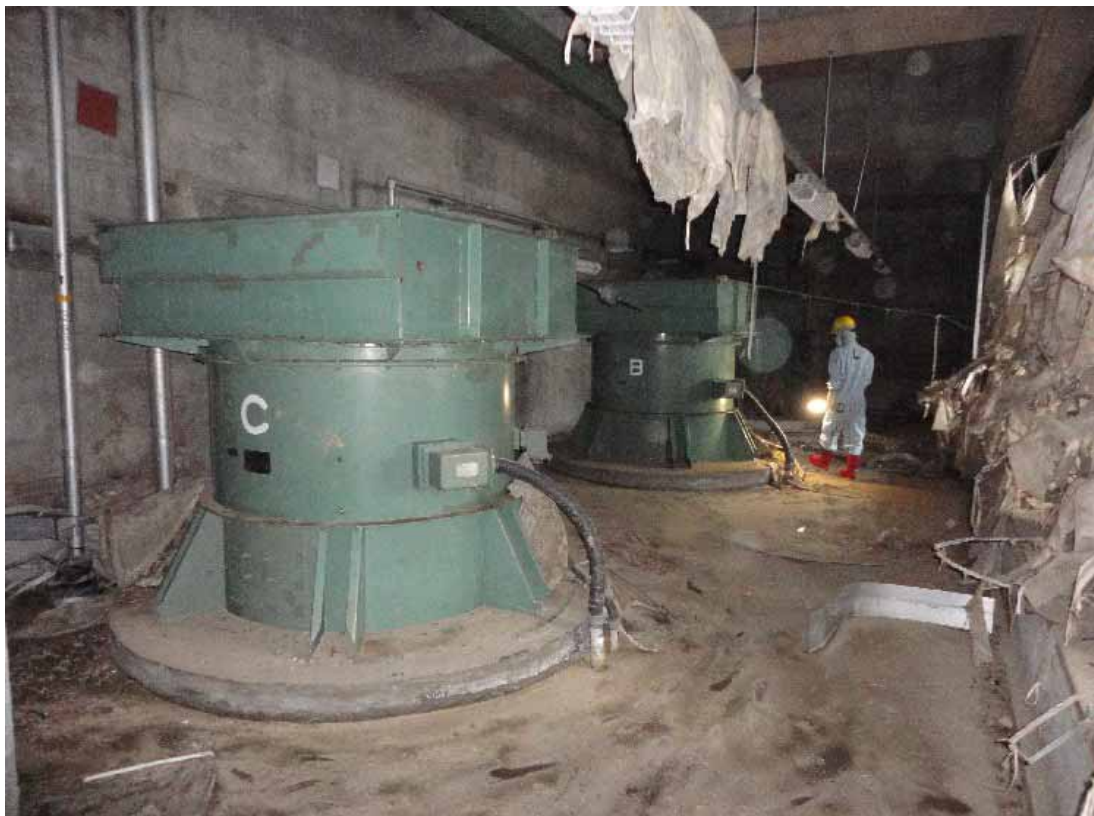
Emergency air blower of emergency diesel generator A

(Before restoration work)

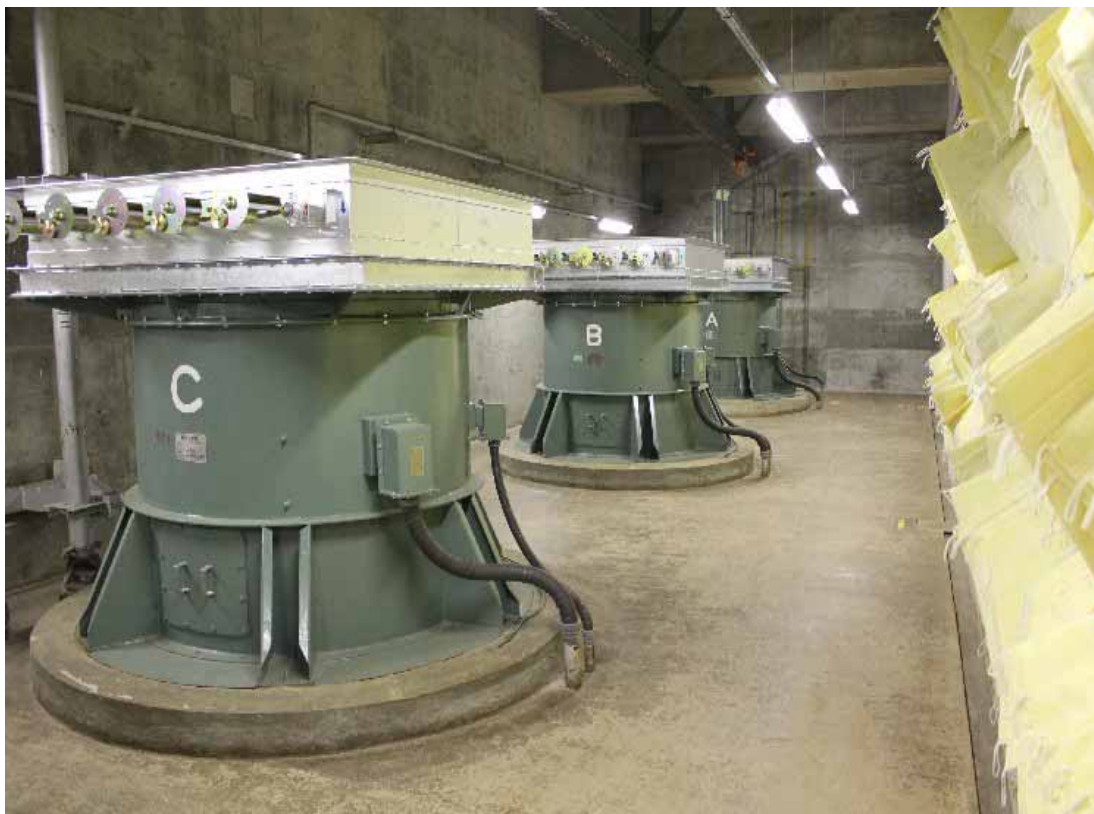
(After restoration work)

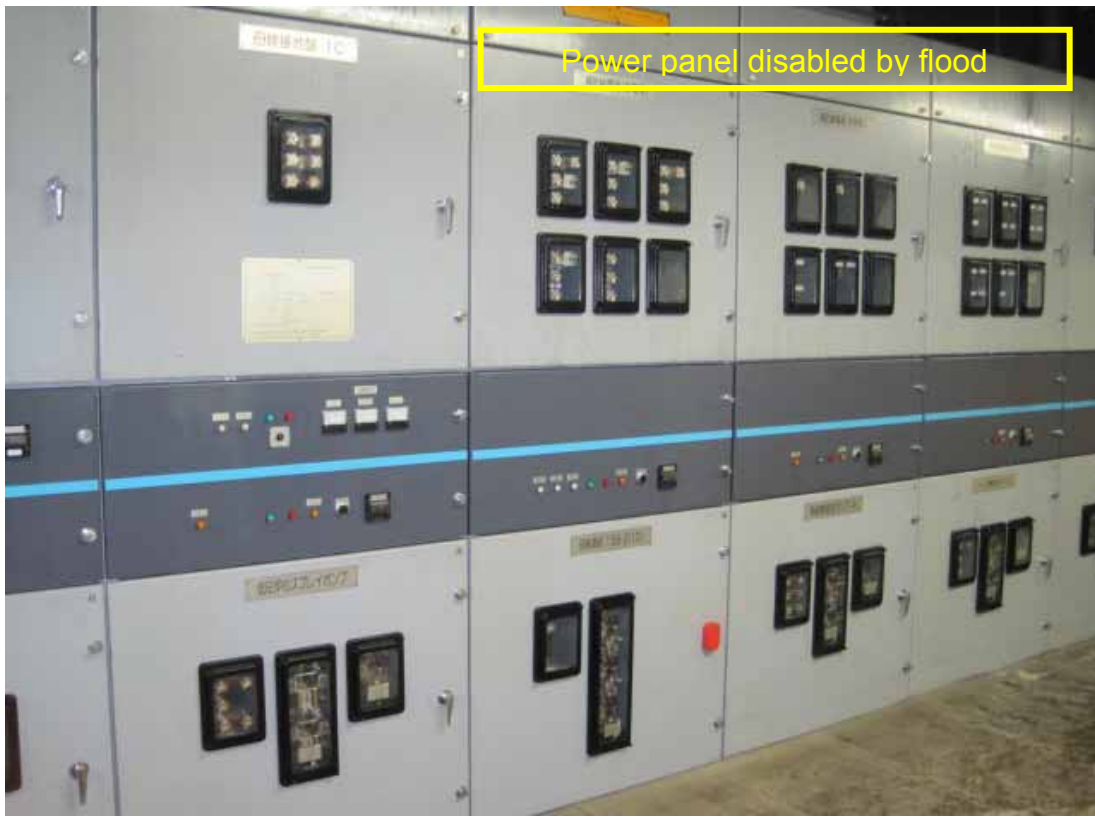
Power panel (metal crad switchgear 1C)

(Before restoration work)

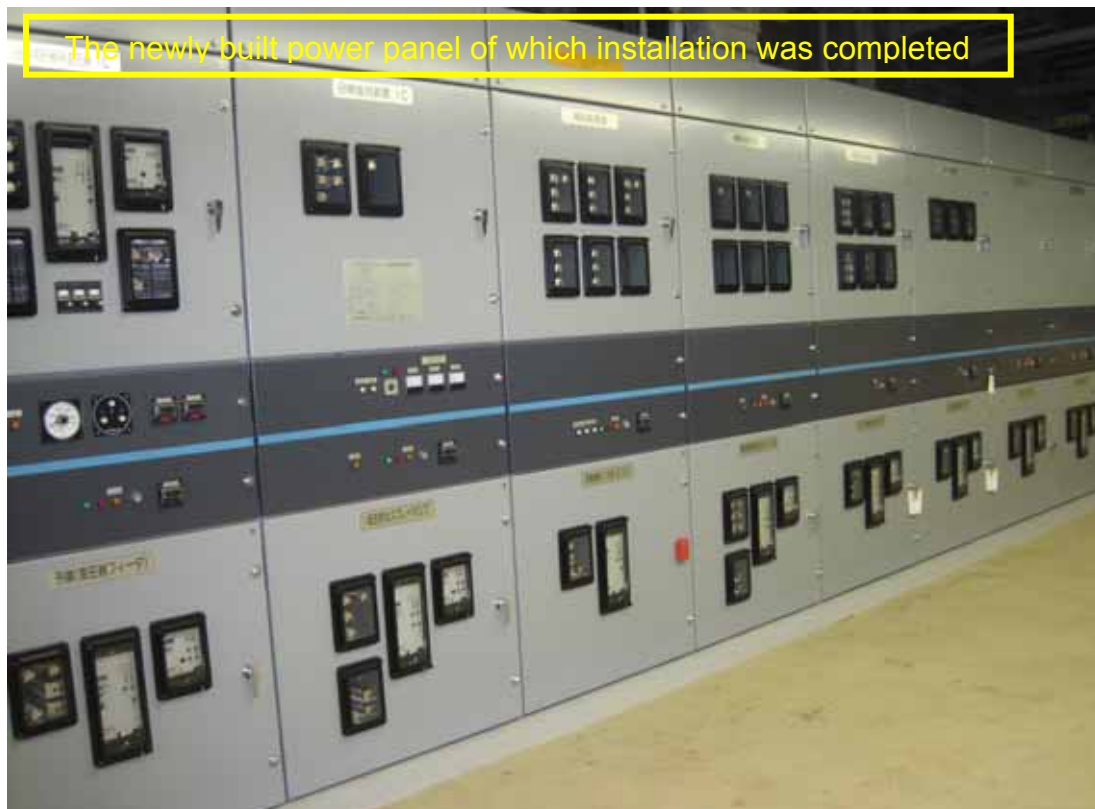
(After restoration work)

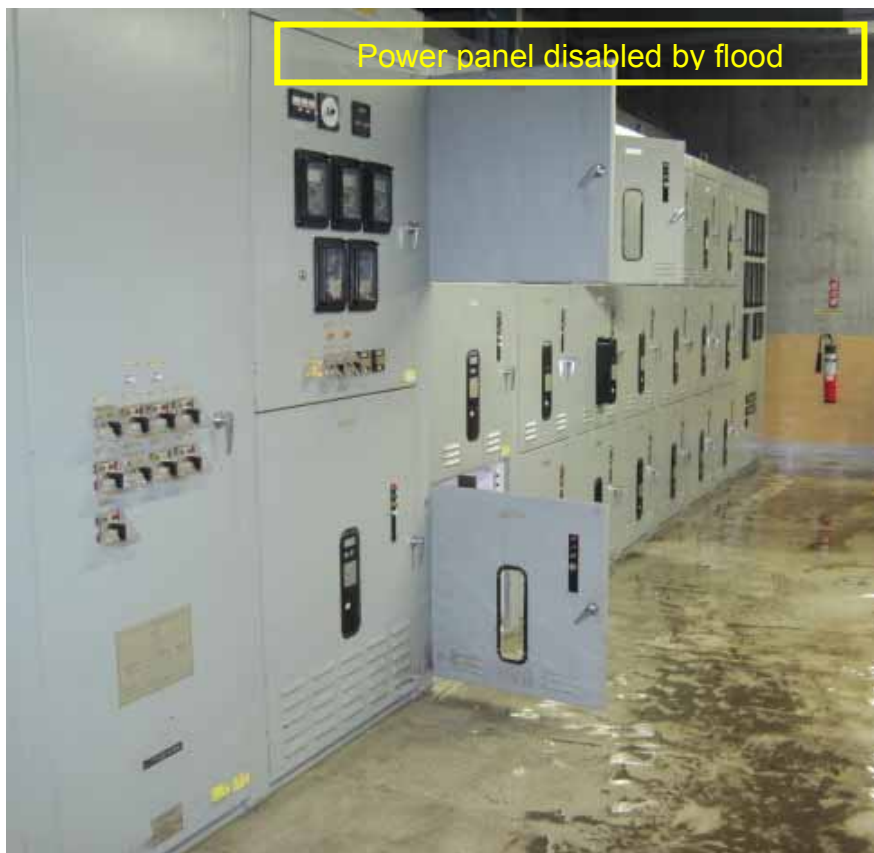
Power panel (Power center 1C-1)

(Before restoration work)

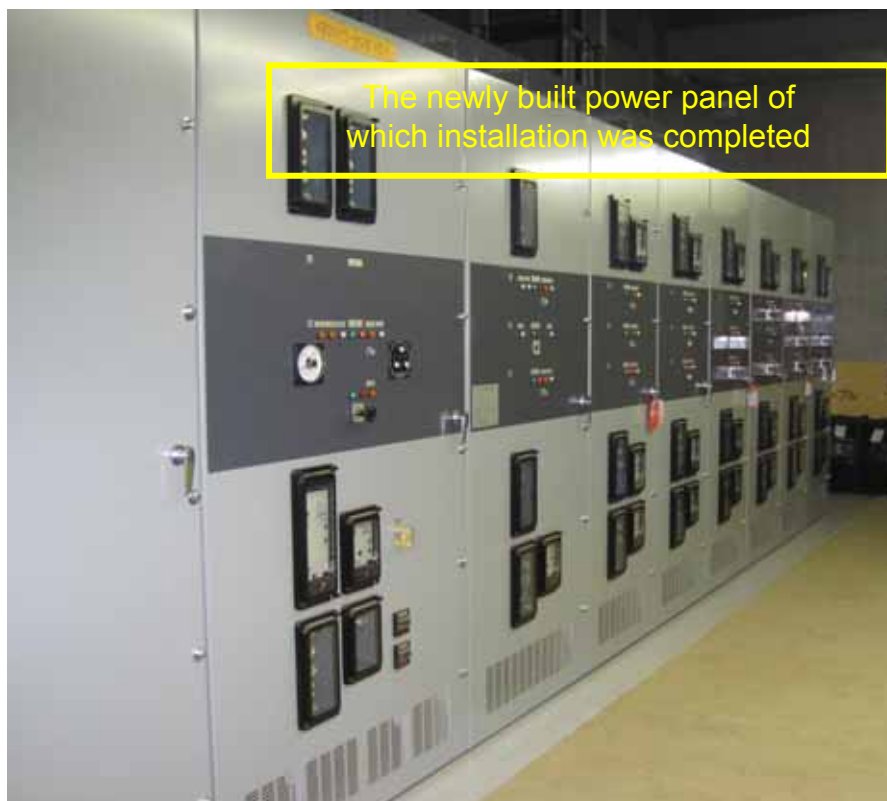
(After restoration work)

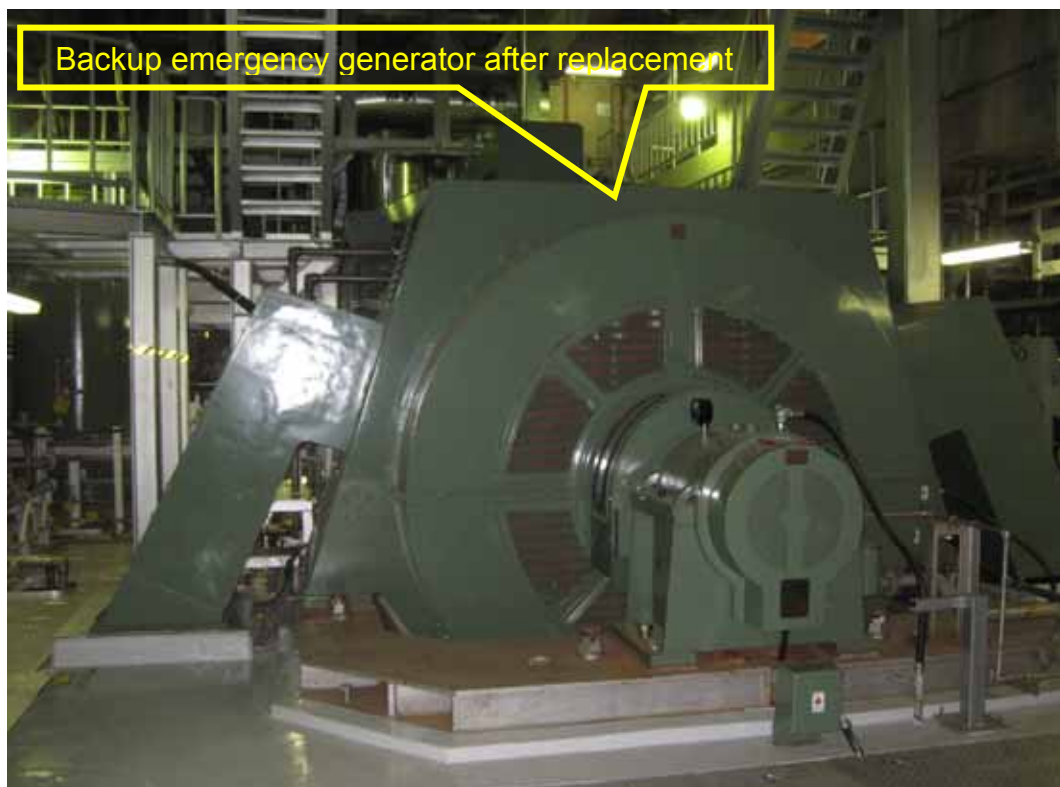
Emergency diesel generator A

(After restoration work)
