<Reference>
September 29, 2013
Tokyo Electric Power Company

Flow Rate Decrease of Slurry Transfer Pump of Multi-nuclide Removal Equipment System C

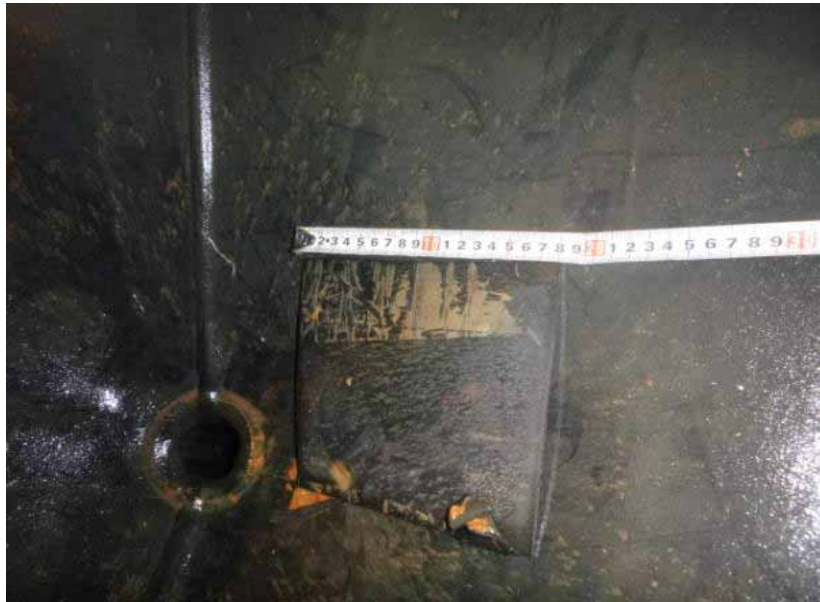
Results of internal inspection of the batch treatment tank 2C

One of the rubber pads for ladder
found detached
(found near the drain hole)

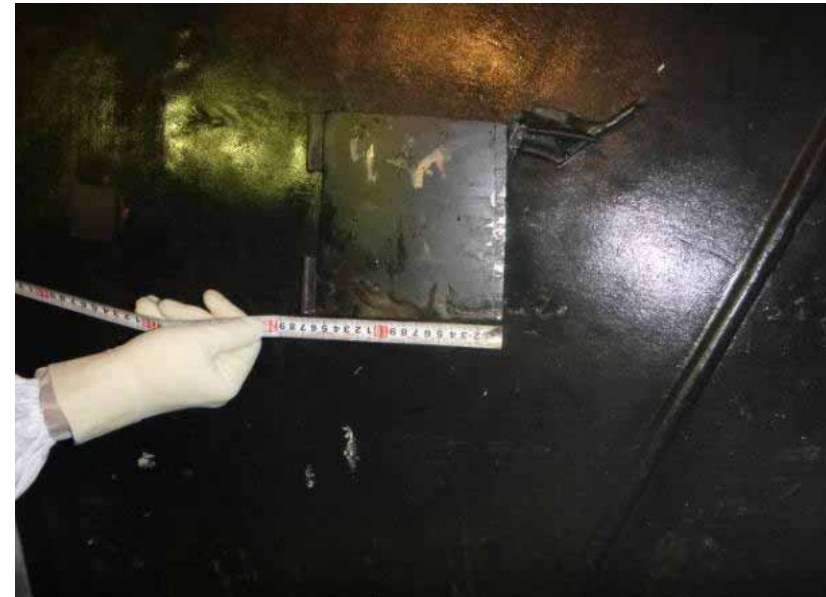
The other one of rubber pad for
ladder found remaining attached
at its original location (measured
for size after being released from
fixation with tape)
