# Progress and improvements of the improved ALPS (multi-nuclide removal) system

- Main facilities of Unit A installed.
- Unit A is under pre-operation inspection from Sept 8. After approval, “hot testing” will be started using actual RO concentrated salt water.
- Main facilities and the roof, walls of Unit C is currently been installed.

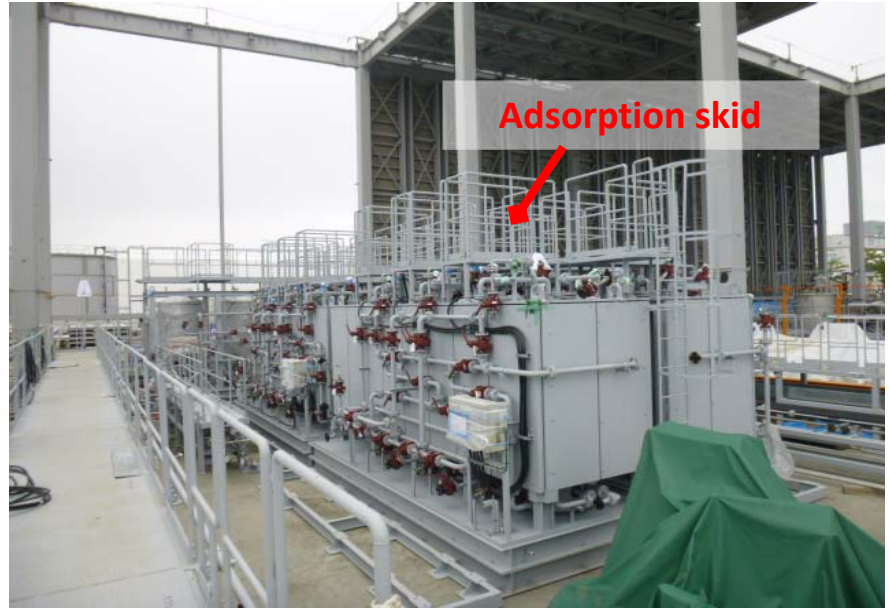
Adsorption tower of improved ALPS building (photo taken on Aug 15 2014)

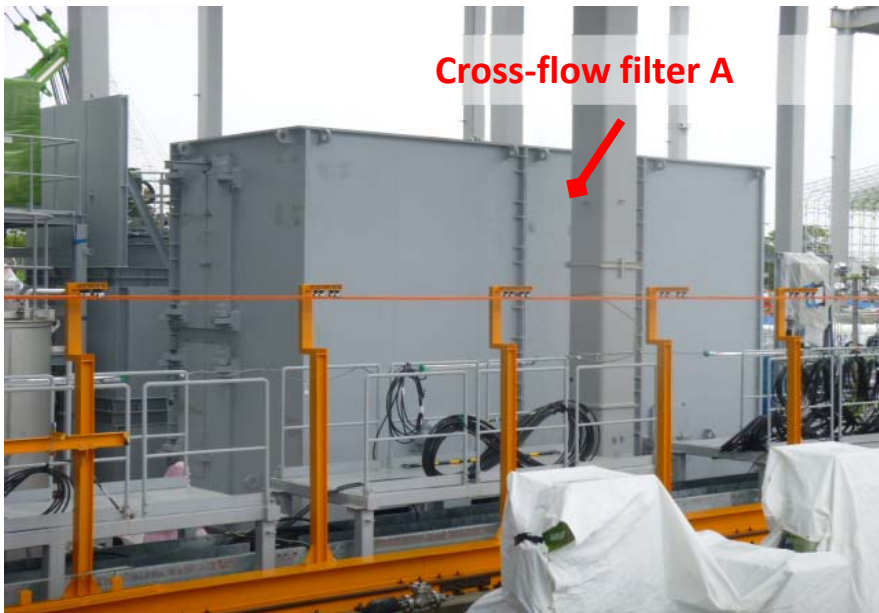
Cross-flow filter (photo taken on Aug 17 2014)

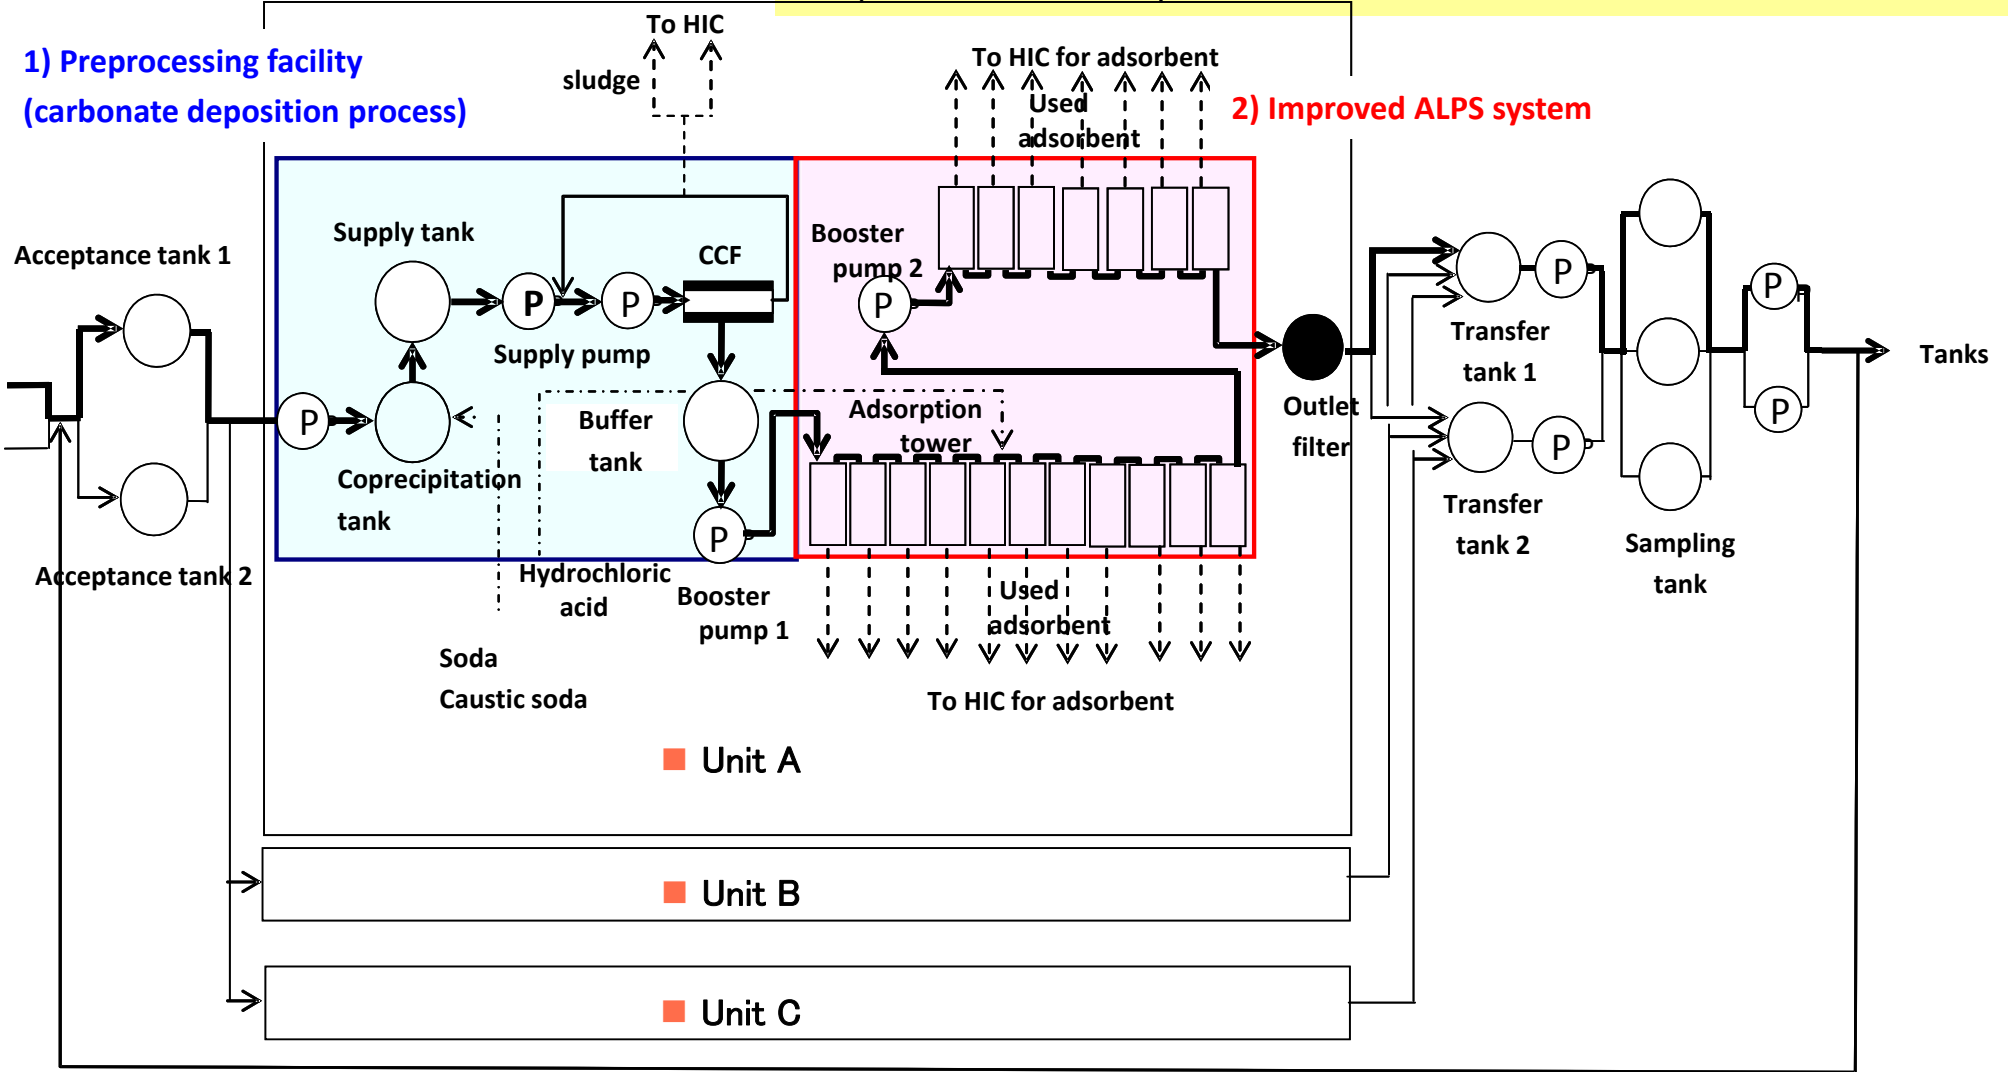
# <Reference> System diagram

## Improved ALPS system

- Difference between the existing ALPS system
  - 1) Preprocessing and steel coprecipitation were taken and treatment conducted at adsorption tower
  - 2) Number of adsorption tower increased from 16 to 18

\*All units are the same design.
