Unit 3 Seawater piping trench schematic cross-sectioned view

Filling up Shaft at Unit 3 Seawater piping trench

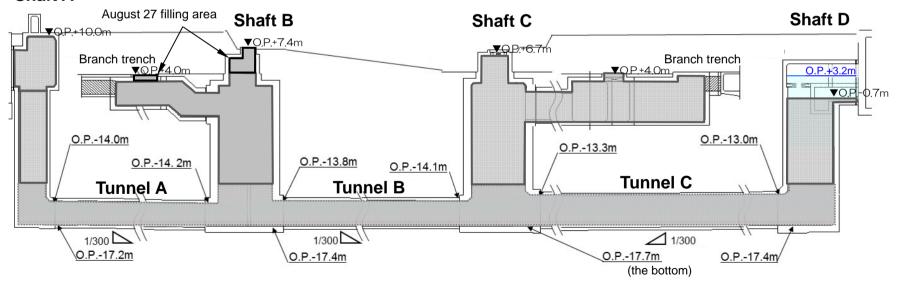
- July 30, 2015 transfer of accumulated water in trench completed.
- Filling up Shaft A and Shaft C to the ground level completed.
- Filling up the main part of Shaft D completed. The top part is connected to the turbine building so filling up is to be continued as the water level of the accumulated water is lowered in the building.
- Filling up of Shaft B completed today (August 27).
