Unit 2 Primary Containment Vessel Investigation  
at Fukushima Daiichi Nuclear Power Station  
(Results of deposit removal work)

Tokyo Electric Power Company Holdings, Inc.

# 4-1. Results of deposit removal work (landing position of the guide pipe)

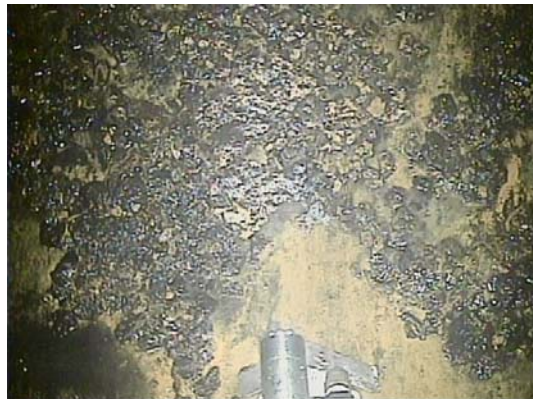
Images from guiding pipe camera

Before the removal

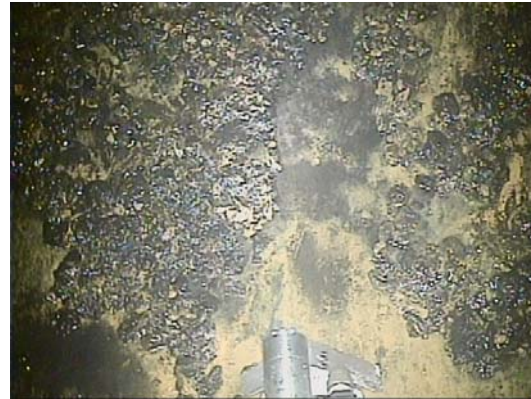
After the removal

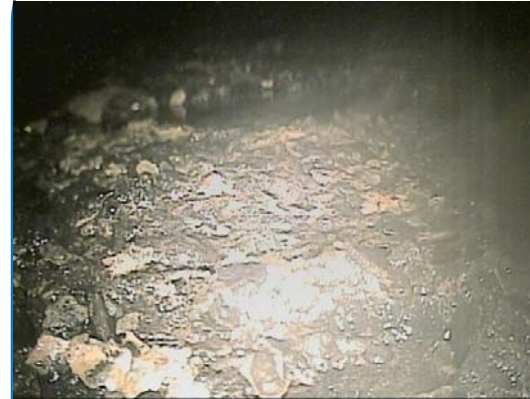
Images from front camera attached to the device

Before the removal

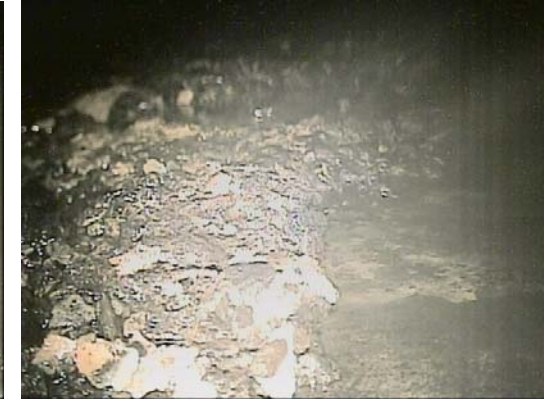
After the removal

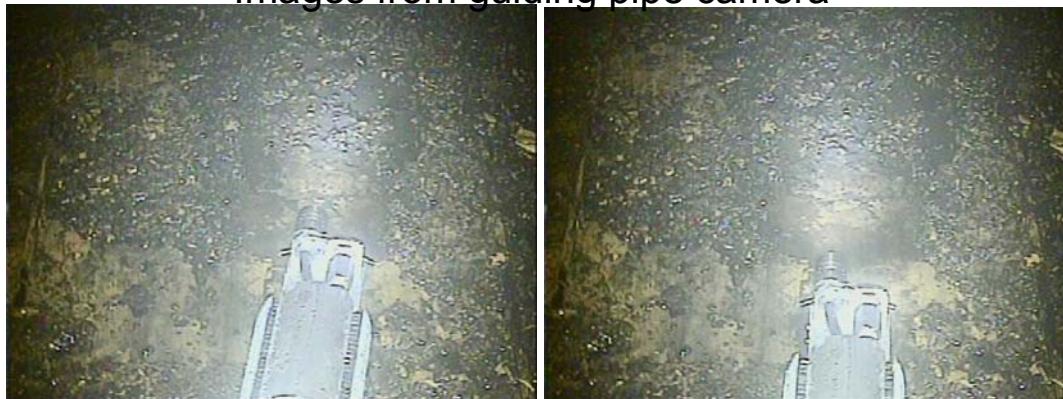
## 4-2. Results of deposit removal work (position where deposits strongly adhered to the rail)

Images from guiding pipe camera

Before the removal

After the removal

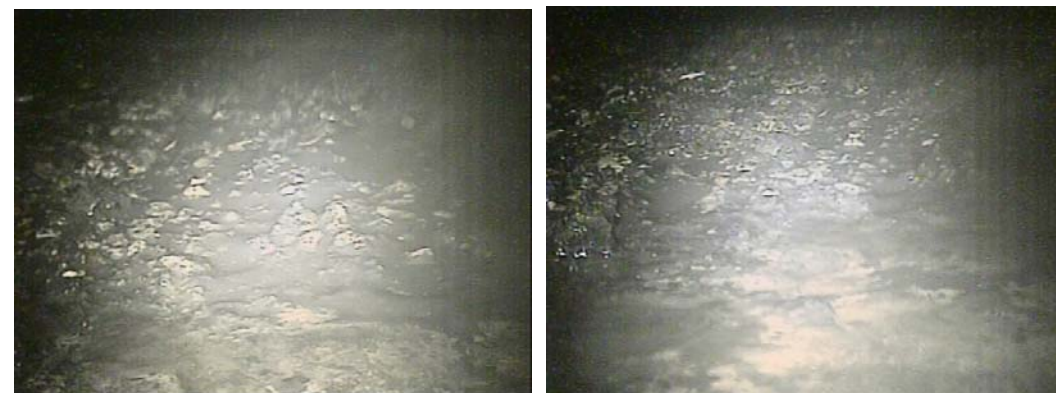
Images from front camera attached to the device

Before the removal

After the removal

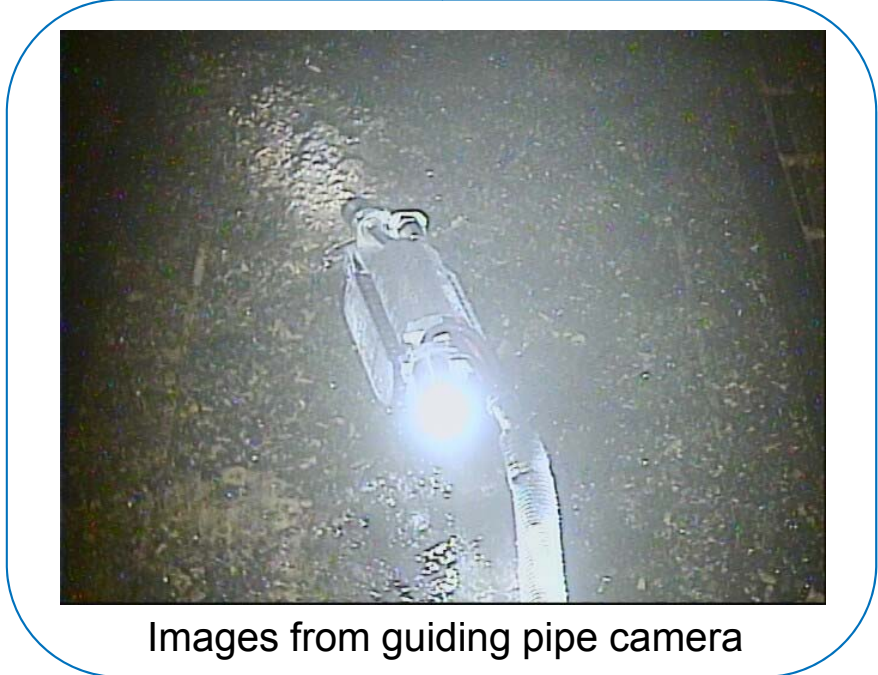
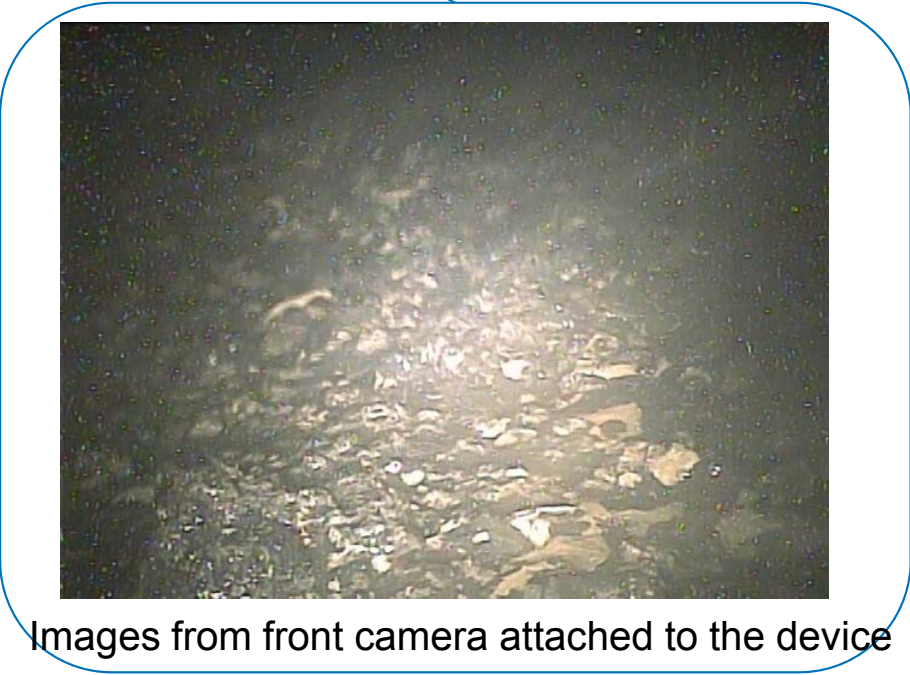
# 4-3. Results of deposit removal work (position where the device run on deposits)

- Today's investigation results
  - The device removed the deposits in a part of the planned area (about 1m out of 5m from the landing point).
  - It took time to remove the deposits because they adhered stronger to the rail as it got closer to the pedestal area.
  - Today's work was closed by retrieving the device before it prevents next investigation with a malfunction of the camera.
  - The device on the deposits could not run on some parts.
- Based on today's investigation results and mock-up testing, we will determine whether to conduct further investigation with the self-propelled investigation device.

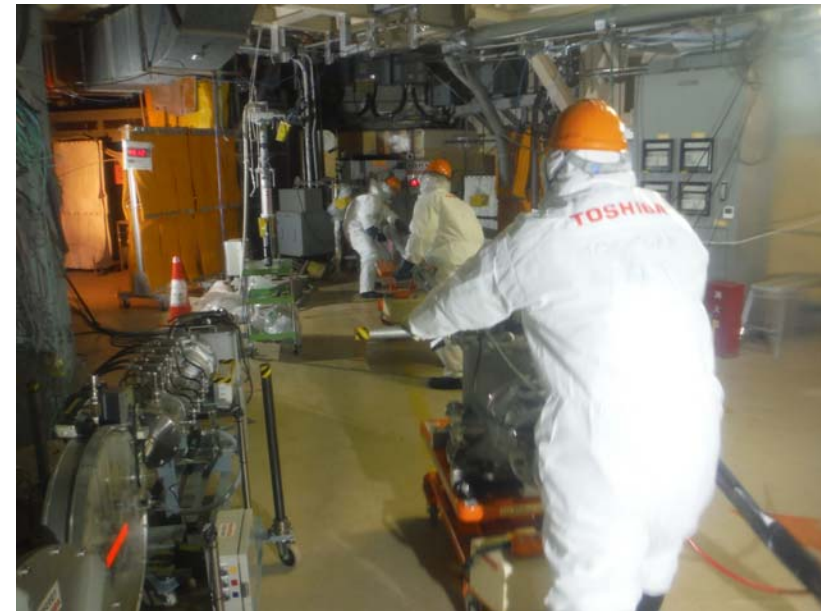
Inside the Unit 2 Reactor Building

The deposit removal work was conducted by remotely operating the device in the remote operation room and by inserting/pulling out the guiding pipe at the field headquarters and inside the Unit 2 Reactor Building.
