Unit 2 Primary Containment Vessel Investigation
at Fukushima Daiichi Nuclear Power Station
(Investigation results by the self-propelled investigation device)

1. Work steps for Unit 2 PCV investigation

2. Investigation results by the self-propelled investigation device (digital images)

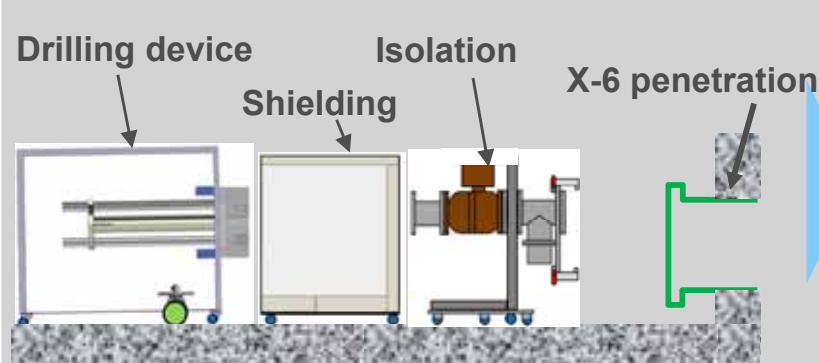
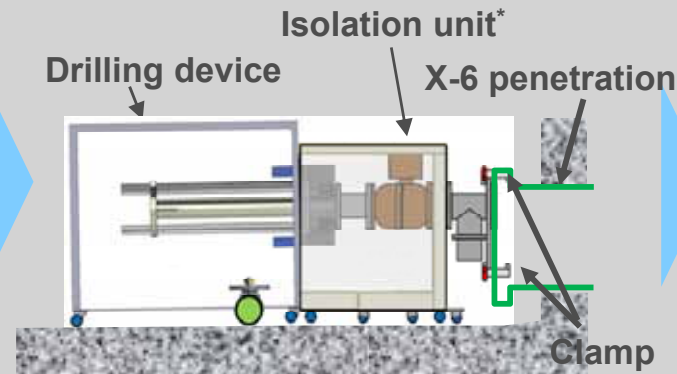
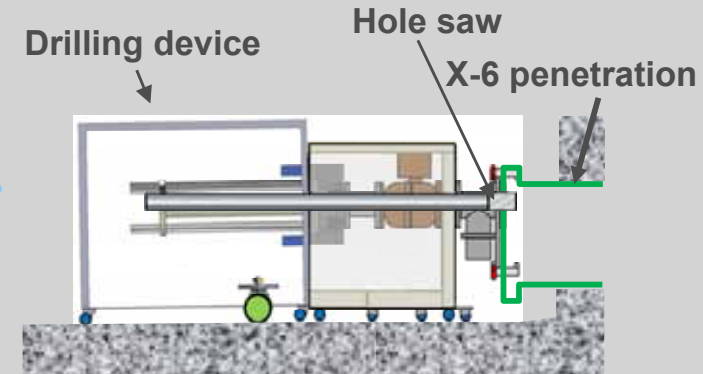
Step 1. Drilling device carried in

Step 2. Drilling device set up

Step 3. Drilling on X-6 penetration

*Combination of isolation and shielding

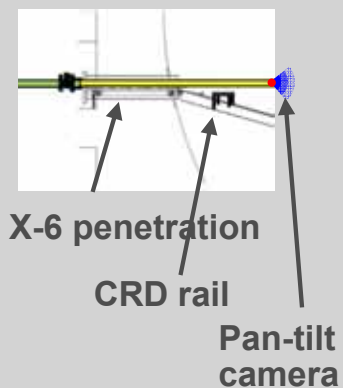
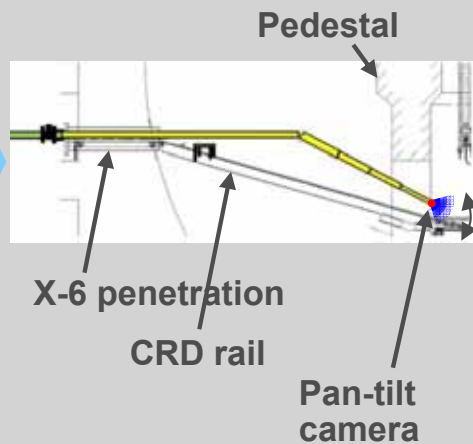
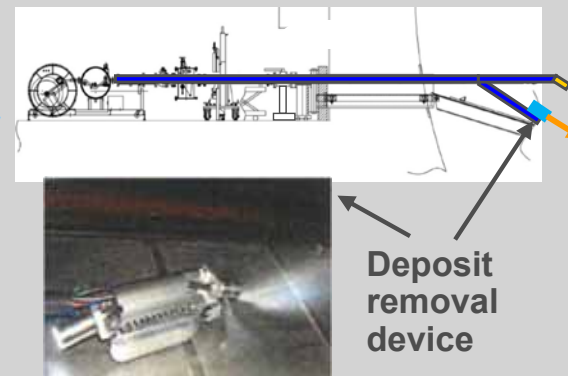
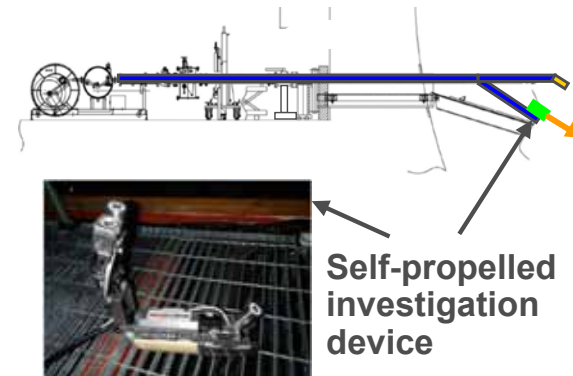
Step 4. Pre-investigation of X-6 penetration and CRD rail using guide pipe

Step 5. Pre-investigation inside pedestal using guide pipe

Step 6. Obstacle removal device inserted*

Step 7. Investigation using self-propelled investigation device

*The device may not be inserted depending on the obstacle conditions.

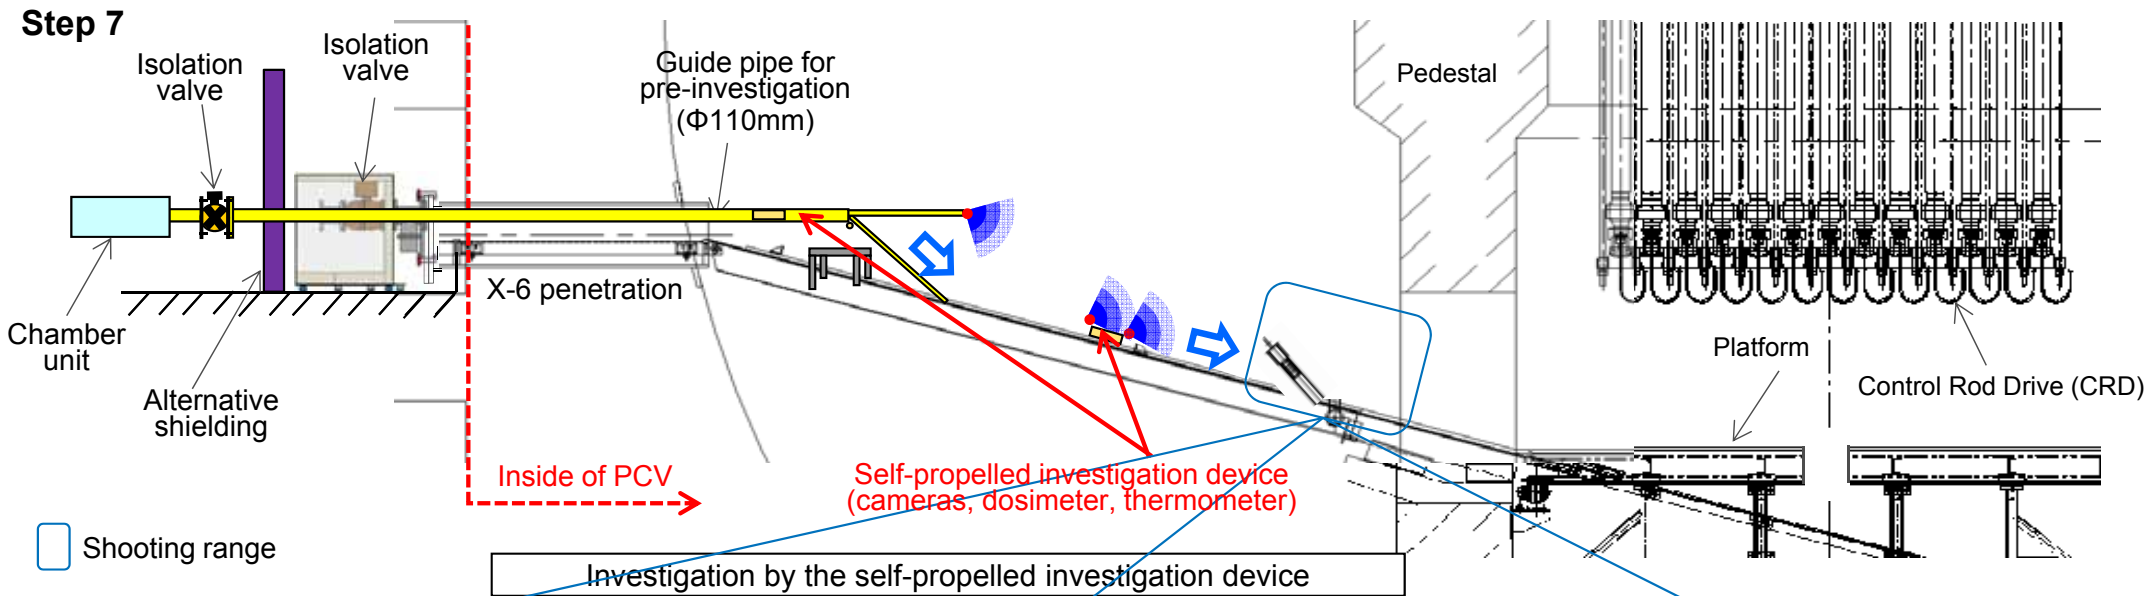
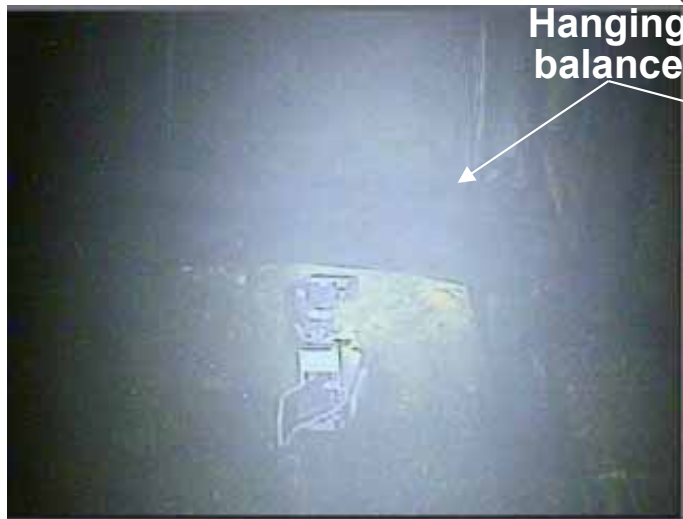
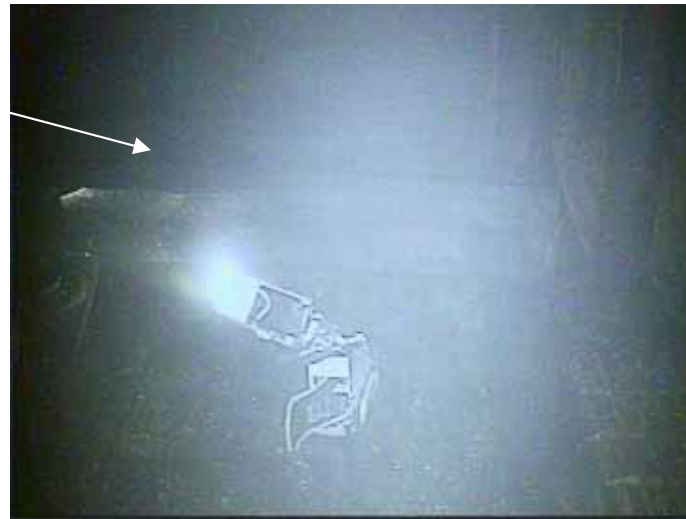
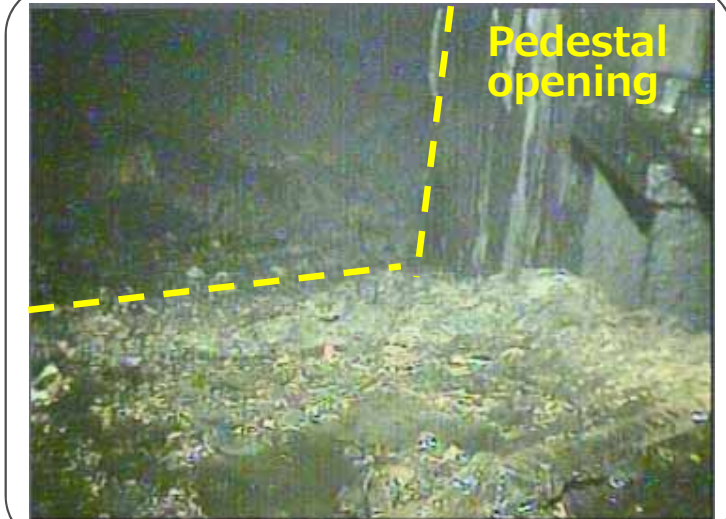
- Today's investigation results
 - The self-propelled investigation device ran on the deposits of the CRD rail and reached the area toward the pedestal (the vicinity of hanging balance), further than the area where the deposit removal device reached.
 - It tried to move further toward the pedestal but could not reach there because the crawler belt on the left side could not move any more.
 - It investigated temperatures and radiation levels on the CRD rail as well as conditions of surrounding structures.
 - The connection cable was cut and the device was left on the side of the CRD rail not to obstruct further investigations.

TEPCO will continue to evaluate the information, such as deposits on the CRD rail and conditions inside the pedestal, obtained from this entire investigation.

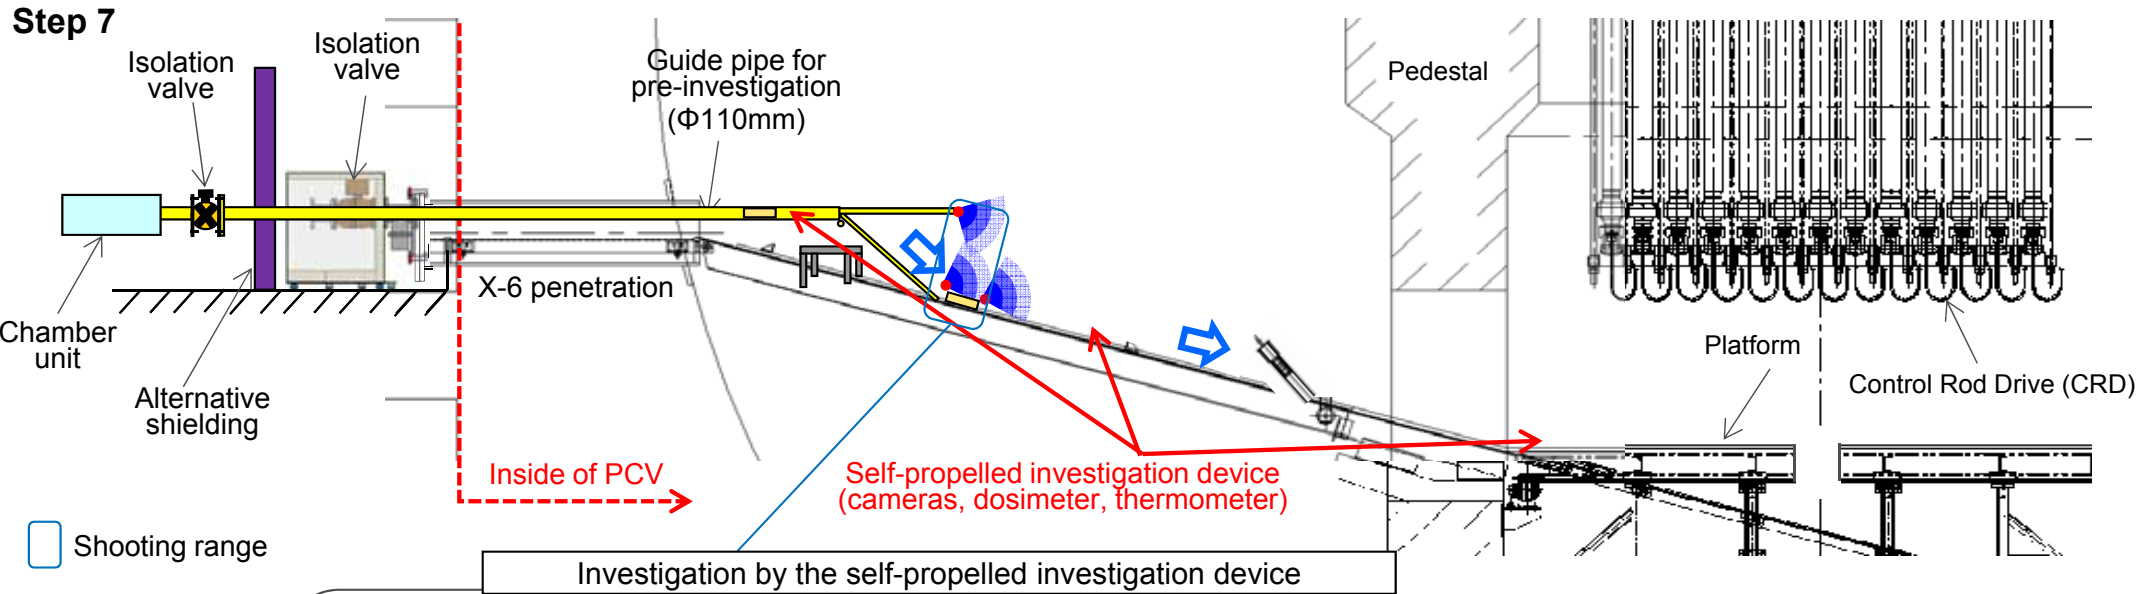
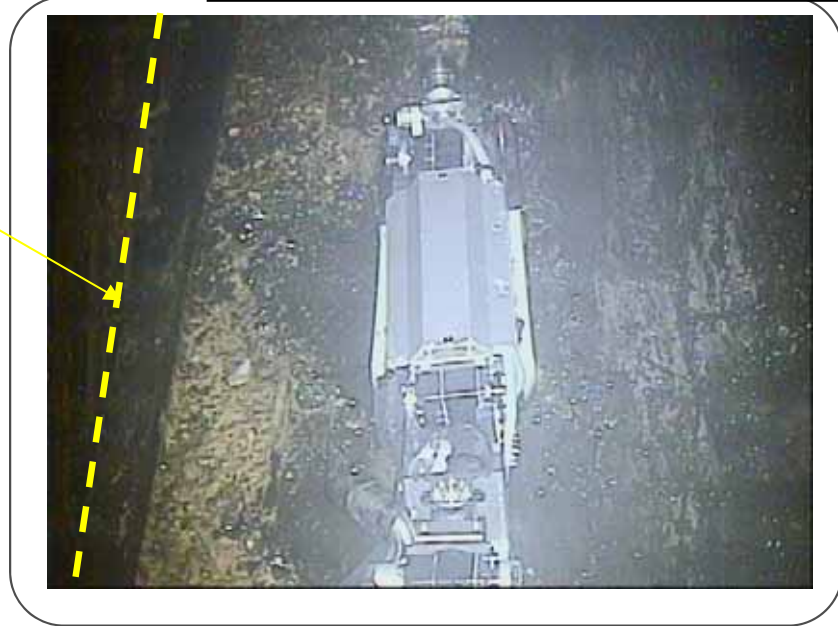
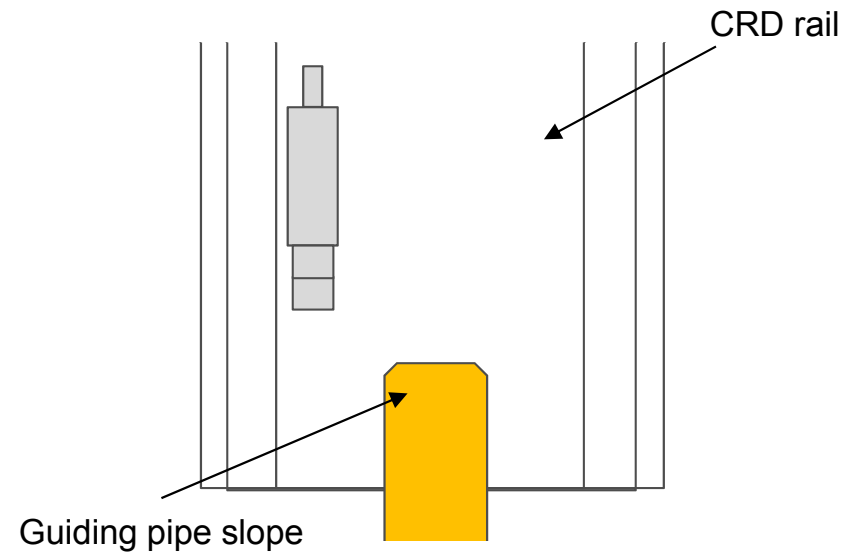
Reference: Location where the device was left

End of CRD rail

Location where the device was left
