1. Progress of Unit 1 PCV internal investigation (Preliminary report of March 18 investigation) 1/2

Reference
March 19, 2017
Tokyo Electric Power Company Holdings, Inc.

1. Progress of Unit 1 PCV internal investigation

(Preliminary report of March 18 investigation) 2/2

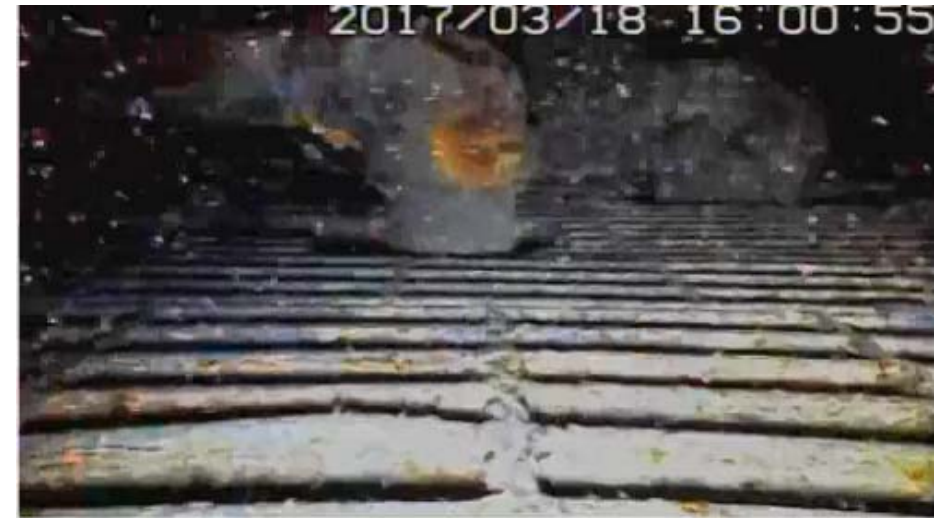
On the metal grating
(Front left-side camera of the investigation device)

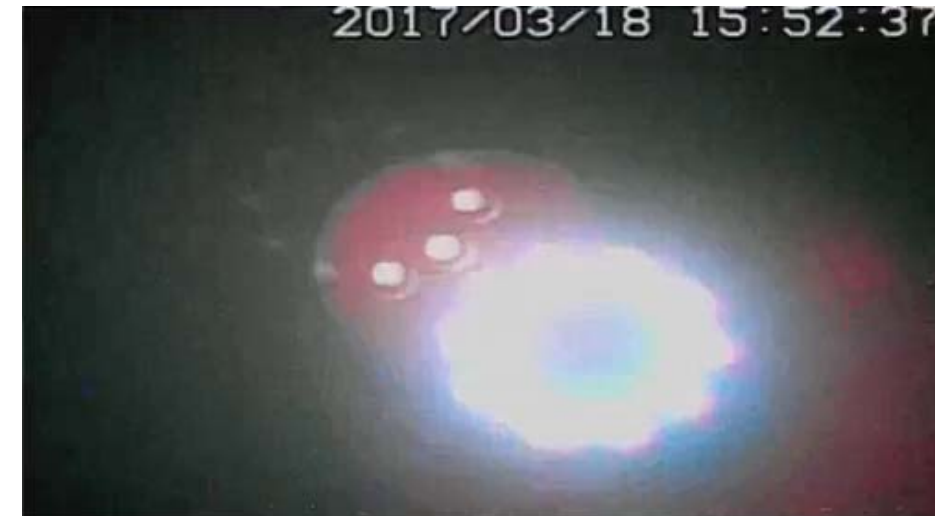
Measurement unit camera before inserted into the water

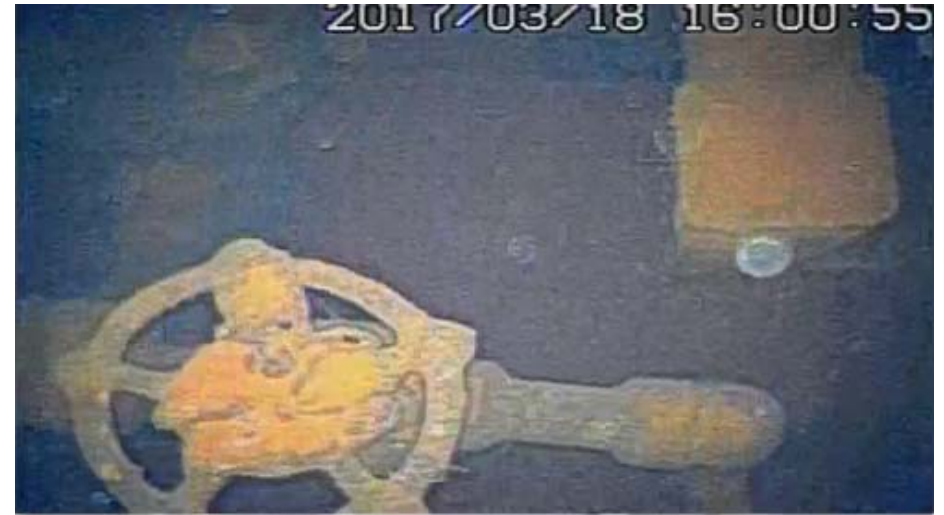
Underwater image at measuring point D0

Radiation dose at measurement point D0

- On metal gating: 7.8 Sv/h
- The lowest point: 1.5 Sv/h (About 1m above the PCV basement floor*)

The conditions of PCV basement will be evaluated after organizing digital images and radiation data.

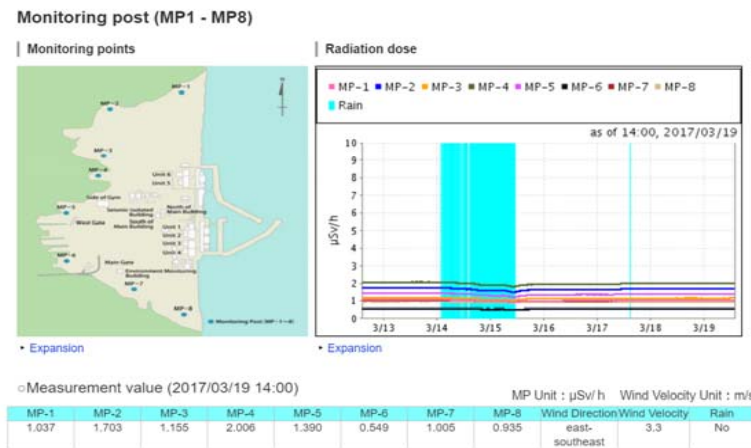
Radiation Dose measured at Monitoring Post of Fukushima Daiichi Nuclear Power Station

The following is the radiation doses of the air measured by the monitoring posts (MP1-8), portable monitoring posts and monitoring cars on the premises of Fukushima Daiichi Nuclear Power Station.

As of 11:40 a.m. on March 19, 2017: about 0.5-2.0 μSv/h
 *Radiation dose including the other influence than the PCV interior

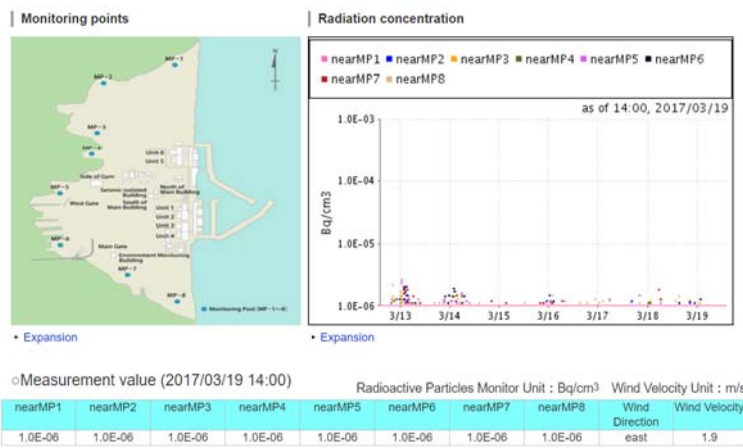
Radioactive Concentration measured at Dust Monitors near the Site Boundary of Fukushima Daiichi Nuclear Power Station

The following are radioactive concentrations in the air measured near the monitoring posts (MP1-8) at the site boundary of Fukushima Daiichi Nuclear Power Station.

As of 11:50 a.m. on March 19, 2017: 1.0E-06Bq/cm³

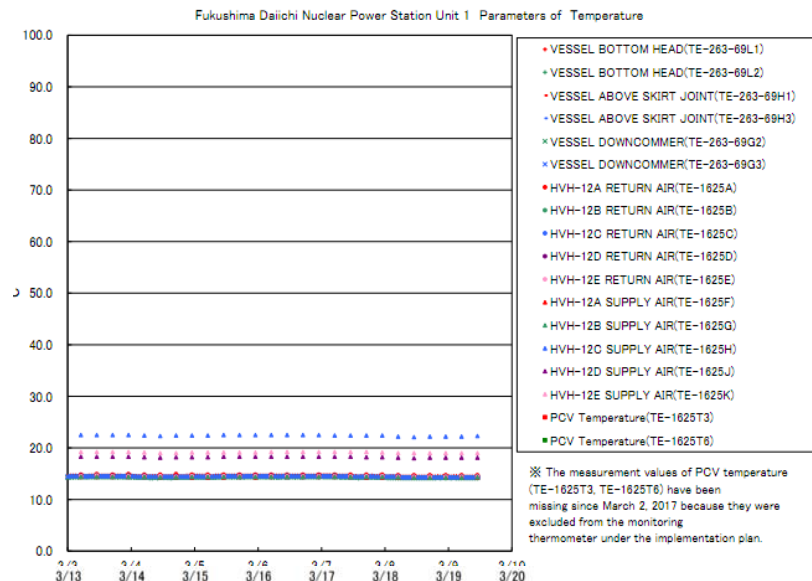
Fukushima Daiichi Nuclear Power Station Plant Parameters

As of 11:00 on March 19 2017

As of 12:00 p.m. on March 19, 2017: about 14-23 °C
