1. Progress of Unit 3 PCV internal investigation (Preliminary report of July 22 investigation) (1/2)

July 22, 2017

Tokyo Electric Power Company Holdings, Inc

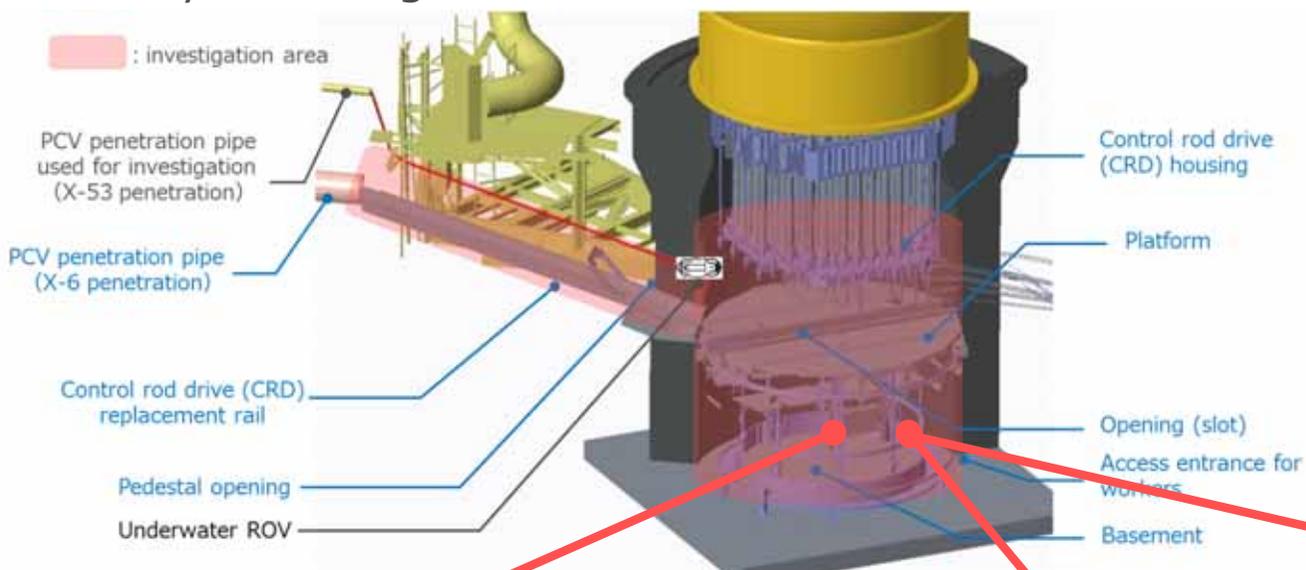
Outline view of investigation

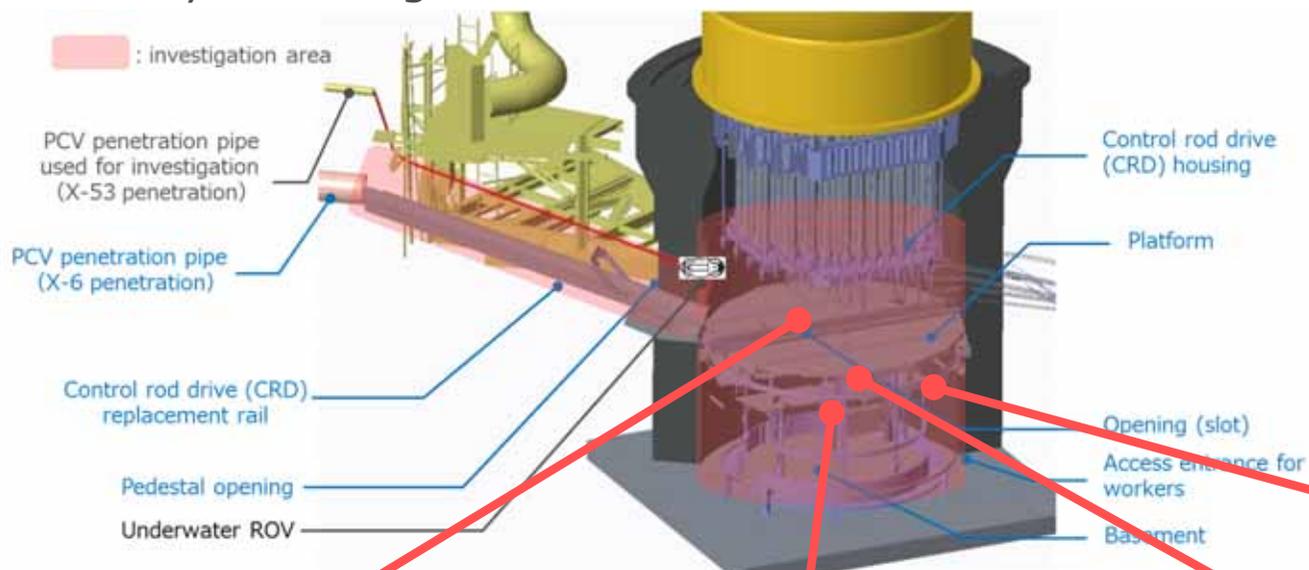
Outline view of investigation

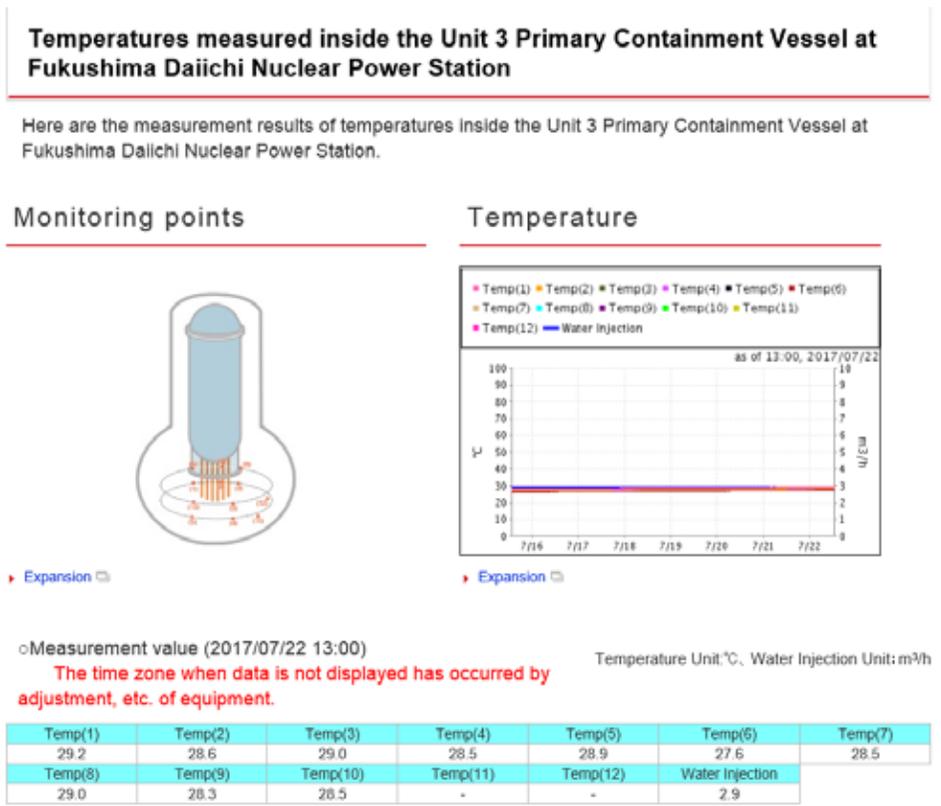
- Plant parameters are monitored all the time during the investigation, and no significant changes have been observed in the PCV internal temperatures after the investigation, compared to the before. The condition of cold shutdown has not been changed.
- Temperature data inside the PCV are available on the website.

(As of 1:00 p.m. on July 22, 2017 : about 27-29 °C)
