### 1 The structure of nitrogen gas separator

< R e f e r e n c e > A p r i l 20, 2012 Tokyo Electric Power Company

# 2 - 1 Description of the trouble of PSA Unit 4 and the corresponding treatment

#### [PSA Unit 3]

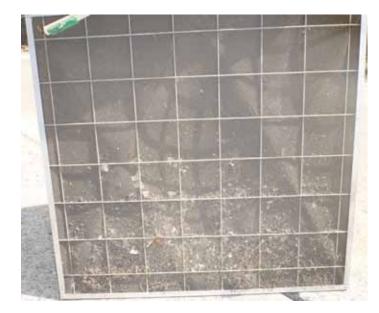
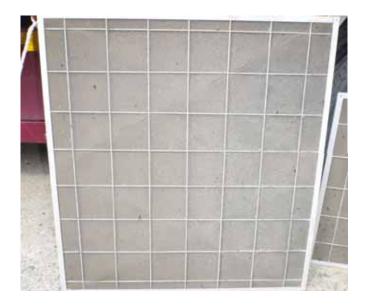
Confirmed "Over current protection" at the alarm display of the compressor itself.

Due to the heavy wind the day before, the filter was clogged with litter, insects, leaves, and others.

Cleaning of inlet filter and dust filter of the compressor was conducted. Then, the separator was rebooted, confirming normal operation.

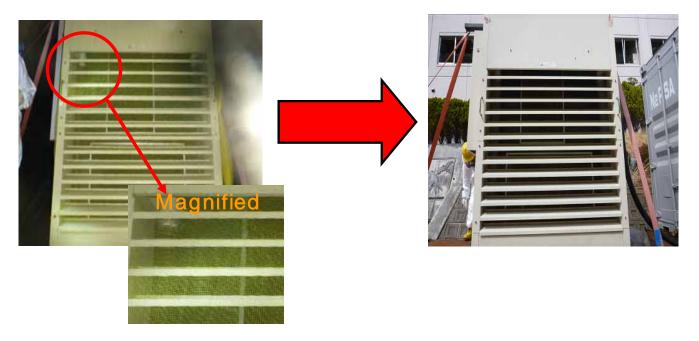
Confirmed "Drier trouble" at the alarm display of the compressor itself.

We confirmed that rain water adhered to the net which had been set to prevent matters including insects from absorbing. Because water rain was suspected as the cause, we removed the net, rebooting the compressor, and confirming normal operation.

Removed the net which had been set in front of the inlet filter of the compressor.
