May 24, 2012

Tokyo Electric Power Company

**Fukushima Daiichi Nuclear Power  
Station Unit 3 Reactor Building First  
Floor TIP Room Environment  
Investigation Result (May 23, 2012)**

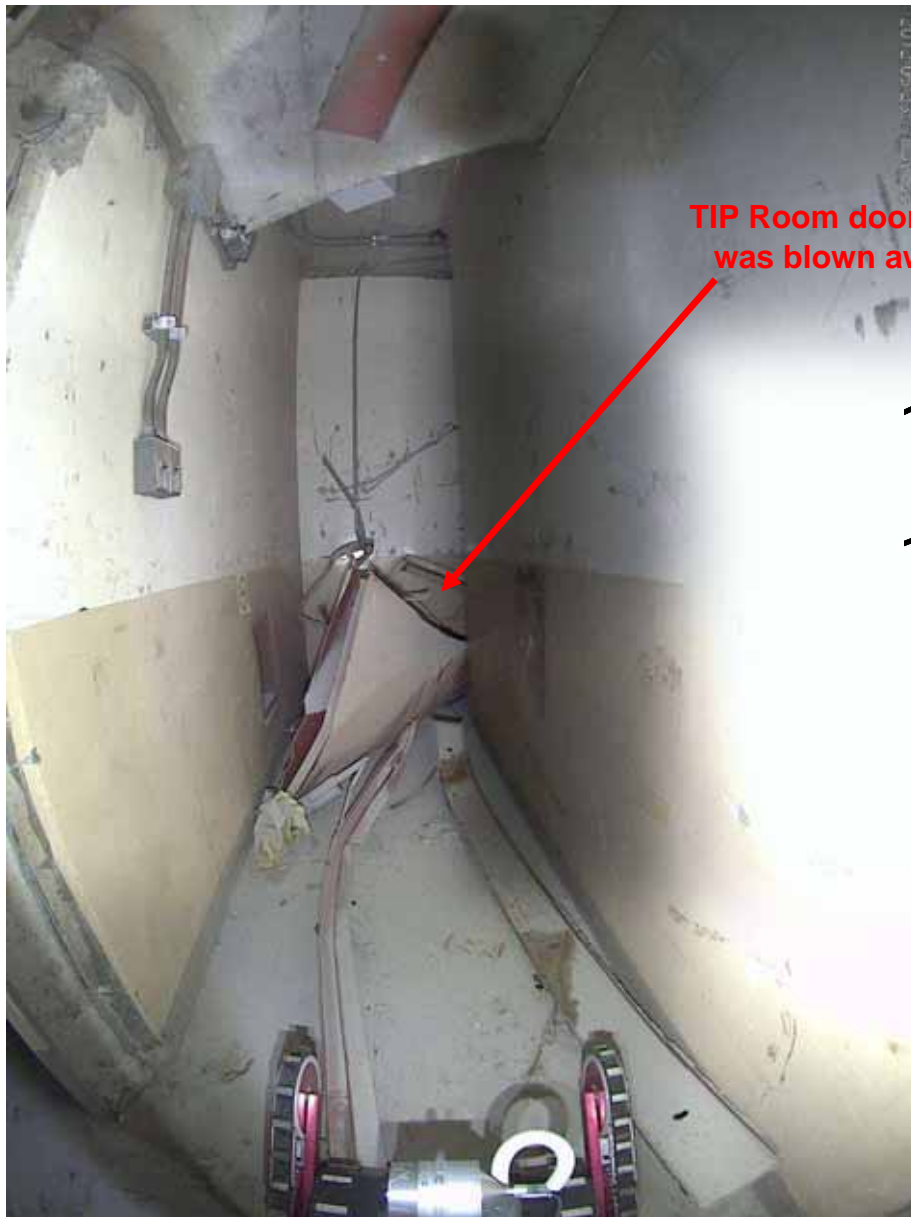
TIP Room door that was blown away

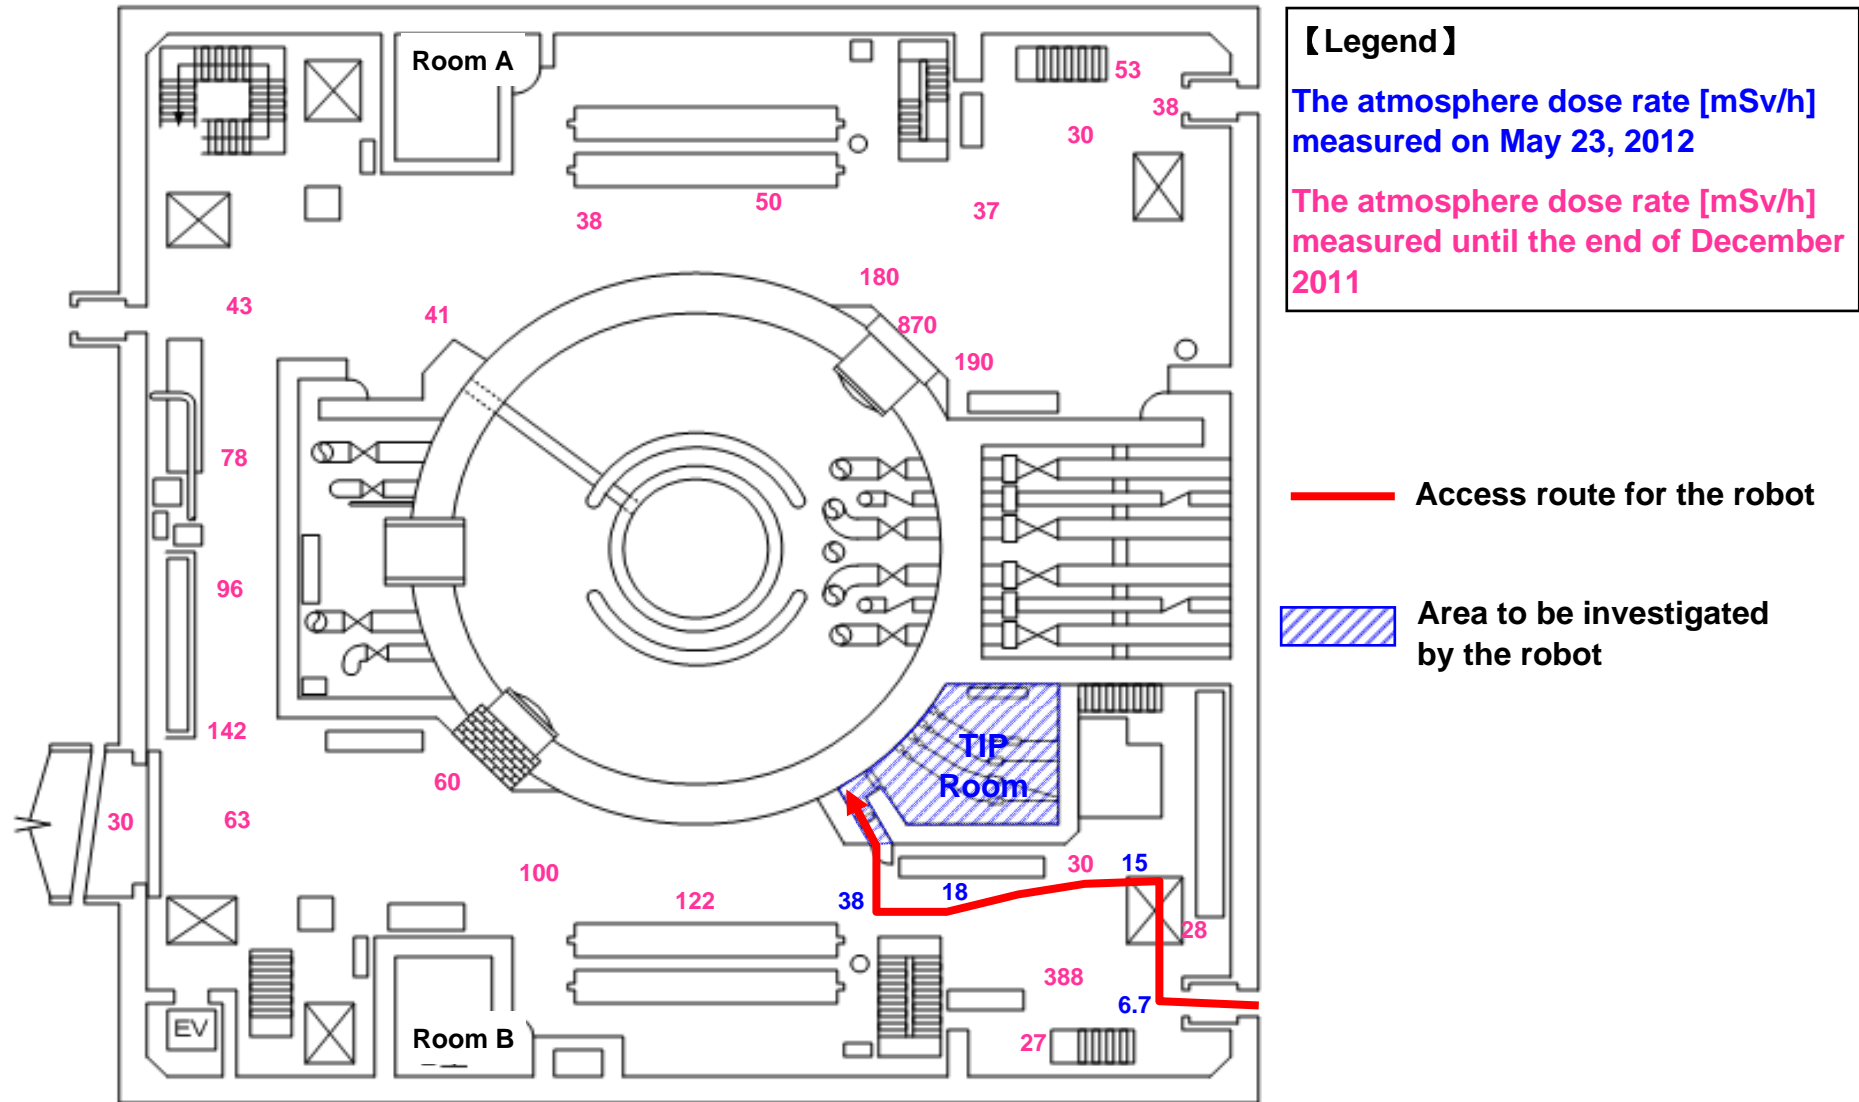
# (Reference) Access Route for the Robot

## Unit 3 Reactor Building First Floor
