Investigation of the Inside of Unit 4 Suppression Chamber at Fukushima Daini Nuclear Power Station

November 21, 2012

Tokyo Electric Power Company

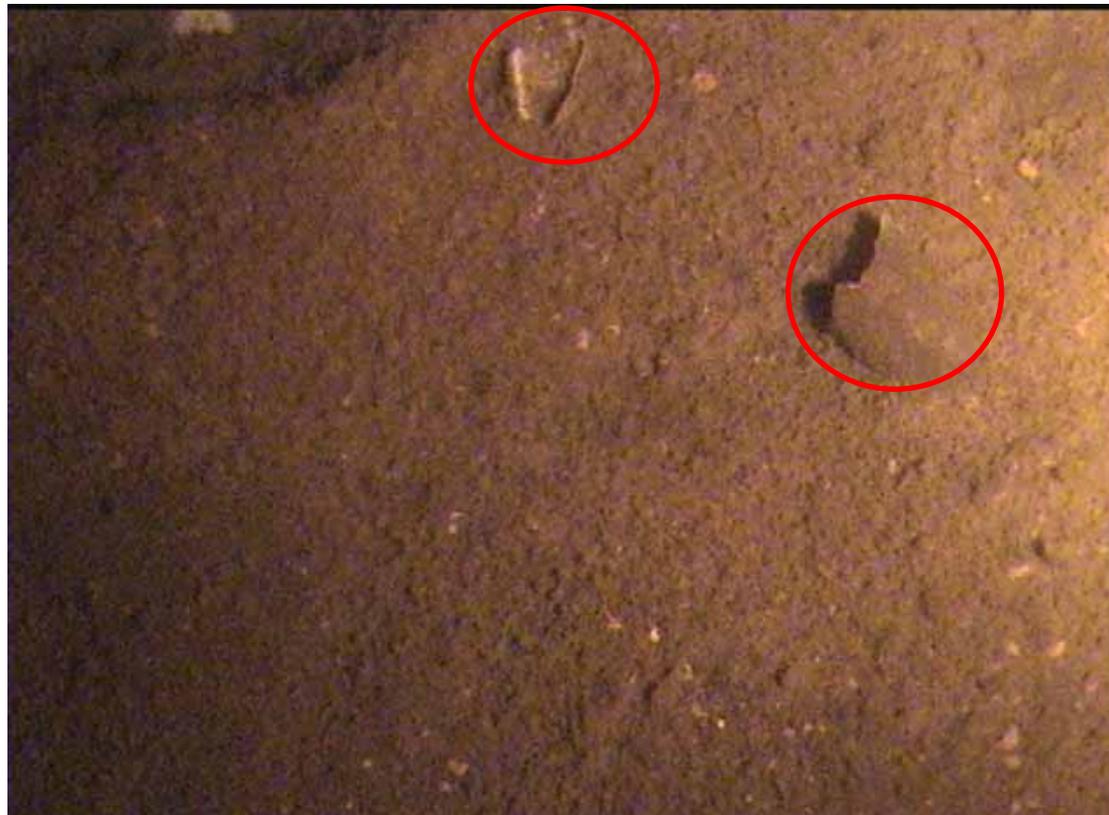
The substances indicated by red circles are paint peel-off.

The brownish powdery accumulation is rust inside the pipe
which came off.
