Drop Test of the HIC for the Multi-nuclide Removal Equipment

1. Drop test

2. Additional drop test (1)

3. Additional drop test (2)

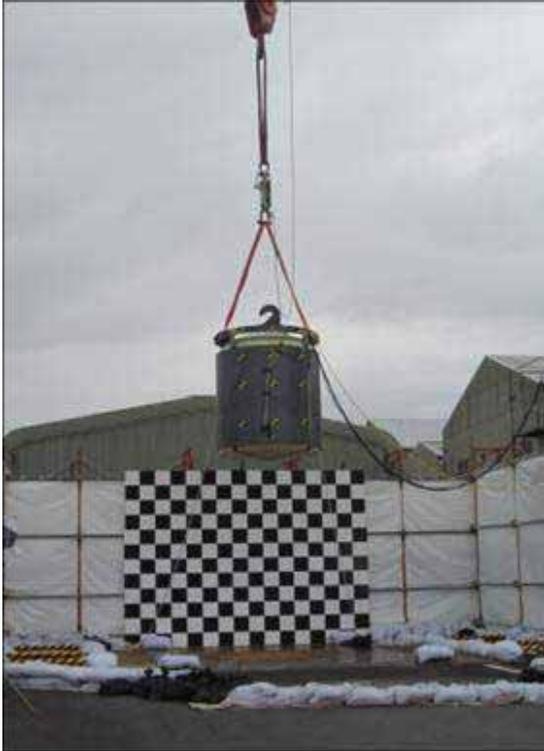
Before falling

Drop test using a HIC with a reinforcement ring attached
(Height at which the HIC was hung : 3m)

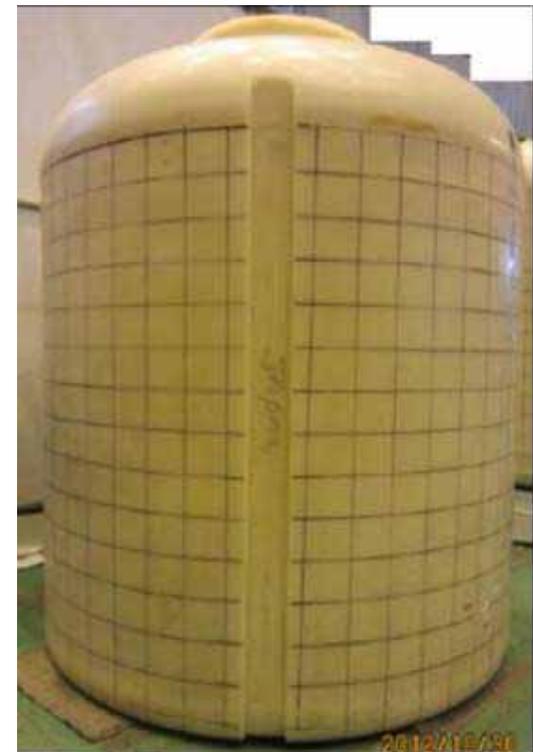
After removing the
reinforcement ring

No contents leakage or damage to the HIC was found though the lower part of the HIC was deformed.

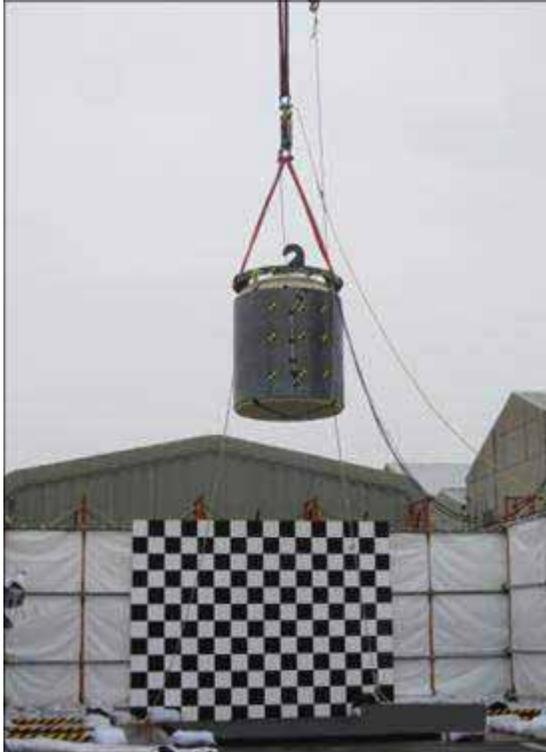
Before falling

Drop test using a HIC with a reinforcement ring attached
(Height at which the HIC was hung : 4.5m, with shock-absorbing material)

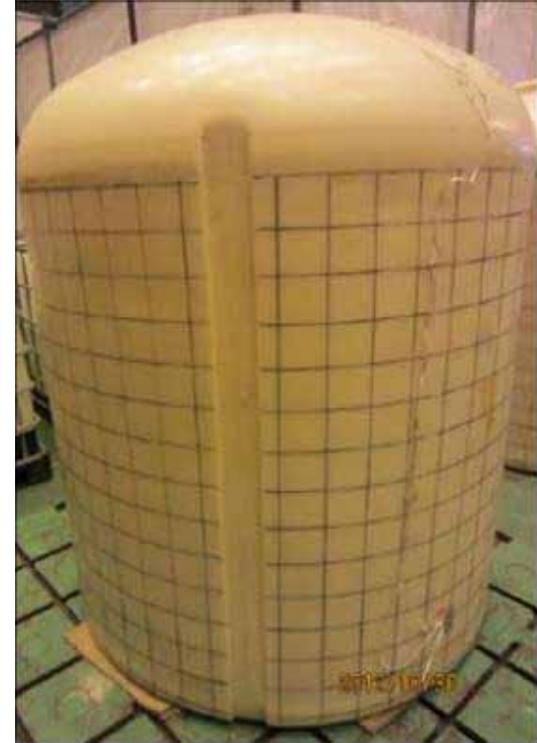
After removing the reinforcement ring

No contents leakage or damage to the HIC was found though the lower part of the HIC was deformed.

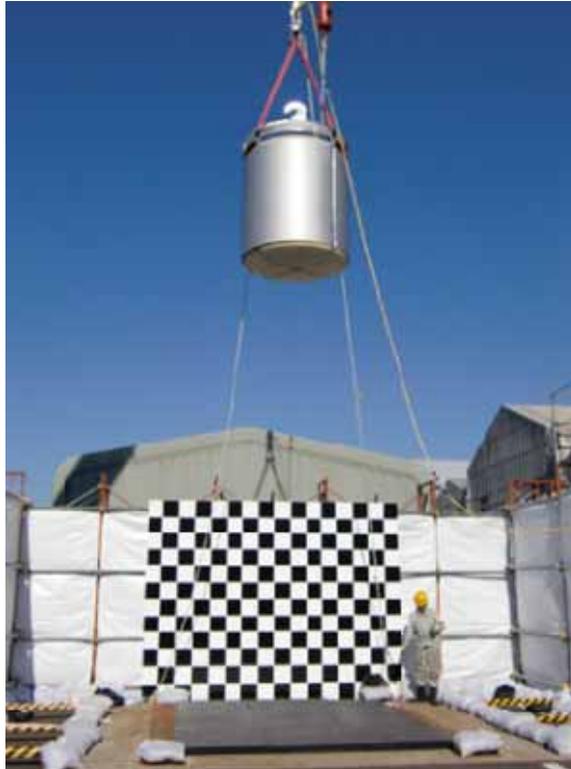
Before falling

(Height at which the HIC was hung : 6m, with shock-absorbing material)

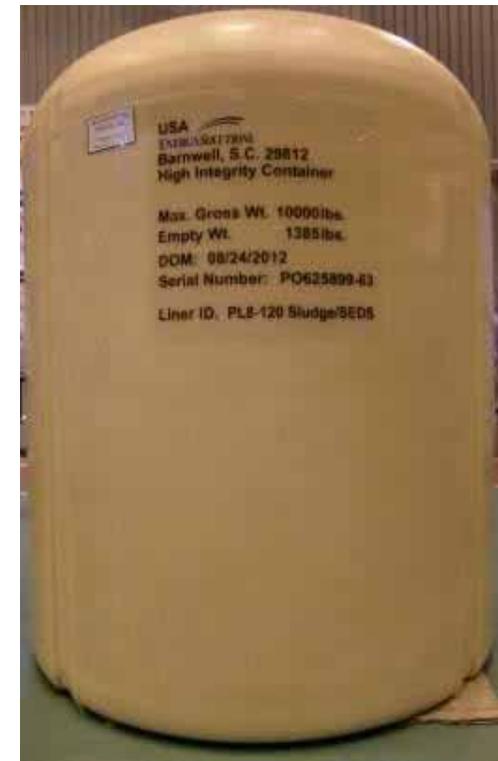
After removing the
reinforcement ring

No contents leakage or damage to the HIC was found though the lower part of the HIC was deformed.

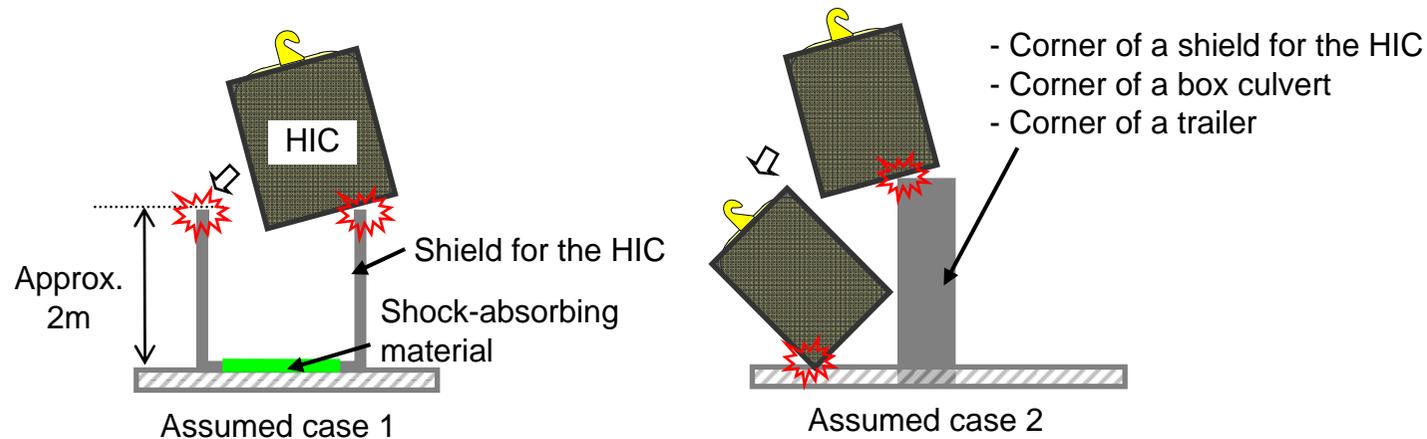
The falling conditions were arranged based on the following scenarios by taking into considerations the falling postures/heights assumed in the multi-nuclide removal equipment area and the primary storage facility area. The soundness of the HIC was evaluated based on these scenarios.

- Falling onto the corner of a shield or box culvert
 - Falling onto the back of a trailer
 - Falling at an angle taking into considerations the secondary collision
 - Falling on another HIC
- etc.

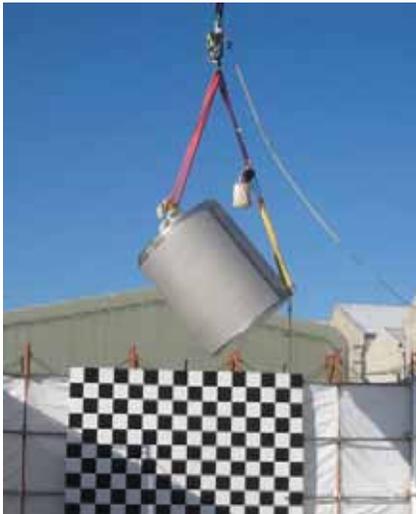
Case 1: Before falling

Case 1: Dropped from 3m at an angle (Falling from the bottom corner)

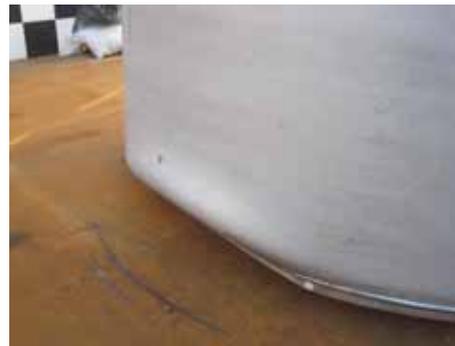
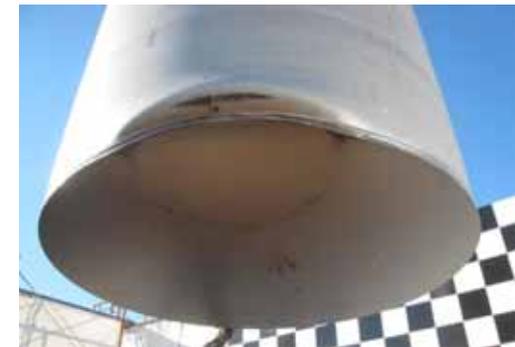
Case 1: After falling

No leakage from the HIC though deformation was found on the bottom corner of the reinforcement.

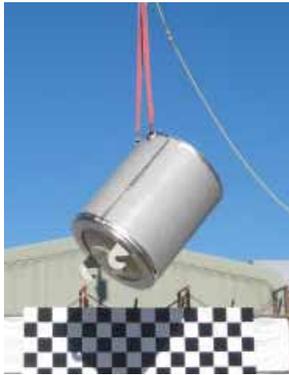
Case 2: Before falling

Case 2: Dropped from 3m at an angle in the opposite direction (Falling from the upper corner)

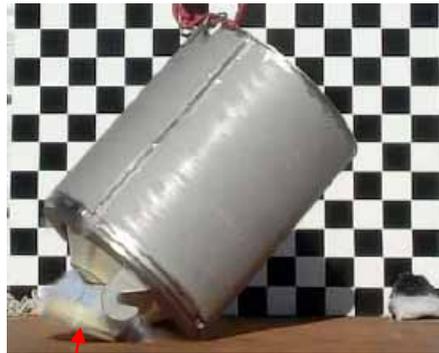
Case 2: After falling

HIC upper lid

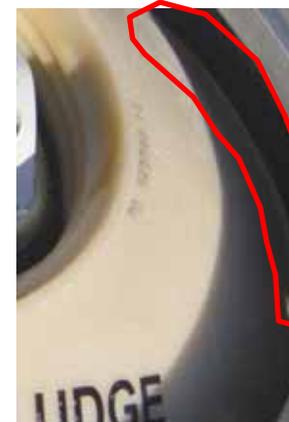
* The upper lid of the HIC came off when dropped. Damage found on the upper part of it.
The portion which got cracked

Measures towards safe HIC handling will be considered based on the obtained results.

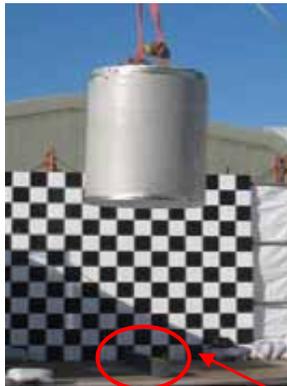
Case 3: Before falling

Case 3: Dropped from 2.6m (Falling onto a 100mm square bar)

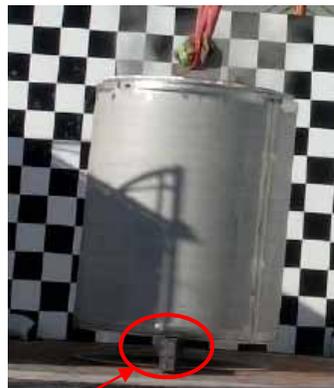
Case 3: After falling

Square bar
(Width: 100mm)

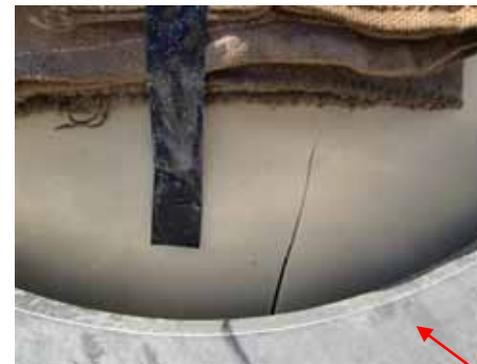
* Damage found on the area with shape inconsistency.
Ring on the upper part
