Progress Status and Future Challenges of the Mid-and-Long-Term Roadmap towards the Decommissioning of TEPCO's Fukushima Daiichi Nuclear Power Station Units 1-4 (Outline)

Progress status

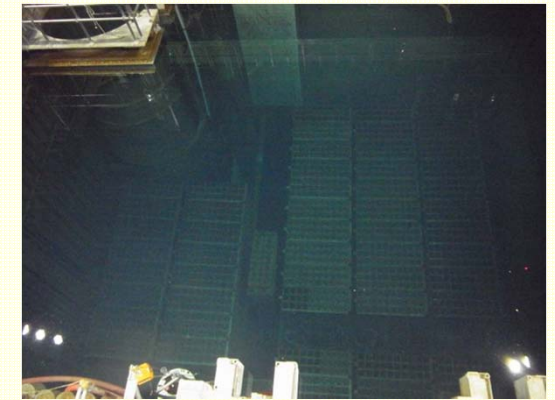
Photo taken on March 12, 2014
<Status inside Unit 4 SFP>

Rubble removal from the Unit 4 spent fuel pool (SFP), which has been operated in parallel with spent fuel removal, has been accomplished. (Large rubble: accomplished on October 2, 2013, small rubble: accomplished on March 8, 2014)

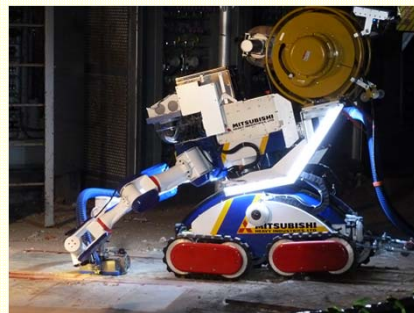
<Vacuuming and blast decontamination equipment>

Demonstration test of the remote-control decontamination equipment was conducted on the 1st floor of the Unit 1 reactor building from January 30 to February 4. The equipment was developed for the fuel debris removal work in future with the subsidy project of the Ministry of Economy, Trade and Industry.

The result showed that the β ray dose rate was reduced by removing dust through vacuuming and the coated surface could be ground by the blast decontamination*.

* Blast decontamination: A method to grind the surface by injecting polygonal steel grains onto the object to be decontaminated (floor surface)

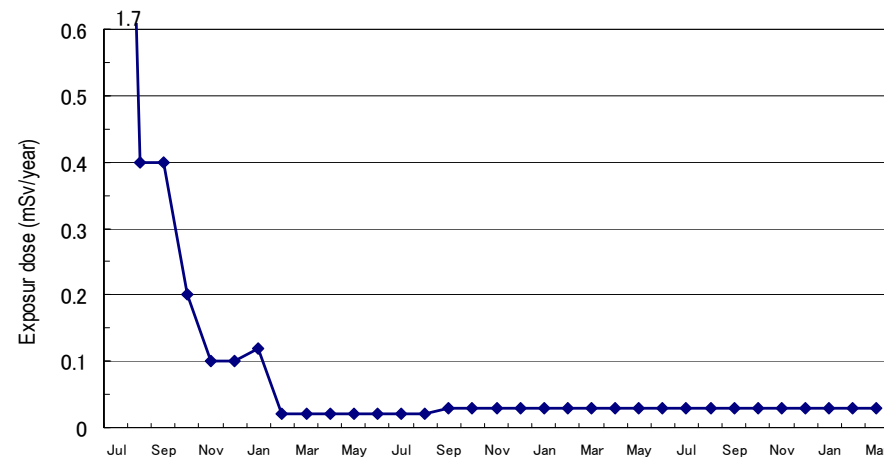
Annual radiation dose at site boundaries by radioactive materials (cesium) released from Reactor Building Units 1-4

The density of radioactive materials newly released from Reactor Building Units 1-4 in the air measured on-site boundaries was evaluated at approx. 1.4×10^{-9} Bq/cm³ for both Cs-134 and -137. The radiation exposure dose due to the release of radioactive materials was 0.03 mSv/year (equivalent to approx. 1/70 of the annual radiation dose by natural radiation (annual average in Japan: approx. 2.1 mSv/year)) at the site boundaries.

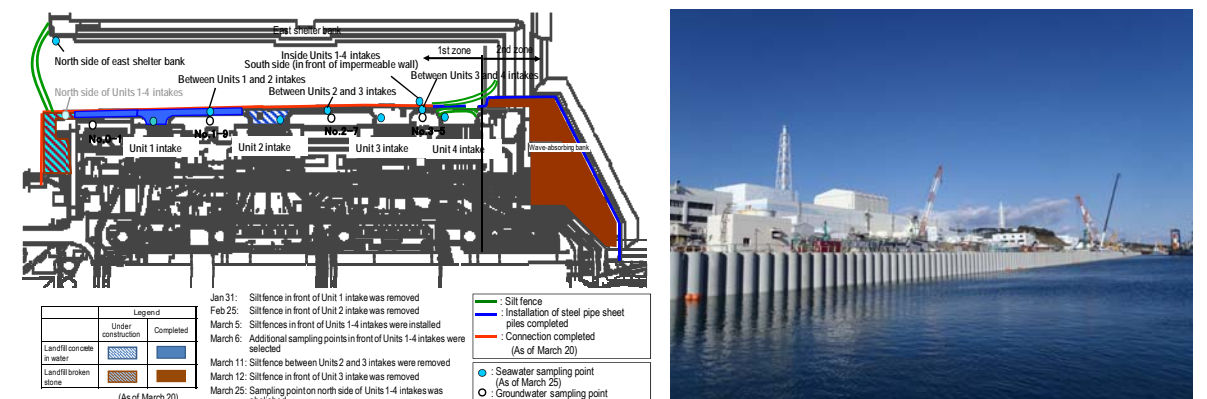
Figure 4: Progress status of impermeable walls on the sea side

- In response to the progress of the construction of impermeable walls on the sea side, placement of concrete in water and landfill are underway inside the impermeable walls from the north side (see Figure 4). In conjunction with these works, removal and installation of silt fences, abolition of sampling points inside the impermeable walls ("North side of Units 1 to 4 intakes" and "Unit 1 intake" and set up of a new sampling point inside the impermeable walls ("South side inside Units 1 to 4 intakes (in front of impermeable walls)") were conducted.

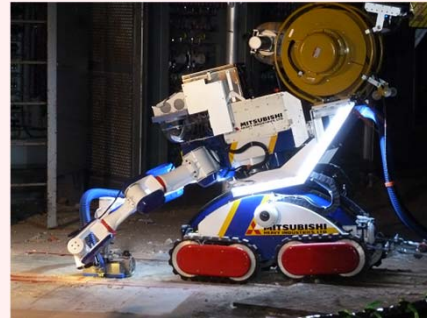
Aspiration and blast decontamination equipment

- Prior to formulating a decontamination plan inside the Reactor Building toward the future removal of debris, demonstration test of the remote-control decontamination equipment was conducted on the 1st floor of the Unit 1 reactor building from January 30 to February 4. The equipment was developed for the fuel debris removal work in future with the subsidy project of the Ministry of Economy, Trade and Industry.
- The result showed that the β ray dose rate was reduced by removing dust through aspiration decontamination and the coated surface was shaved by the following blast decontamination*.

* Blast decontamination: A method to shave the surface by injecting polygonal steel grains to the object to be decontaminated (floor surface)

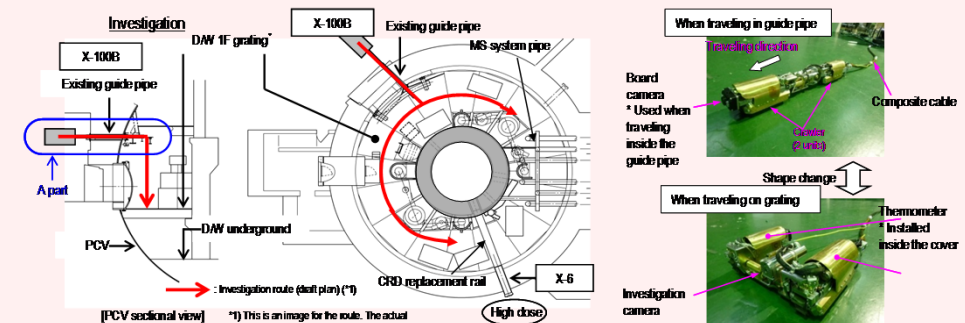
- Crawler-type equipment with a shape-changing structure which allows it to enter the PCV from the narrow access entrance (bore: ϕ 100mm), and stability travel on the grating is currently under development. A field demonstration is scheduled for the 2nd half of FY2014.

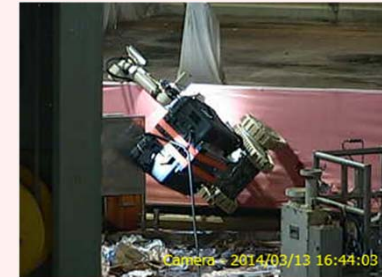
- To investigate the contamination status of the Reactor Building 5th floor, investigative equipment (gamma camera, radiation dose gauge, optical camera) will be suspended through holes drilled in the building roof. In addition, core samples on the 5th floor are collected using remote-control robot.
- To ensure the operation route of the robot for collecting floor core samples, fences on the operating floor⁽⁶⁾ were removed using the remote control robot (March 13 and 14).
- As the robot fell during the operation and the battery became low, the relevant robot could not be collected. Removal of fences was completed and the core was collected within the accessible range (from March 20-26).

Status of remote-control robot falling down

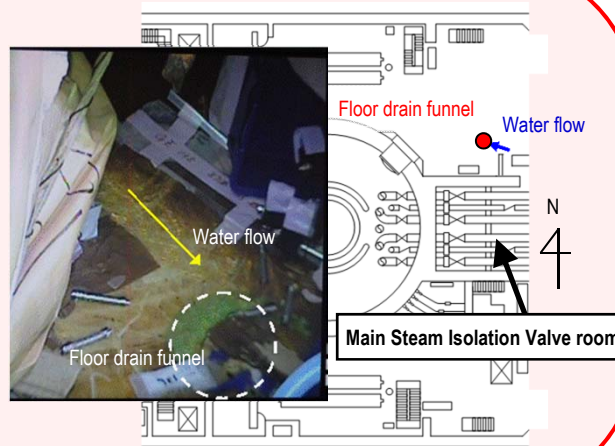
<Outline of the water flow status>

Based on the analytical results of temperature and radioactive materials of the water flow, and examination by drawings, there is a high likelihood of accumulated water, for which an indoor investigation will be conducted.

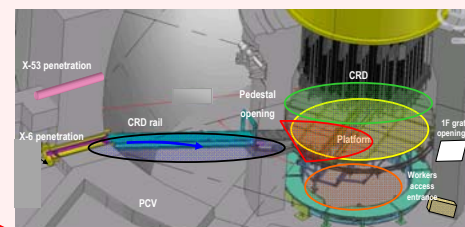
- (1) Investigation from X-53 penetration
 - Following decontamination, a field investigation is scheduled in the areas around X-53 penetration to determine the policy for conducting the inside investigation and equipment specifications.
- (2) Investigation plan following the investigation of X-53 penetration
 - Based on the measurement values of hydraulic head pressure inside the PCV, X-6 penetration may sink. It is estimated that access to X-6 penetration is difficult.
 - For access from another penetration, approaches such as "further downsizing the equipment" or "moving in water to access the pedestal" are necessary and will be examined.

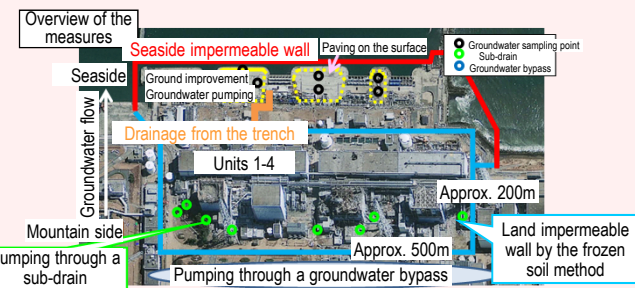
- Preventing leakage of contaminated water
 - Underground soil improvement behind the bank protection to prevent expansion of radioactive materials. (Between Units 1 and 2: completed on August 9, 2013; between Units 2 and 3: from August 29 and completed on December 12, 2013; between Units 3 and 4: from August 23, 2013 and completed on January 23)

- To prevent the ingress of rainwater, the ground surface is being paved with asphalt (commenced on November 25, 2013)
- Removing the contamination source

- Removal and closure of contaminated water such as branch trench (completed on September 19, 2013)
 - Purification and removal of contaminated water in the main trench (Unit 2: Purification commenced on November 14, 2013; Unit 3: commenced on November 15, 2013) (Frozen water stoppage, water drainage: Freezing is scheduled for commencement by end March)
