Fukushima Daiichi Nuclear Power Station Response after the earthquake

Time line sequence of major events following earthquake to May 12th (Sat) for Unit 1 at Fukushima Daiichi Nuclear Power Station

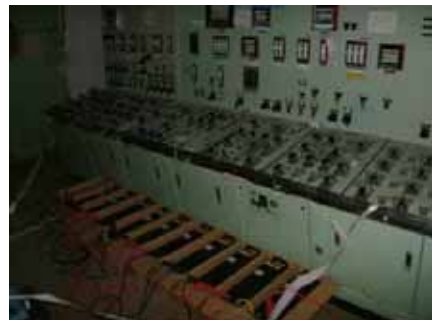
Temporary Batteries were used to supply power to instrumentation

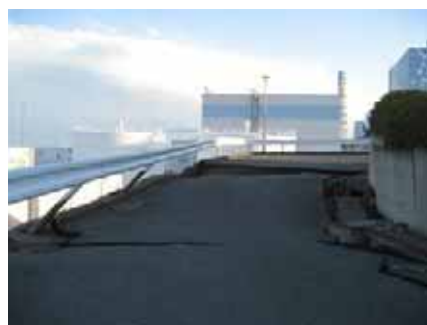
Sagging of Road

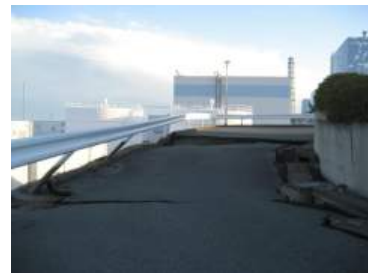
Sagged Road in the Site

- One fire engine was made ready for injection to the RPV. Other two fire engines were unavailable, for one was failed by the tsunami and the other was not able to move from the area near Unit 5/6. Damages on the road and debris by the tsunami divided the access route between Units 1 – 4 side and Units 5,6 side.

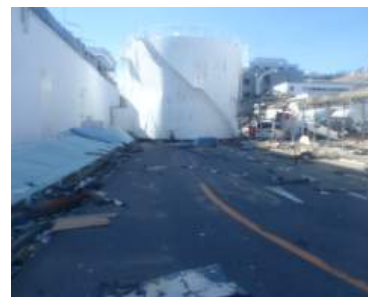
Tank moved by Tsunami

- **There were a lot of obstacles to deploy the available fire engine close to Unit 1. Tank swept by the tsunami blocked a road in front of the old-administration building and the road was impassable. The gate at the physical protection headquarters lost power and did not open. The restoration team of the site emergency response headquarters looked for rout in the site, then got access for the fire engine by breaking a lock at the gate between Units 2 and 3.**

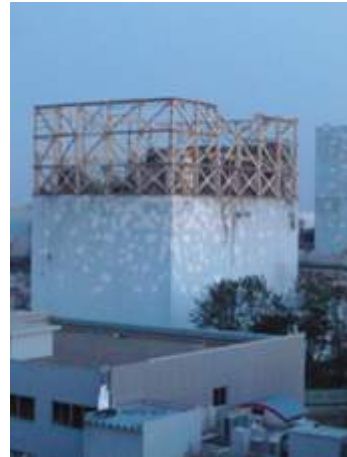
Explosion of Unit 1 Reactor Building

- At 15:36, **Unit 1 reactor building exploded.**
 - **Workers at the field evacuated, rescued and transported the injured.** (TEPCO: 3, Contractor: 2)
 - **To verify safety and see effect of the explosion, field survey and walk down were conducted.** (Status of fire engines, damages to the buildings and smoking etc.) Fire engines maintained their function though windshield was broken.

- As for the SLC pump, **ballistic fragments by the explosion damaged cable damaged the cable and high-voltage power supply vehicle stopped automatically.**

- **The hoses prepared for seawater injection was also damaged.**
- **It was impossible to resume restoration work until evacuation, confirmation of the safety of workers and the field were completed.**

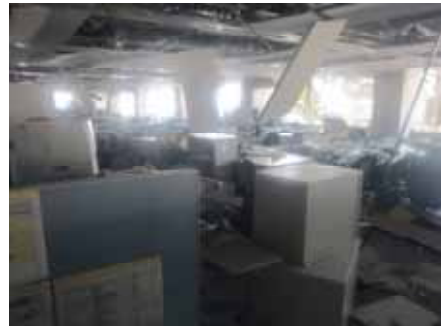
The status of administration main building

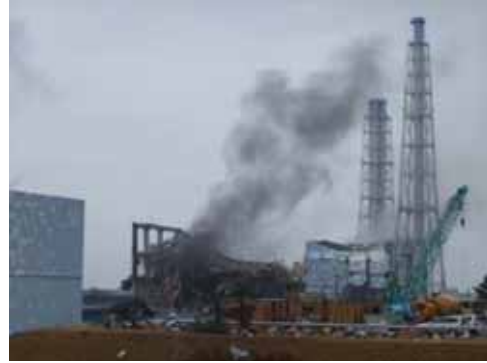
External View of Unit 3 after explosion

- Rubbles with high level of radioactivity were scattered around by the explosion. Seawater injection was stopped since fire engines and hoses got damaged. Due to the rubbles the vertical shaft of reversing valve became unusable.
