State of Immediate Response after Disaster Struck at Fukushima Daiichi Power Station

This document is compilation of facts as they are known at the present time based on a variety of report and eye witness accounts. If and when new facts come to light hereafter as the investigation continues, they will be disclosed at that time.

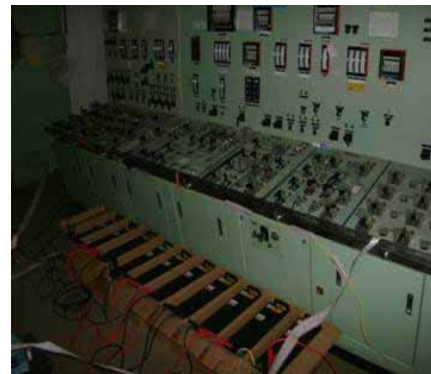
Connecting temporary battery to power instrumentation

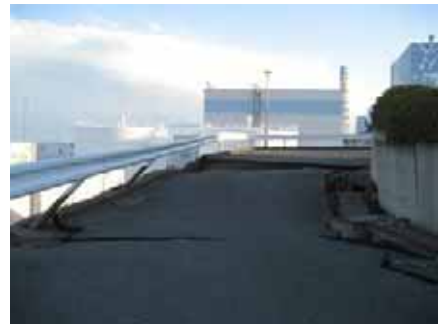
Road subsidence

- The work was made very difficult **due to the darkness, pools of standing water from the tsunami, scattered debris obstructing the way, missing manhole covers on the roads, and generally poor working conditions.** The work was especially onerous, searching in the darkness for places to punch through in order to lay the cables, breaking down doors to secure the route and so on. To make it worse, **large-scale tsunami warnings continued and frequent aftershocks shook the premises, and work was constantly constrained by the need to take refuge.**

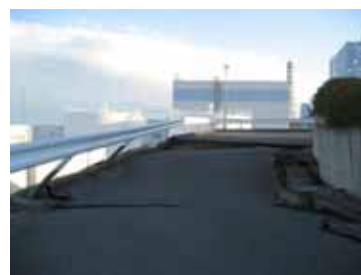
Road on station grounds

from the Units 5 & 6 side. (the road was damaged and debris from the tsunami cut off the route connecting the Units 5 & 6 side.)

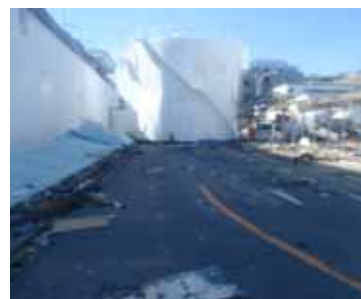
Tank washed up by tsunami

- **There were numerous obstacles to getting the one usable fire-engine to the deployment site near Unit 1. The road passing in front of the former main office building was impassible due to a tank that had been washed into the road by the tsunami blocking passage. The gate to Protection Headquarters could not be opened because there was no electric power. The Emergency Countermeasures Headquarters Restoration Team searched for passable routes within the station grounds, then the lock on the gate between Units 2 and 3 had to be broken to get the gate opened, and thus the route for the vehicles was secured.**
- Regarding the fire-trucks, consideration was given to pumping water to the reactor

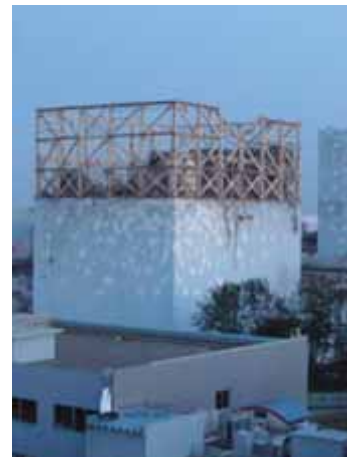
Unit 1 reactor building explosion
Windows on the fire-engine were broken, but functionality was not damaged.

- **The cables that had been laid to the SLC pump were damaged by flying debris from the explosion, and the high-voltage power generating truck shut itself down automatically.**
- **The hose that had been readied for pumping in seawater was damaged.**

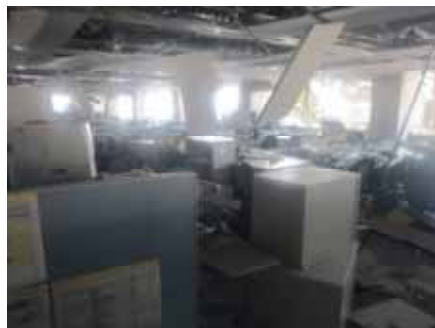
- **As aftershocks continued rocking the power station,** the Emergency Countermeasures Headquarters Restoration Team **entered the Main Office building, which was then designated as off limits, in order to retrieve the blueprints so as to confirm the type and structure of the S/C vent valve (AO valve) needed for the venting operation to determine whether they could be opened manually or not,** as well as making inquiries to contractors. As the result of checking the blueprints, it was confirmed that **the S/C small vent valve (AO valve) had handles and therefore could be opened manually,** and this information was conveyed to the Main Control Room.

Main Office Damage

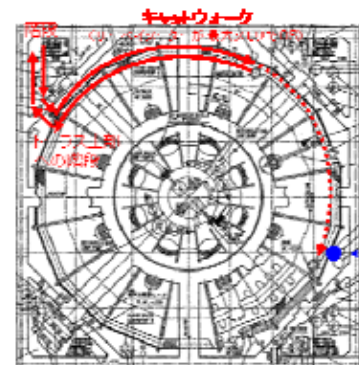
R/B B1

- Team No. 2 sets out from Main Control Room at 9:24 heading for the Torus chamber in order to open the S/C small vent valve (AO valve). **On the way, radiation rises**, and there is the possibility of exceeding the dose limit of 100 mSv, so at about 9:30 the team turn back.
- Team No. 3 mission is cancelled due to high radiation dose. Emergency Countermeasures Headquarters notified.

AO valve

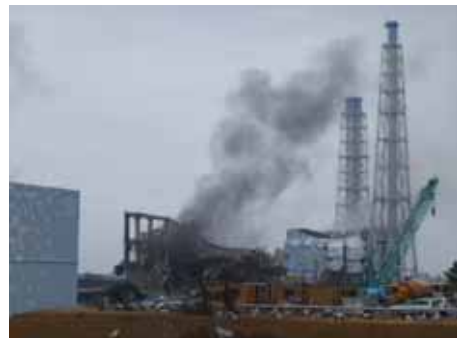
- All workers except for the shift personnel in the Main Control Room stopped work and evacuated to the seismic-isolated building. Restoration work could not be started right away due to ascertaining safety of workers and checking the field conditions. Four TEPCO employees, three contractors, and four Self Defence force personnel were injured.
- The explosion scattered highly radioactive debris throughout the area. Fire truck and hoses are damaged, seawater injection halted. The back wash valve pit became unusable due to the rubble.

Unit 3 after explosion

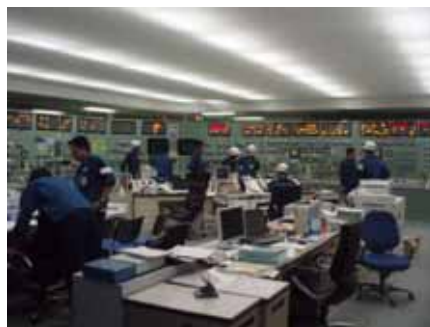
Unit 5/6 main control room: Unit 6 side

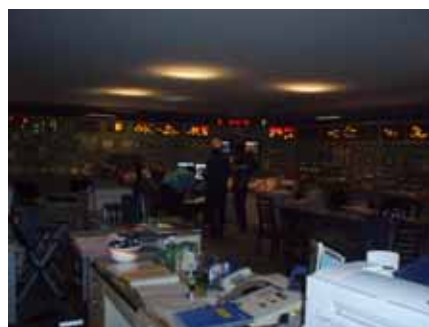
- Meanwhile, on the Unit 5 side, emergency lights gradually went out, reaching a state of total darkness, but some of the monitoring instruments were operating on DC power supply even after the station blackout, **and the indicated values necessary for conducting Unit 5 recovery operations could be verified.**

Unit 5/6 main control room: Unit 5 side
(Lighting only from emergency lights)

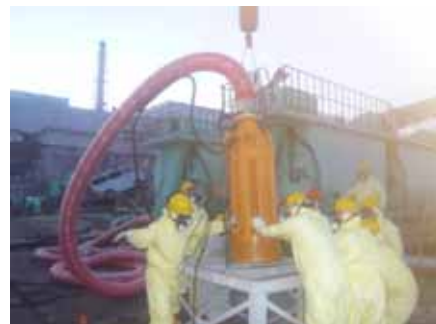
Work conditions for installation of underwater pump

began to be given to **connecting general service underwater pumps to a seawater system pipe temporarily for restoration as an RHR alternative cooling seawater pump.**

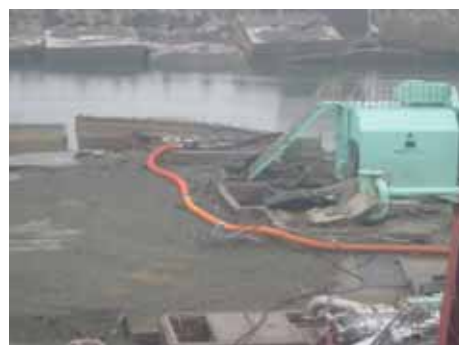
Underwater pump installation conditions
(arrangement done at later date)

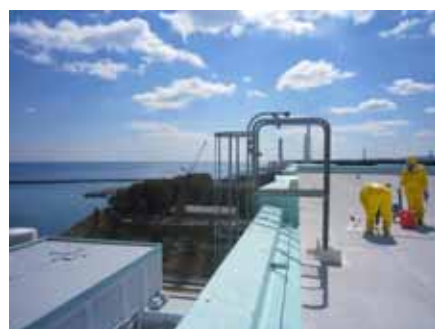
Work conditions on the roof

capacity might be lost due to aftershocks, as a precaution, it was decided to examine measures for preventing the retention of hydrogen gas. On March 18th, a boring machine was used to drill holes at three locations (diameter ranging from approximately 3.5 centimeters to approximately 7 centimeters) on the roof (concrete) of the Unit 5 and Unit 6 reactor buildings.

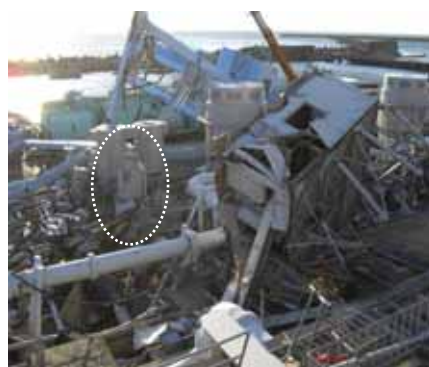
- With regard to the seawater pump for cooling the Unit 6 DG (6A), although it had been covered with seawater in the tsunami, operators and recovery teams conducted a visual inspection of the inundation situation of the outdoor seawater pump area, the external condition of the damage and other such conditions, and carried out measurements of insulation resistance and other functions

Condition of seawater pump area
(: indicates the DG (6A) seawater pump)

to verify soundness, and it was started up at 19:07 on March 18th.
