Progress Status Classified by Issues (Photos and Figures)

Issues	Countermeasures	Implementation Status	Reference (Photos and Figures)
I. Cooling (1) Reactor Unit 1	Countermeasure [76] Improvement of working environment	Removal of debris, measurement of radiation dose, entrance into buildings (May 9) RPV water level gauge calibration (May 10) PCV pressure gauge calibration (May 11) Installation of water level gauge at basement of Reactor Building (May 27) Installation of temporary RPV pressure gauge (Jun. 3)	<div style="display: flex; flex-wrap: wrap;"> <div style="width: 50%;">

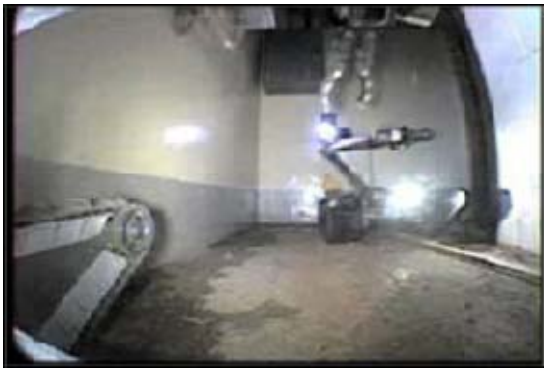
<p>Checking the reactor buildings by Packbot</p> </div> <div style="width: 50%;">

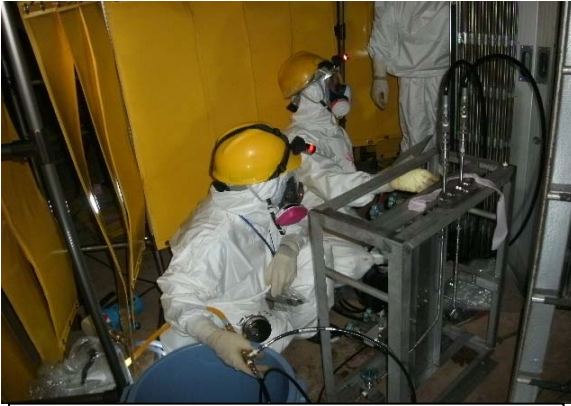
<p>Measuring radiation dose inside the reactor buildings</p> </div> <div style="width: 50%;">

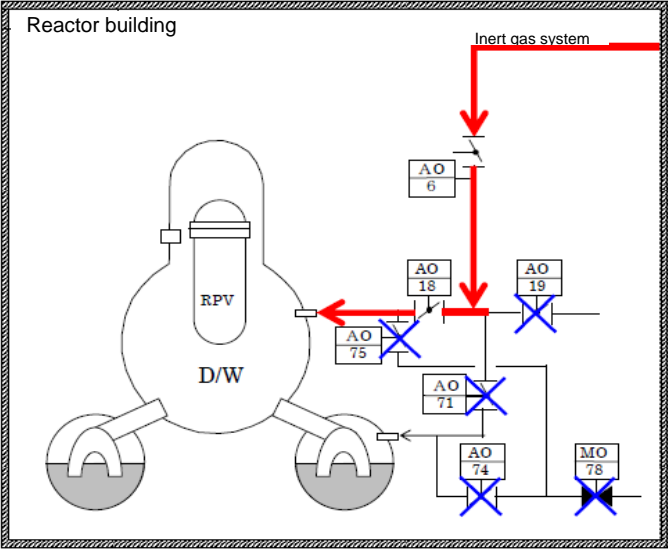
<p>System outline of nitrogen gas injection</p> </div> <div style="width: 35%; text-align: center;"> <p>Nitrogen gas supply apparatus</p>

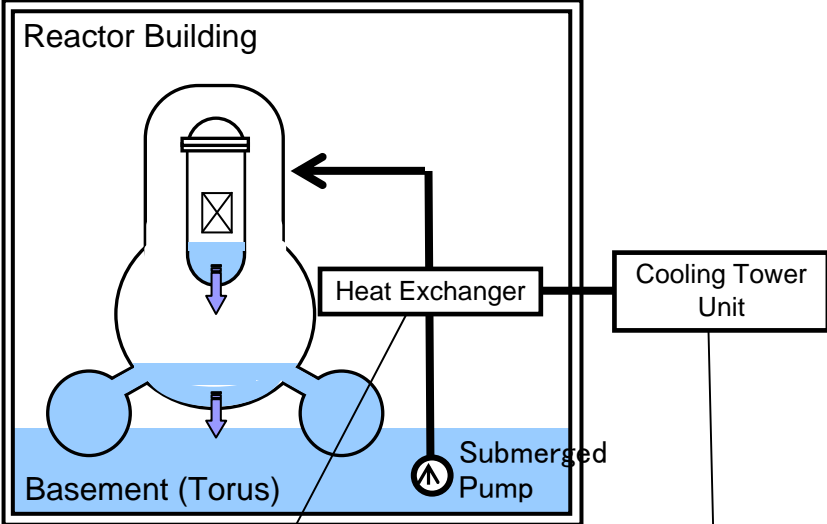
Issues	Countermeasures	Implementation Status	Reference (Photos and Figures)
I. Cooling (1) Reactor Unit 1	Countermeasure [13] Securing heat exchange function for the reactor	<p>- Due to the leakage from the primary containment vessel (PCV), we judged that it is difficult to secure water level of PCV.</p> <p>- Therefore, we changed the plan to give priority to the establishment of circulating water cooling for the reactor.</p> <p>- We are studying the reactor cooling system by using heat exchanger as a mid to long term solution.</p> <p>(work implemented)</p> <p>- Completed the assembly of cooling tower unit and shielding equipment to reduce exposure dose for outdoor work (from May 17 to Jun. 17)</p>	<div style="border: 1px solid black; padding: 5px; margin-bottom: 10px;"> [Under consideration] Outline of circulating cooling system within the reactor building </div>

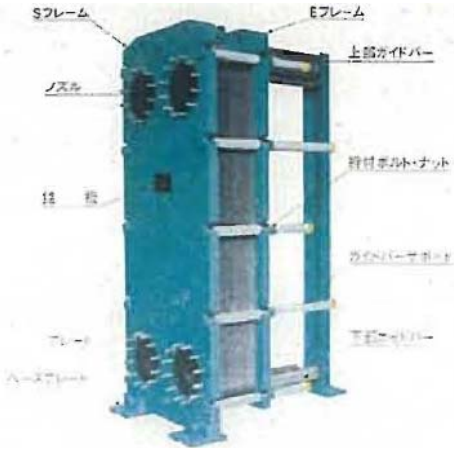
<p>Plate-type heat exchanger</p> </div> <div style="text-align: center;">

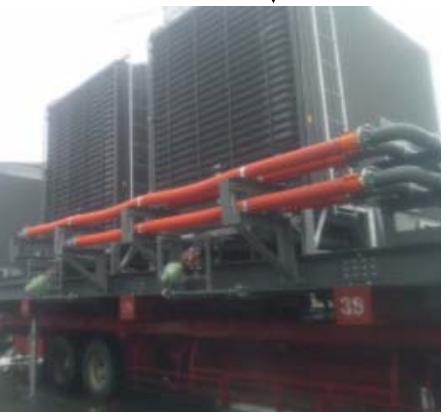
<p>Cooling tower unit</p> </div> <div style="text-align: center;">

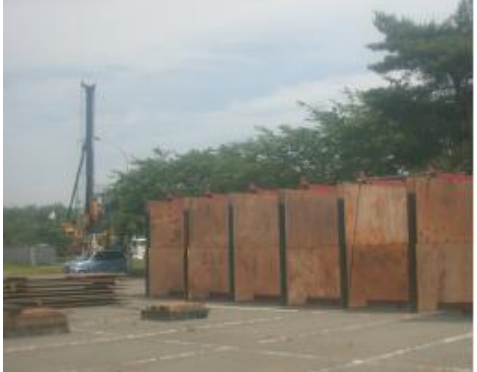
<p>Shielding equipment to reduce exposure dose for outdoor work</p> </div> </div> <div style="margin-top: 10px; text-align: center;"> <p>Jun. 3, Completion of assembly of cooling unit on the trailer</p> </div> <div style="margin-top: 10px;"> <div style="border: 1px solid black; padding: 5px; display: inline-block;"> Demolished and removed debris at the truck bay door, which would have been obstacles for installation of alternative cooling facilities (from May 10 to May 15) </div>

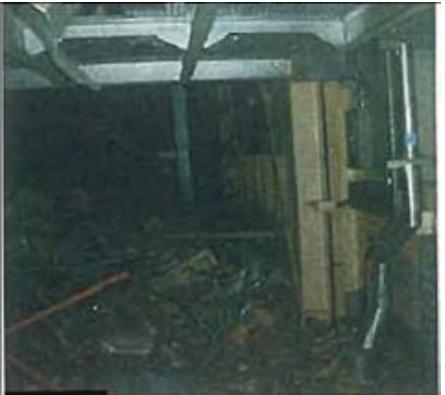
<p style="text-align: center;">Inside reactor building of Unit 1 in front of the truck bay door</p> </div>

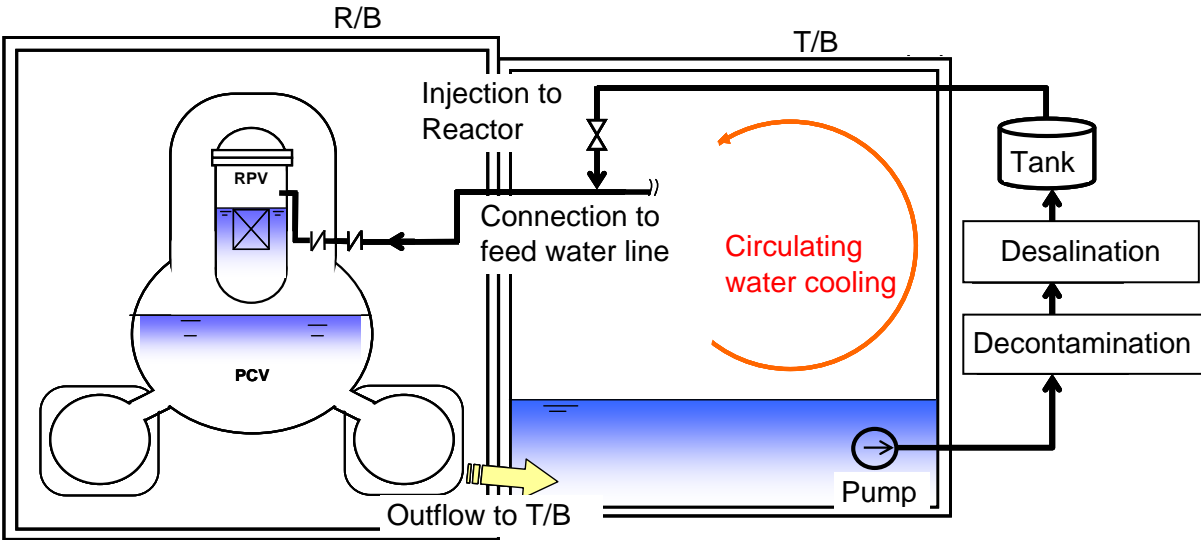
<div style="border: 1px solid black; padding: 5px; text-align: center; margin-top: 10px;"> System outline of water reuse as reactor coolant by processing accumulated water </div>

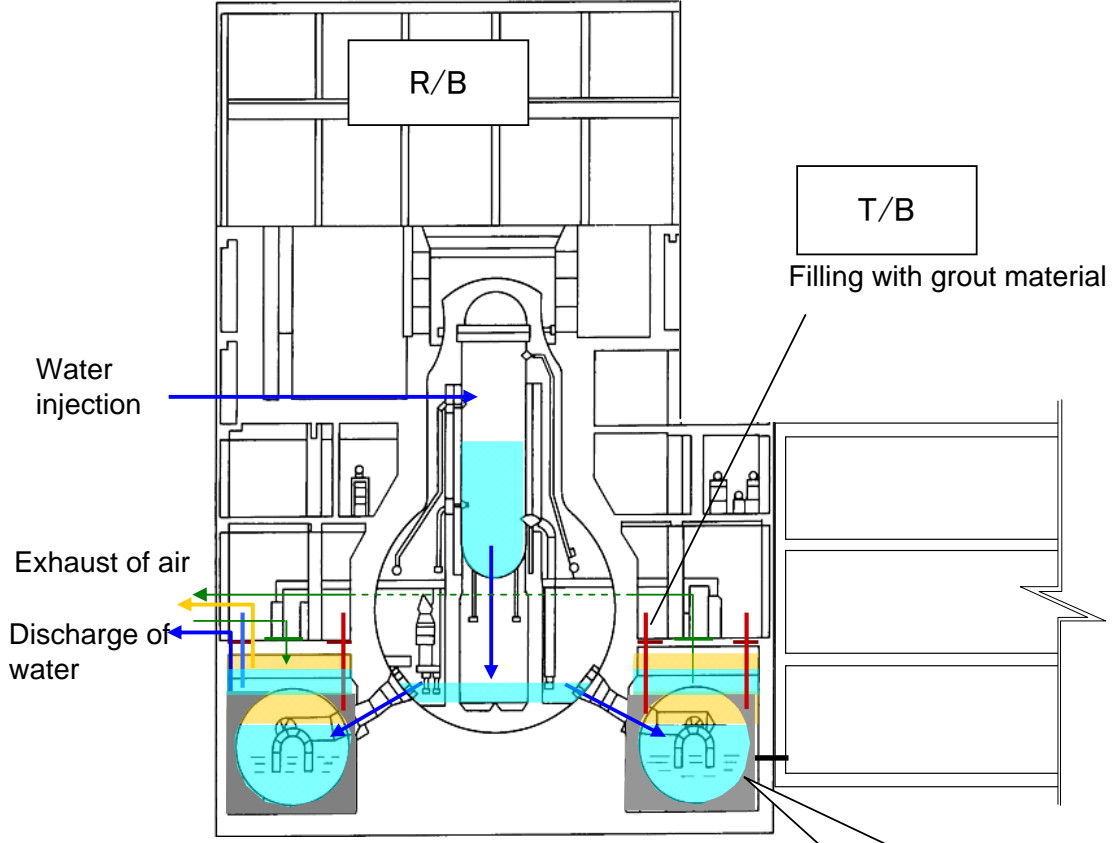
<div style="border: 1px solid black; padding: 5px; margin-top: 10px;"> Drilling the 1st floor of the reactor building, filling the whole torus room with grout material. </div>
	Countermeasure [11] Nitrogen gas injection	In operation from Jun. 28.	
	Countermeasure [13] Secure heat exchange function	- Prioritize the achievement of circulation cooling of reactors by circulating water cooling. For the reactor cooling facilities using heat exchanger, examine its implementation as mid to long term measures.

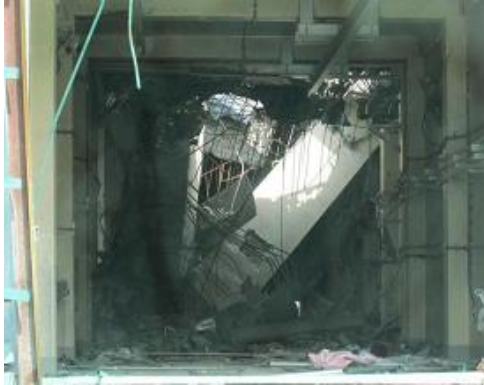
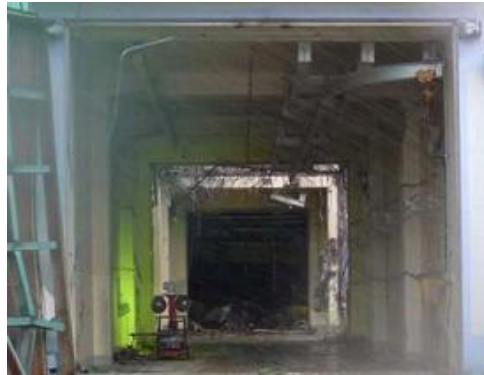
<p>(After removal May 30)</p> </div> <div style="text-align: center;"> <p>Machine hatch space on the 1st floor of the reactor building</p>

<p>(After removal Jun. 4)</p> </div> </div> <div style="text-align: center; border: 1px solid black; padding: 5px; margin-top: 10px;"> Situation of demolishing and removing debris </div>

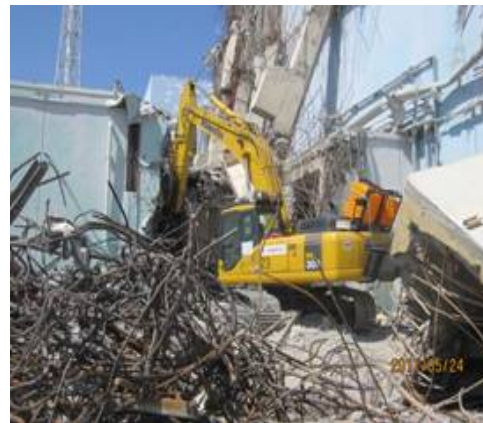
Removal of outside pillars using wirelessly-controlled backhoe

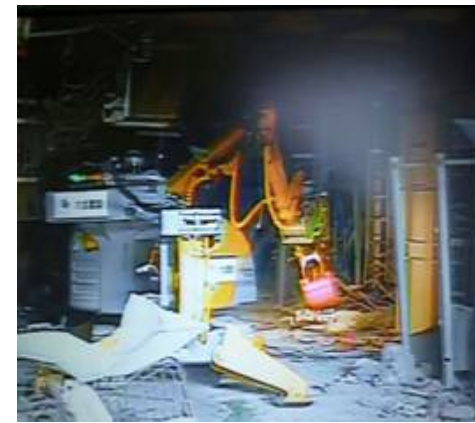
Removal of debris using Brokk (wired remote control)

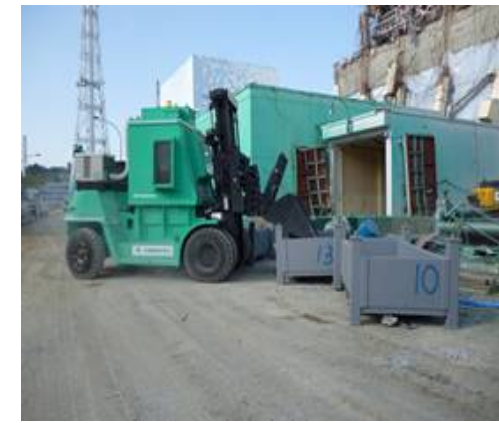
Container loading using shielded forklift

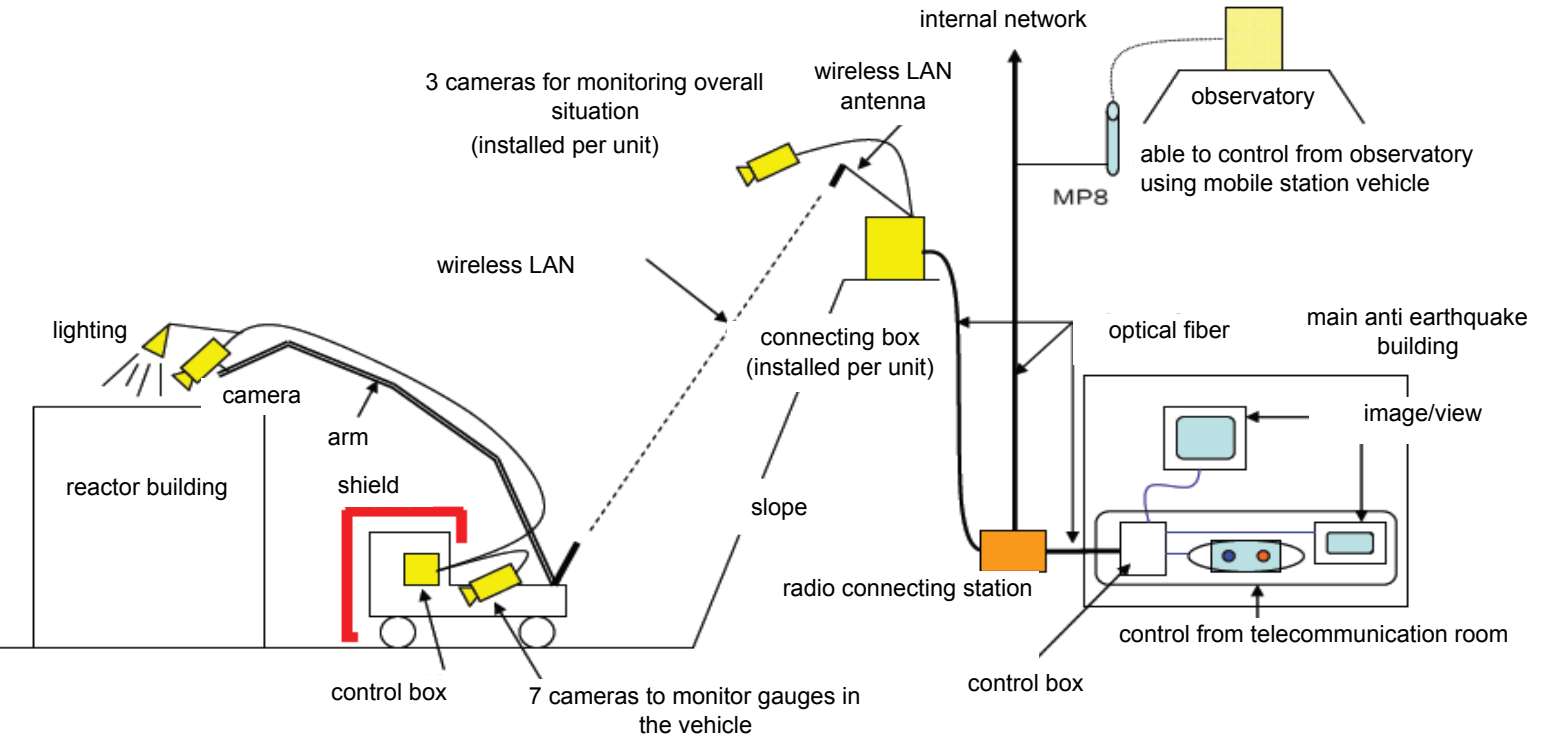
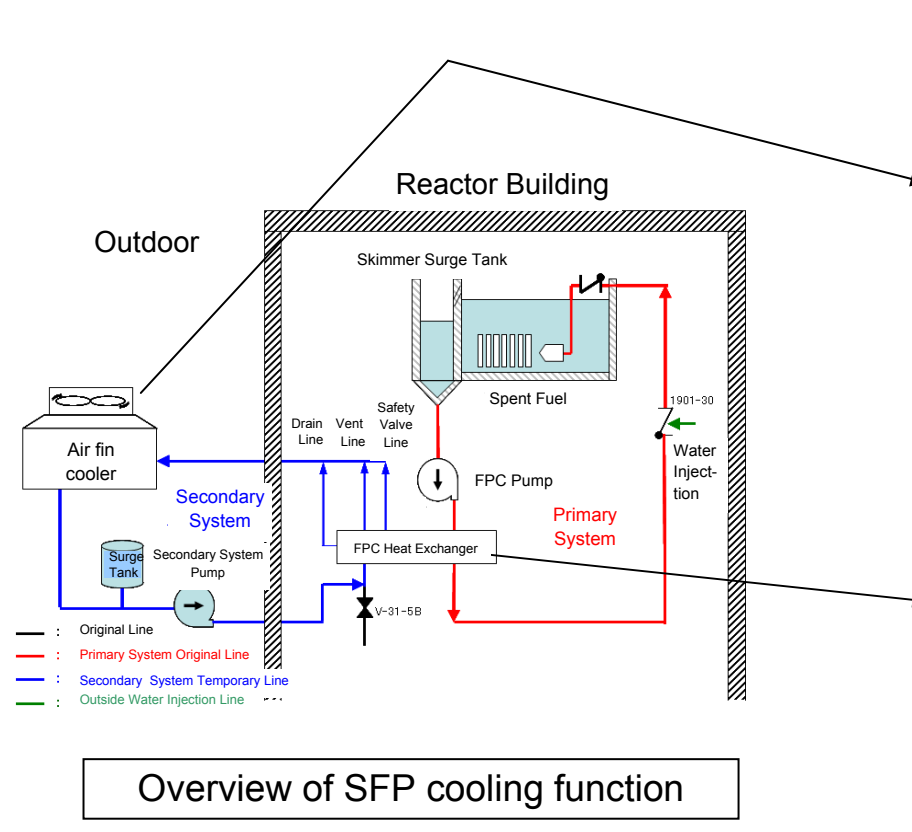
Overview of SFP cooling function

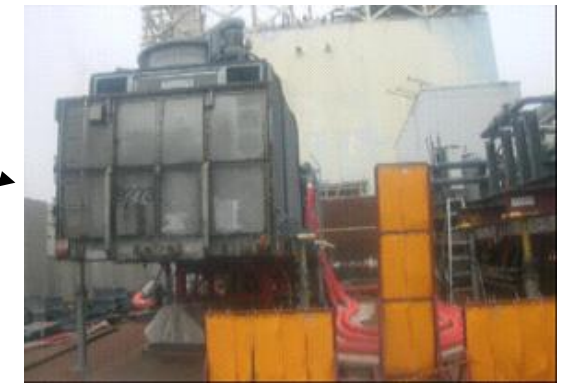
Air fin cooler

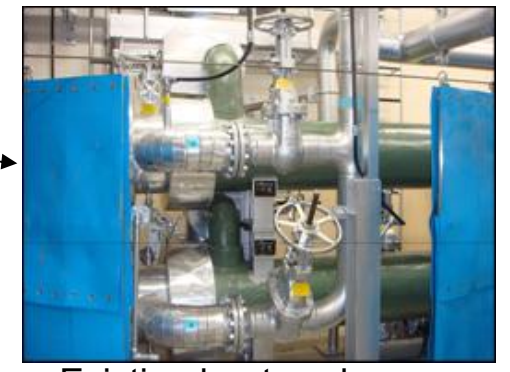
Existing heat exchanger

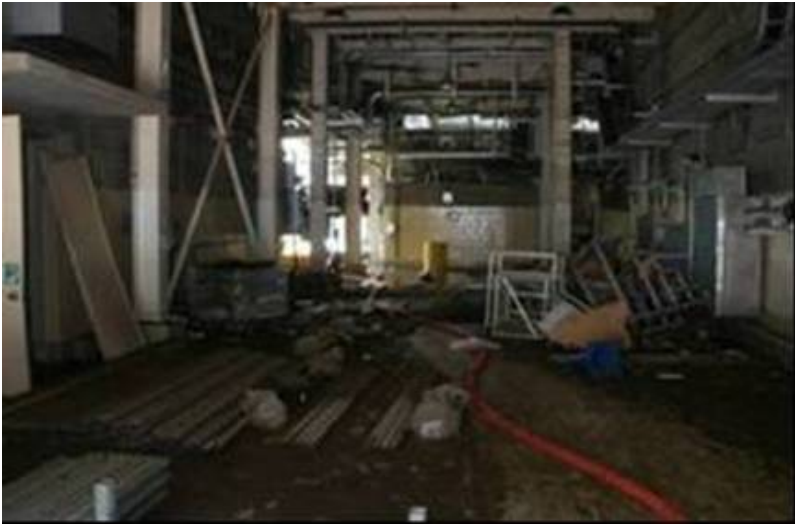
<div style="display: flex; justify-content: space-around; margin-top: 10px;"> <div data-bbox="1368 856 2122 919" style="border: 1px solid black; padding: 2px;">Debris in Unit 2 Waste Treatment Building</div> <div data-bbox="2184 856 2763 919" style="border: 1px solid black; padding: 2px;">Unit 2 Heat Exchanger Unit</div> </div>

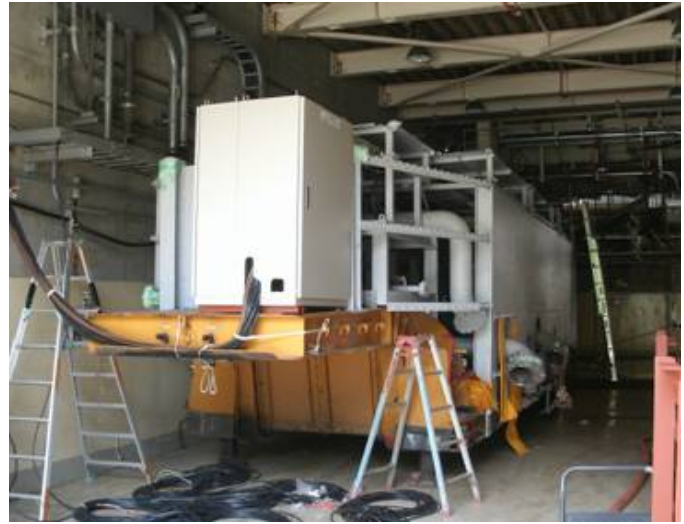
- Installation work of heat exchanger completed. Circulating cooling system is under operation (from May 31).			
	Unit 3 Countermeasure [22] Continuation of water injection by "Giraffe" etc	- Standby as backup after restoration of normal cooling system - Reliability improvement: enhanced durability of hoses - Measures to reduce radiation dose: switch to remote-controlled operation

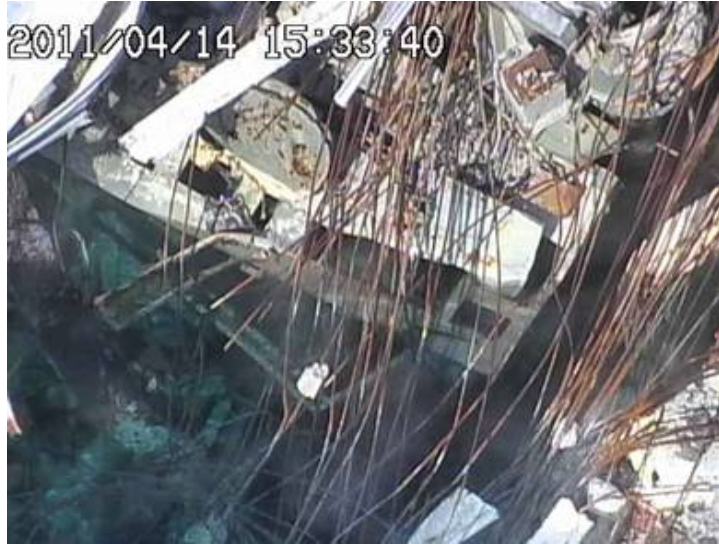
<div style="display: flex; justify-content: space-around; margin-top: 10px;"> <div data-bbox="1457 1759 2003 1822" style="border: 1px solid black; padding: 2px;">Unit 3 Spent Fuel Pool</div> <div data-bbox="2157 1759 2709 1822" style="border: 1px solid black; padding: 2px;">Unit 3 Heat Exchanger Unit</div> </div>		
		Countermeasure [24] Restoration of normal cooling system			- Confirmation of system integrity through water level measurement by "Giraffe," etc. (from May 8 to May 15) - Water injection through normal cooling system (from May 16 to Jun. 29)

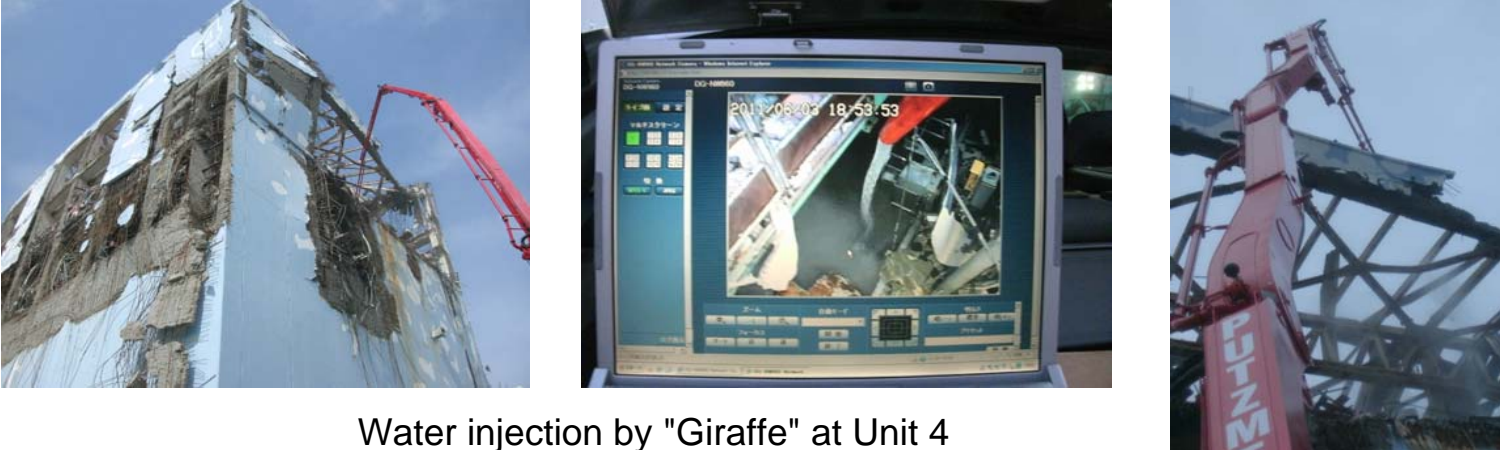
<p style="text-align: center;">Water injection by "Giraffe" at Unit 4</p>
	Countermeasure [24] Restoration of normal cooling system	- Water injection by installing alternative equipment to "Giraffe" (from Jun. 17)

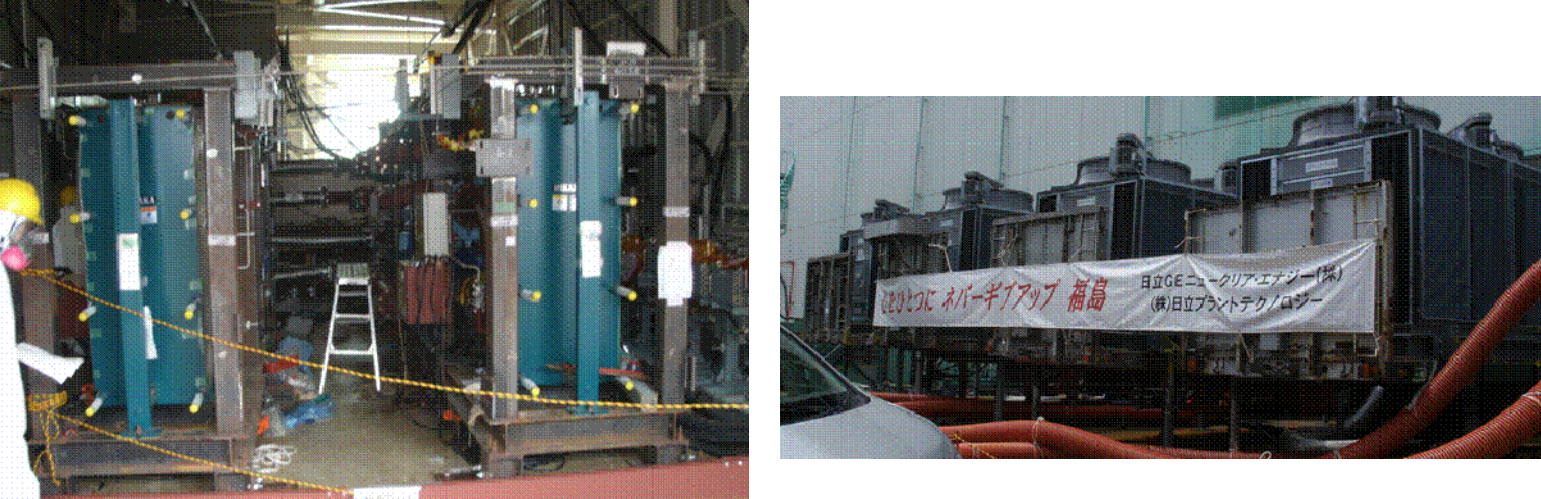
<div style="display: flex; justify-content: space-around; margin-top: 10px;"> <div style="border: 1px solid black; padding: 5px; text-align: center;">Unit 4 Heat Exchanger Unit</div> <div style="border: 1px solid black; padding: 5px; text-align: center;">Air Fin Cooler</div> </div>

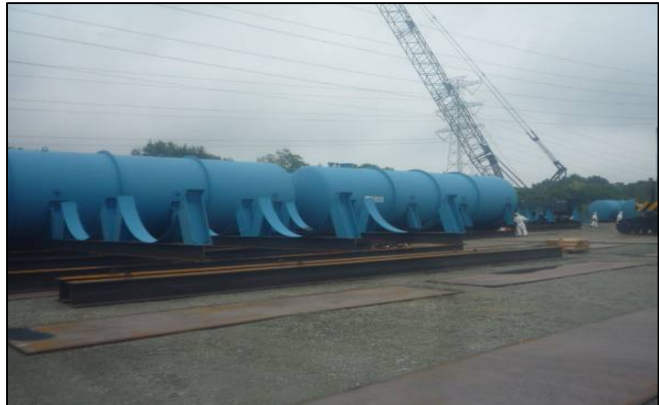
<p style="text-align: center;">Tanks to receive processed water (H1 area)</p> </div> <div data-bbox="2131 756 2745 1207">

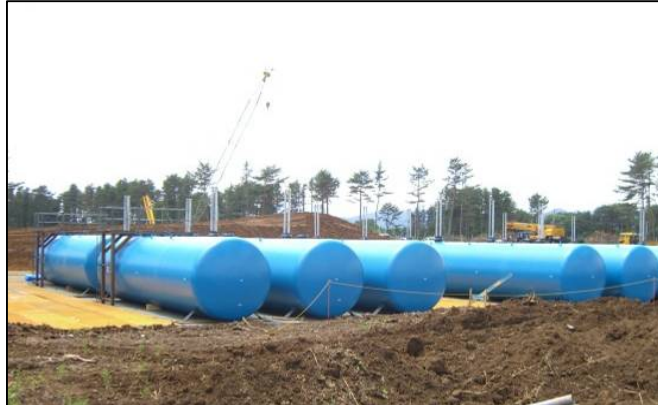
<p style="text-align: center;">Underground disaster prevention tanks for processed water (Highly contaminated water)</p> </div> </div> <div style="text-align: center; margin: 10px 0;">

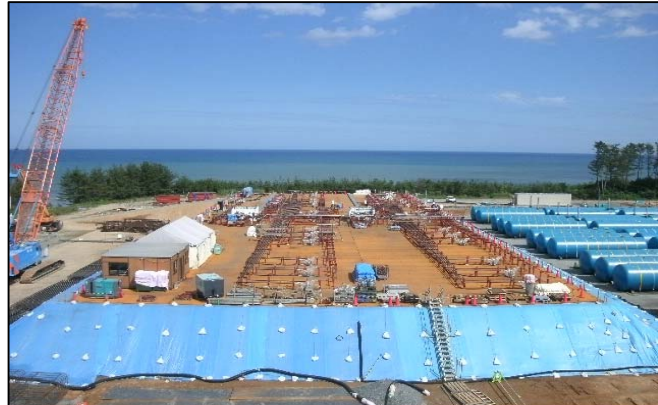
<p style="text-align: center;">Underground disaster prevention tanks for processed water (Highly contaminated water)</p> </div>

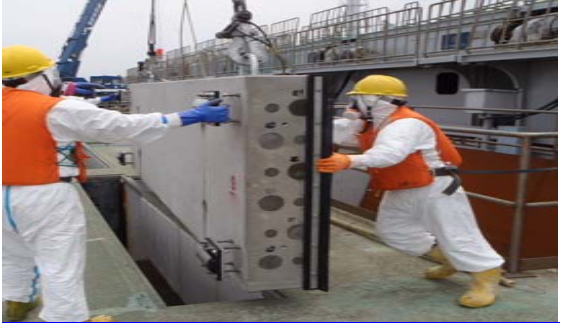
<p>Sliding concrete wall at intake (Setting work)</p> </div> <div style="width: 50%; text-align: center;">   <p>Placing steel pipe</p> </div> <div style="width: 50%; text-align: center;">

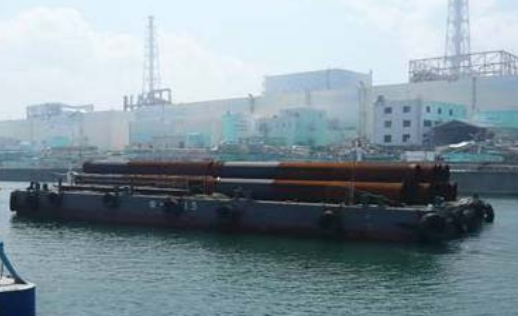
<p>Shipping steel pipe sheet pile</p> </div> <div style="width: 50%; text-align: center;"> <p><Adsorption of cesium by zeolite></p>

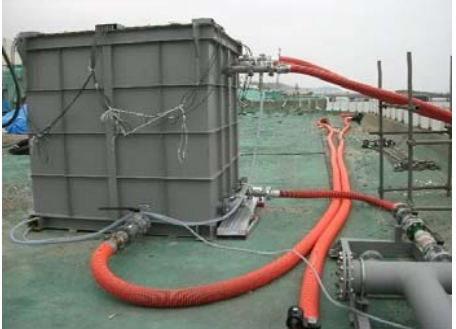
</div> <div style="width: 50%; text-align: center;"> <p><Appearance of the system></p>

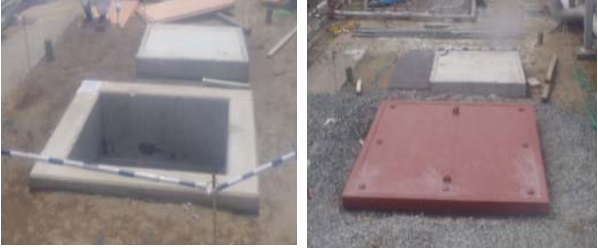
<p>Closure of sea water piping vertical shaft (left: before closure, right: after closure)</p> </div> <div style="width: 50%; text-align: center;">

<p>Countermeasure [65] Containment of high level radioactive water</p> <ul style="list-style-type: none"> - Closure of sea water piping vertical shaft <p>Unit 2: completed on Jun. 2, Unit 3: completed on May 26, Unit 4: completed on Apr. 6</p> <ul style="list-style-type: none"> - Closure of pits and others <p>Unit 1: completed on May 17 Unit 2: completed on Jun. 9 Unit 3: completed on Jun. 10 Unit 4: completed on Jun. 10</p>	<div style="display: flex; flex-wrap: wrap;"> <div style="width: 50%; text-align: center;">

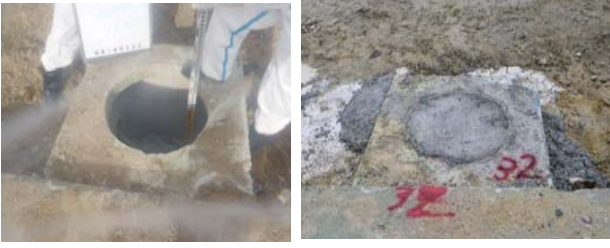
<p>Closure of pit (left: before closure, right: after closure)</p> </div> </div>

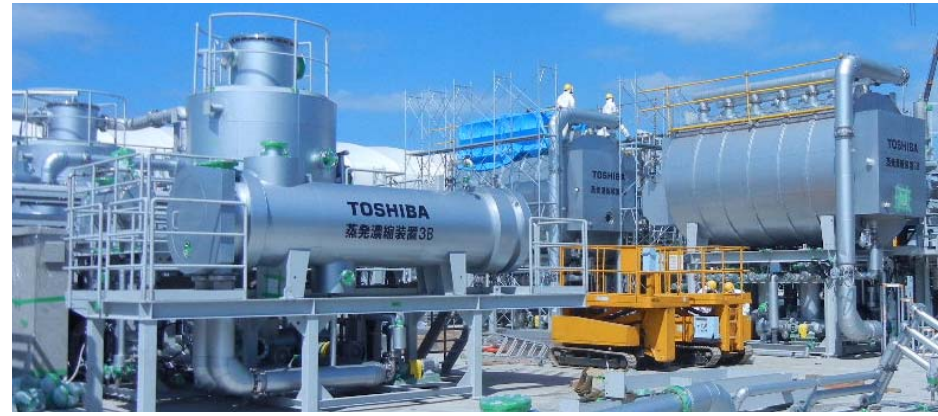
<p style="text-align: center;">Evaporative concentration apparatus (3A/B/C)</p>

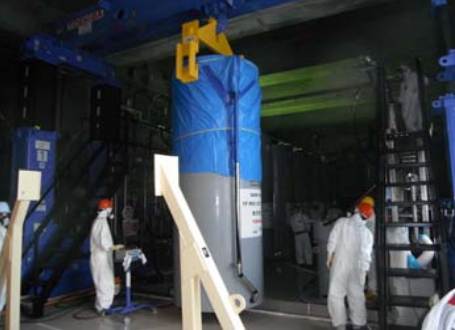
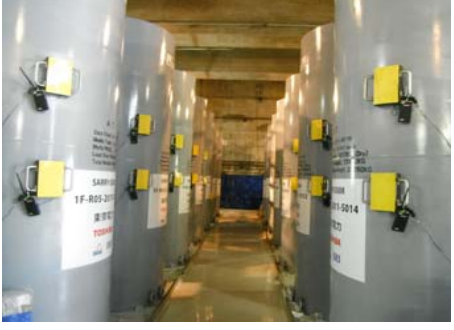
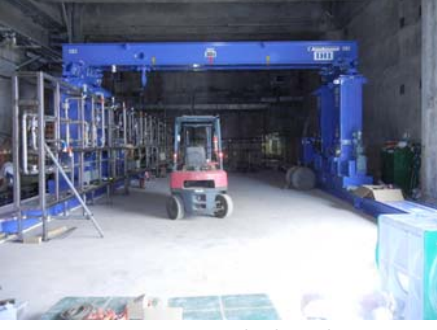
</div> <div style="display: flex; justify-content: space-around; margin-top: 10px;"> <div style="text-align: center;"> <p>Installation of cesium adsorption tower</p>

</div> <div style="text-align: center;"> <p>Cesium adsorption towers</p>

</div> <div style="text-align: center;"> <p>Installation of lifter for changing adsorption towers</p>

</div> </div> <div style="margin-top: 20px;"> <p>Removes oil etc</p> <p>Removes Cs. Front row contains low level adsorption material, the back row contains high level</p> <p>Install special heavy machinery for lifting (hydraulic) and transfer machinery indoors, remove and transfer waste adsorption tower</p>

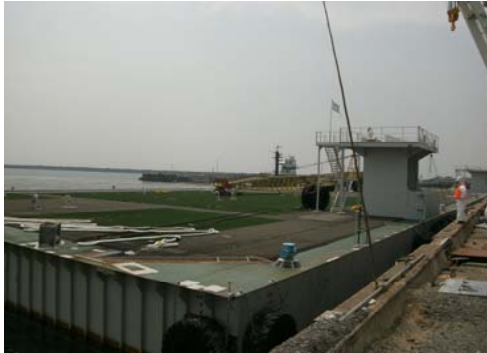
Issues	Countermeasures	Implementation status	Reference (Photos and Figures)
II. Mitigation (3) Accumulated Water	Low level	<p>Countermeasure [40, 41] Increase storage capacity / decontamination</p> <p>Increase of storage capacity and continuation of decontamination of contaminated water</p> <ul style="list-style-type: none"> - Installation of tanks for processed water: <ul style="list-style-type: none"> Waste liquid RO supply <ul style="list-style-type: none"> B Area 6,200t (May 31) RO processed water temporary storage tank <ul style="list-style-type: none"> D Area 5,000t (May 10) RO condensed water temporary storage tank <ul style="list-style-type: none"> E Area 8,000t (May 22) RO condensed water storage tank <ul style="list-style-type: none"> H Area 55,000t (Sep. 16) Evaporation treatment fresh water storage tank <ul style="list-style-type: none"> H Area 5,000t (Jul. 21) Evaporation waste liquid storage tank <ul style="list-style-type: none"> H Area 5,000t (Jul. 31) - Low level tank <ul style="list-style-type: none"> F Area 12,200t (May 31) - Megafloat <ul style="list-style-type: none"> 10,000t (May 21) 	<div style="display: flex; justify-content: space-around; align-items: flex-start;"> <div style="text-align: center;"> <p><Megafloat></p>

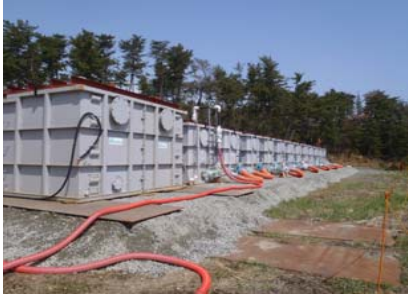
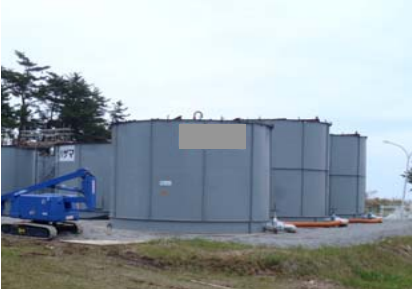
</div> <div style="text-align: center;"> <p><F Area Tanks></p> <div style="display: flex; justify-content: space-around;"> <div style="text-align: center;"> <p><Square shape tanks></p>

</div> <div style="text-align: center;"> <p><Round shape tanks></p>

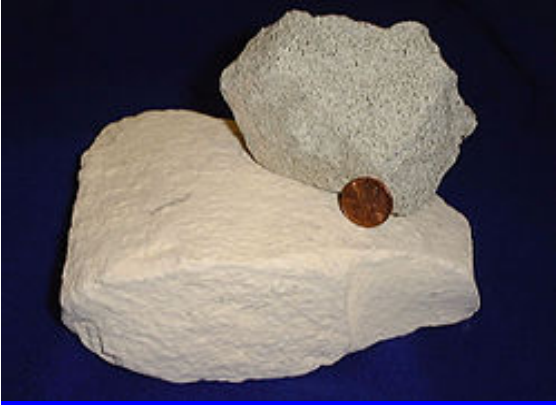
<p>Utilization of decontaminant (zeolite)</p> <p>Setting in water, self-circulation and adsorption of Cesium by zeolite</p> <p>Decontamination of accumulated water in Unit 6 T/B after transferring to receiver tanks for low level water</p> <p>Full-scale operation (from May 1)</p>

<div style="background-color: blue; color: white; padding: 5px; text-align: center; margin-top: 5px;"> Decontaminant (zeolite) </div>

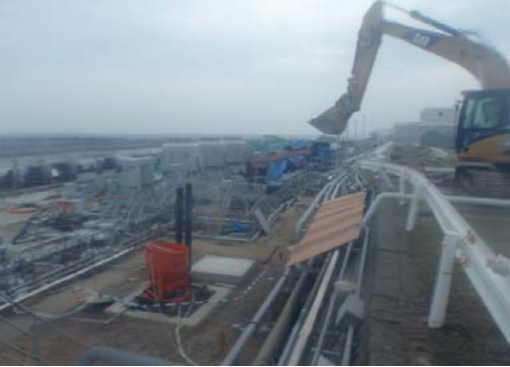
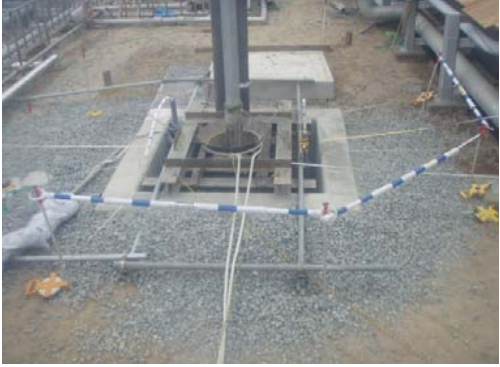
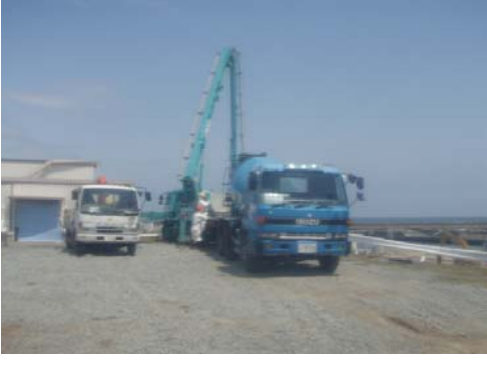
</div> <div style="display: flex; justify-content: space-around; margin-top: 5px;"> <div style="border: 1px solid black; padding: 2px; text-align: center;">Putting in crushed stones</div> <div style="border: 1px solid black; padding: 2px; text-align: center;">Concrete placement</div> <div style="border: 1px solid black; padding: 2px; text-align: center;">Mortar placement</div> </div>

Issues	Countermeasures	Implementation status	Reference (Photos and Figures)
II. Mitigation (4) Groundwater	Countermeasure [66] Consideration of mitigation measures of groundwater contamination	<ul style="list-style-type: none"> - Closing of vertical shaft of seawater pipe Unit 2: Completed on Jun. 2 Unit 3: Completed on May 26 Unit 4: Completed on Apr. 6 - Closure of pits, etc. Unit 1: Completed on May 17 Unit 2: Completed on Jun. 9 Unit 3: Completed on Jun. 10 Unit 4: Completed on Jun. 10 	<div style="display: flex; justify-content: space-around;">

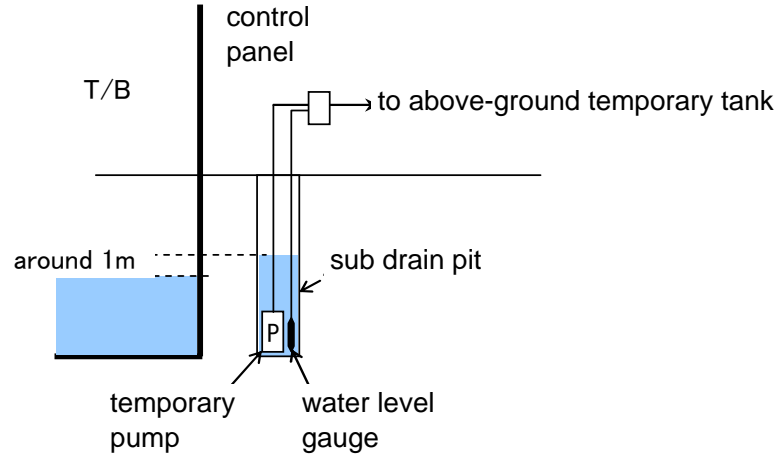
<p style="text-align: center;">Image of restoration of sub drain pump</p>
	Countermeasure [68] Construction of shielding wall of groundwater	<ul style="list-style-type: none"> - Completed basic design of shielding wall on Aug. 31 - Under investigation of underground water level, water quality, etc. by boring. <p><Next step></p> <ul style="list-style-type: none"> - Implement study for optimization of shielding section, installation plan. - Start construction for sea side area during Step 2 - Investigate and study for landward area by the end of Step 2 	<div style="display: flex; justify-content: space-between;"> <div style="width: 45%;">

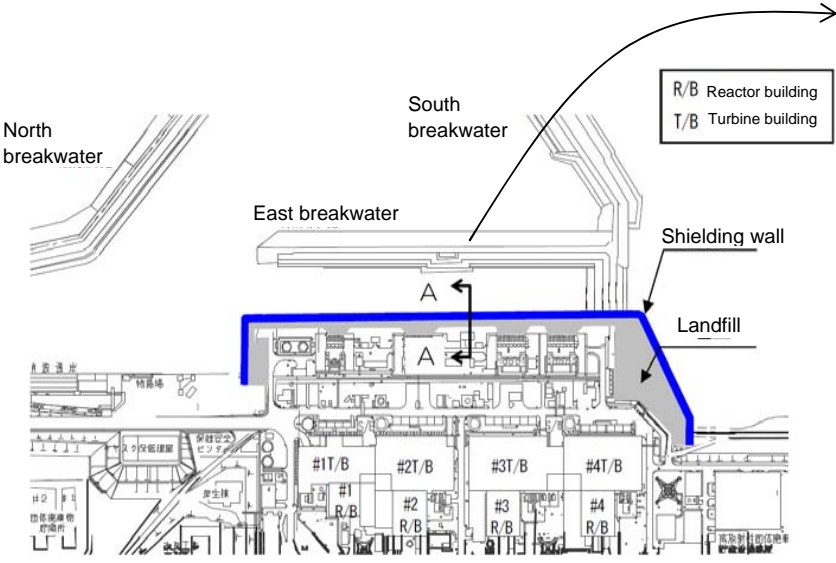
<p style="text-align: center;">Plain view</p> </div> <div style="width: 45%;">

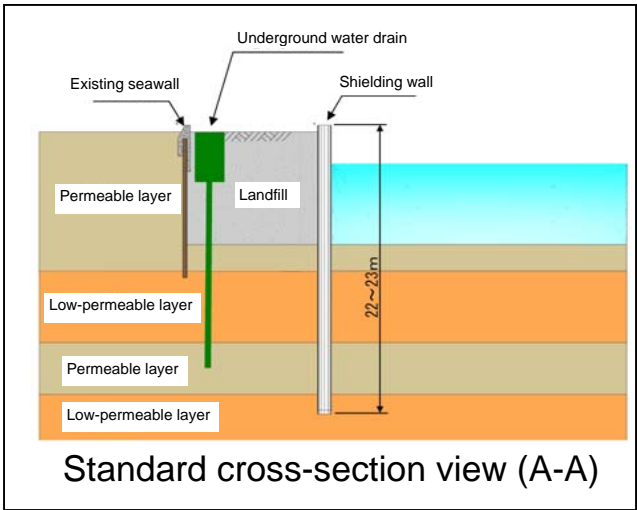
<p style="text-align: center;">Standard cross-section view (A-A)</p> </div> </div> <p style="text-align: right;">Figure of basic plan of shielding wall</p>

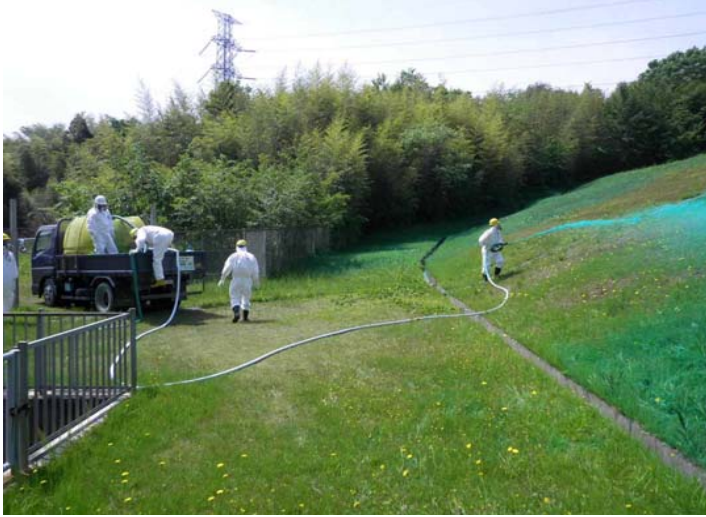
<p style="text-align: center;">Dispersion of inhibitors in the Power Station (slope)</p>

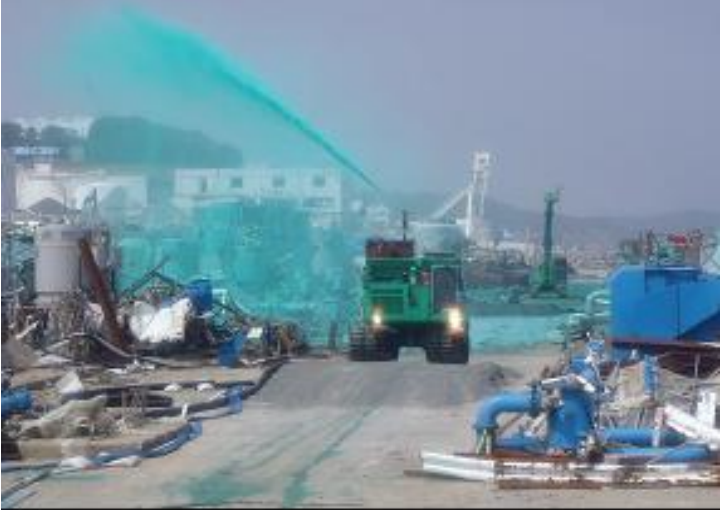
<p style="text-align: center;">Dispersion of inhibitors around buildings of Units 1 to 4 by crawler dump</p>

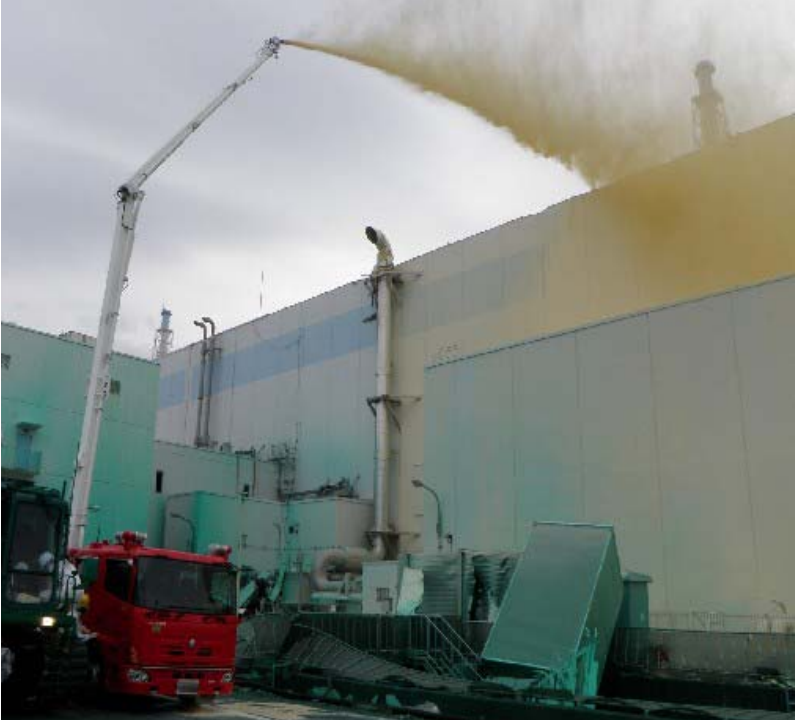
<p style="text-align: center;">Dispersion of inhibitors by bending spray tower vehicle</p>

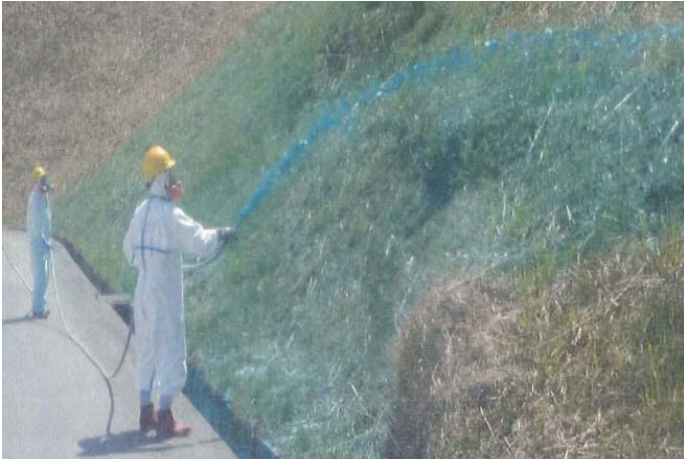
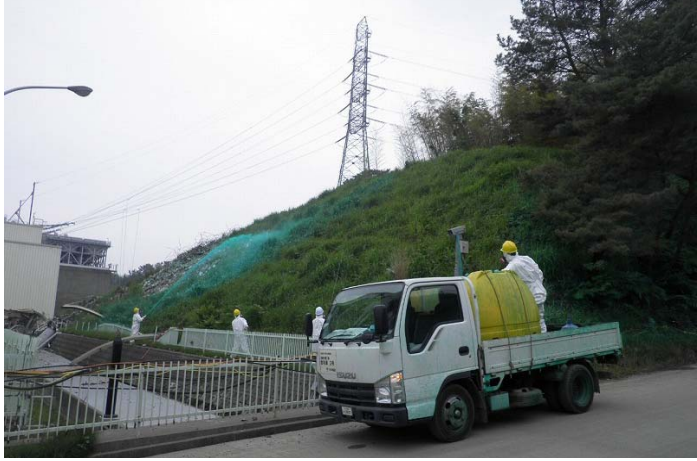
Dispersion of inhibitors in the Power Station (slope)	Dispersion of inhibitors in the Power Station (slope)

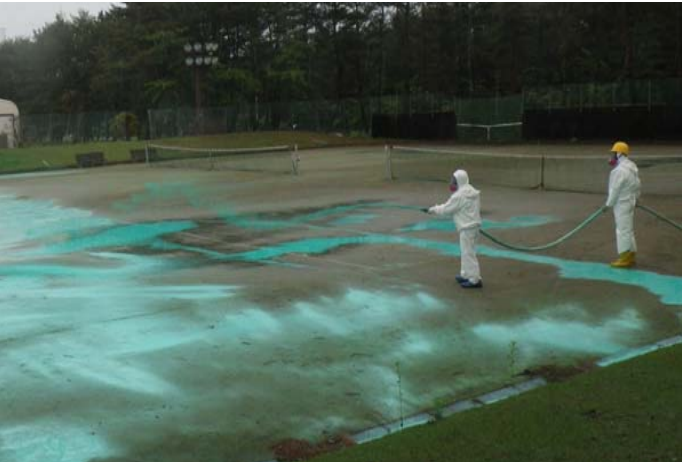
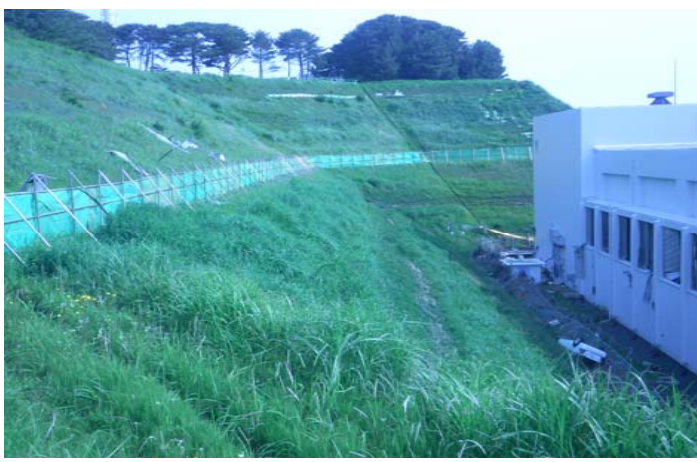
Dispersion of inhibitors in the Power Station (flat surface)	After dispersion of inhibitors in the Power Station (slope)

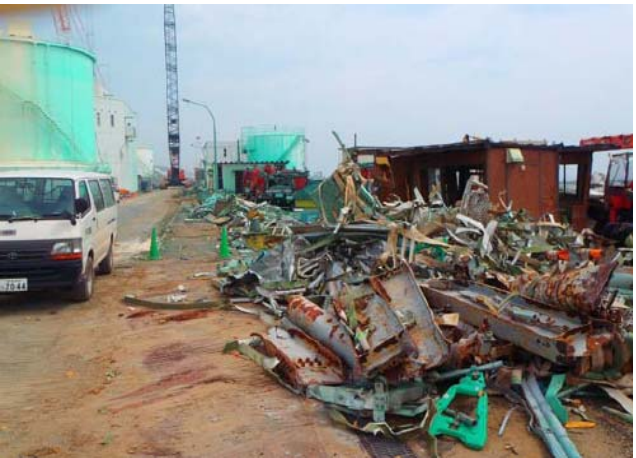
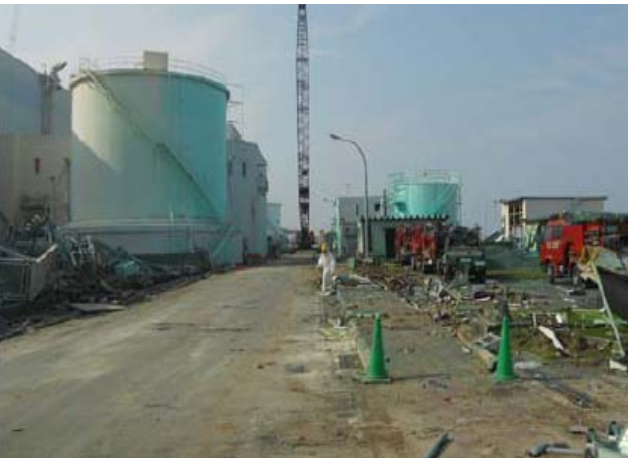
<p>Before removal</p> </div> <div style="font-size: 2em;">➔</div> <div style="text-align: center;">

<p>After removal</p> </div> </div> <div style="display: flex; justify-content: space-around; margin-top: 20px;"> <div style="text-align: center;">

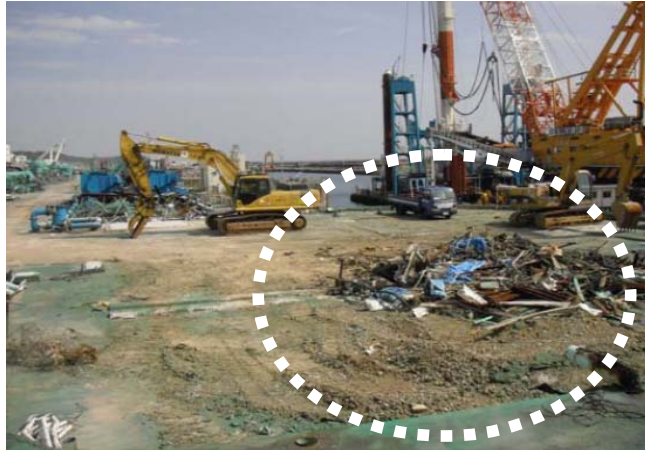
<p>Before removal</p> </div> <div style="font-size: 2em;">➔</div> <div style="text-align: center;">

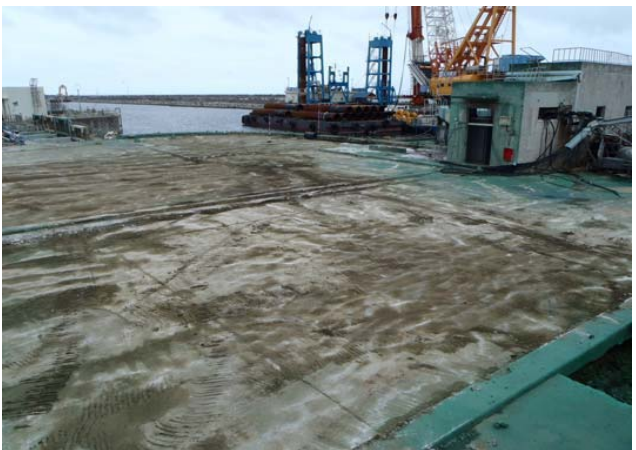
<p>After removal</p> </div> </div> <div style="display: flex; justify-content: space-around; margin-top: 20px;"> <div style="text-align: center;">

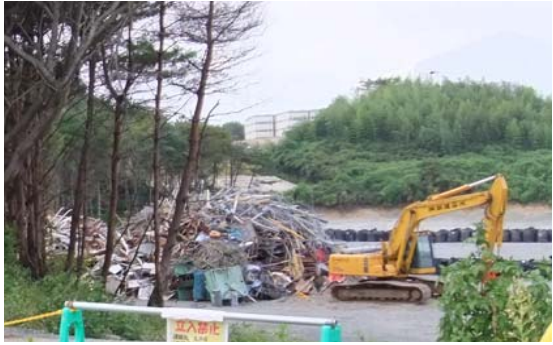
<p>Storage at the yard within the site</p> </div> <div style="text-align: center;">

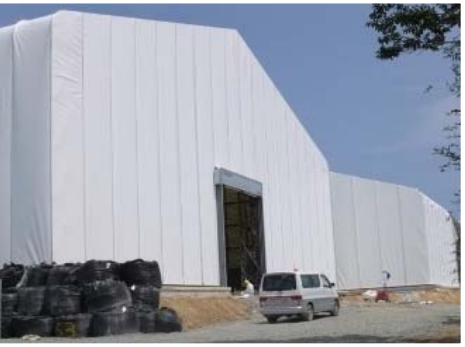
<p>Storage tent</p> </div> <div style="text-align: center;">

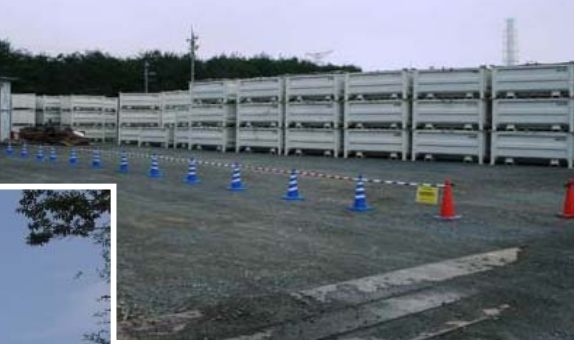
<p>Containers</p> </div> </div> <div style="text-align: center; margin-top: 20px;"> <p>Status of the storage areas of the removed debris</p> </div>

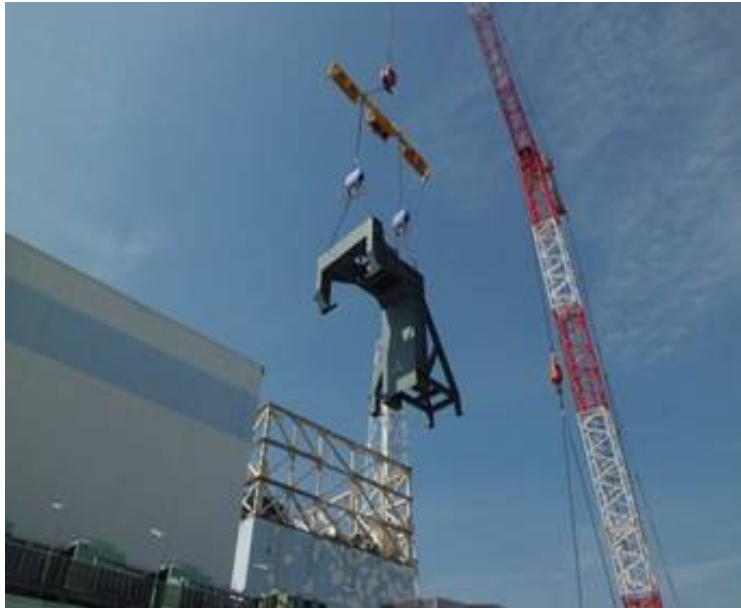
<p>Aug 10: Start of steel-frame work</p> </div> <div style="text-align: center;">

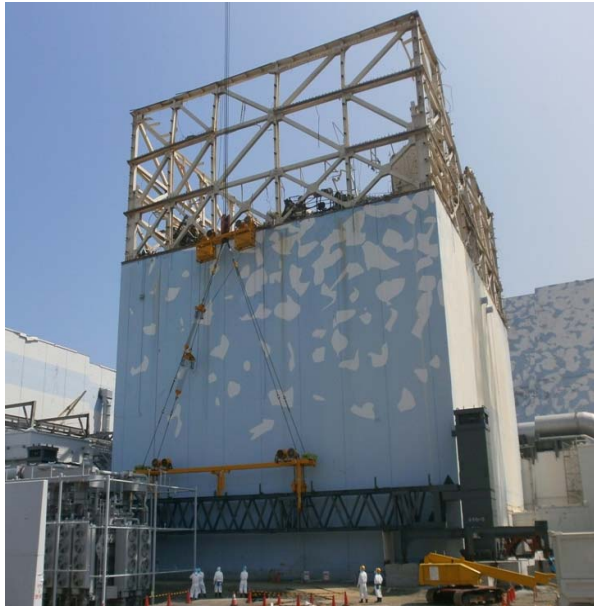
<p>Aug 14: Status of steel-frame work (north side)</p> </div> <div style="text-align: center;">
