Progress Status Classified by Issues (Photos and Figures)

Issues	Countermeasures	Implementation Status	Reference (Photos and Figures)
I. Cooling (1) Reactor Unit 1	Countermeasure [76] Improvement of working environment	Removal of debris, measurement of radiation dose, entrance into buildings (May 9) RPV water level gauge calibration (May 10) PCV pressure gauge calibration (May 11) Installation of water level gauge at basement of Reactor Building (May 27) Installation of temporary RPV pressure gauge (Jun. 3)	<div style="display: flex; flex-wrap: wrap;"> <div style="width: 50%;">

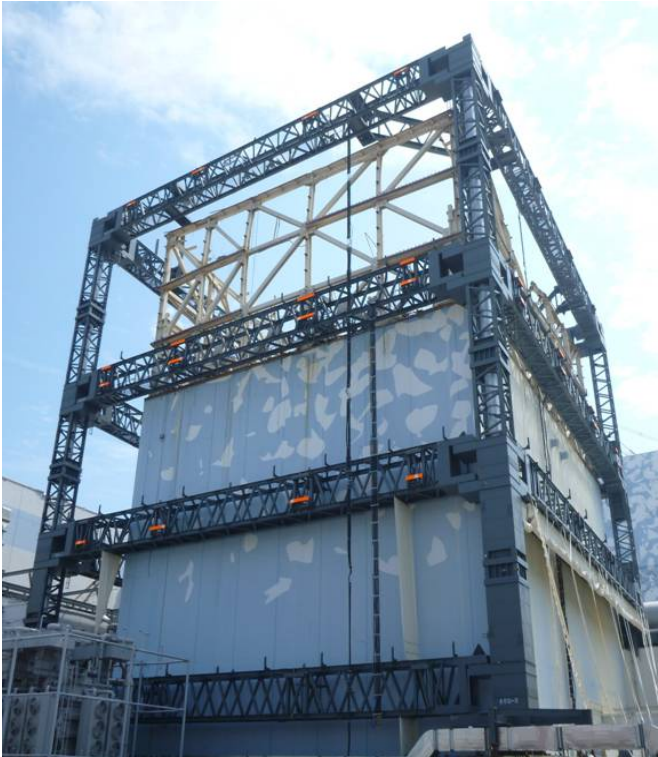
<p>Sep. 9: Completion of steel-frame work (northwest side)</p> </div> <div style="text-align: center;">

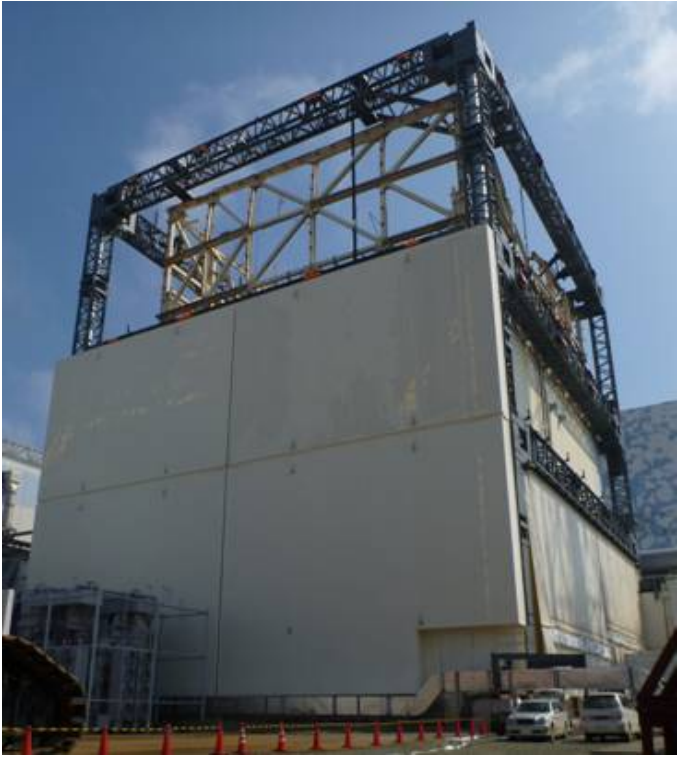
<p>Sep 15: Status of wall panels (northwest side)</p> </div> </div>

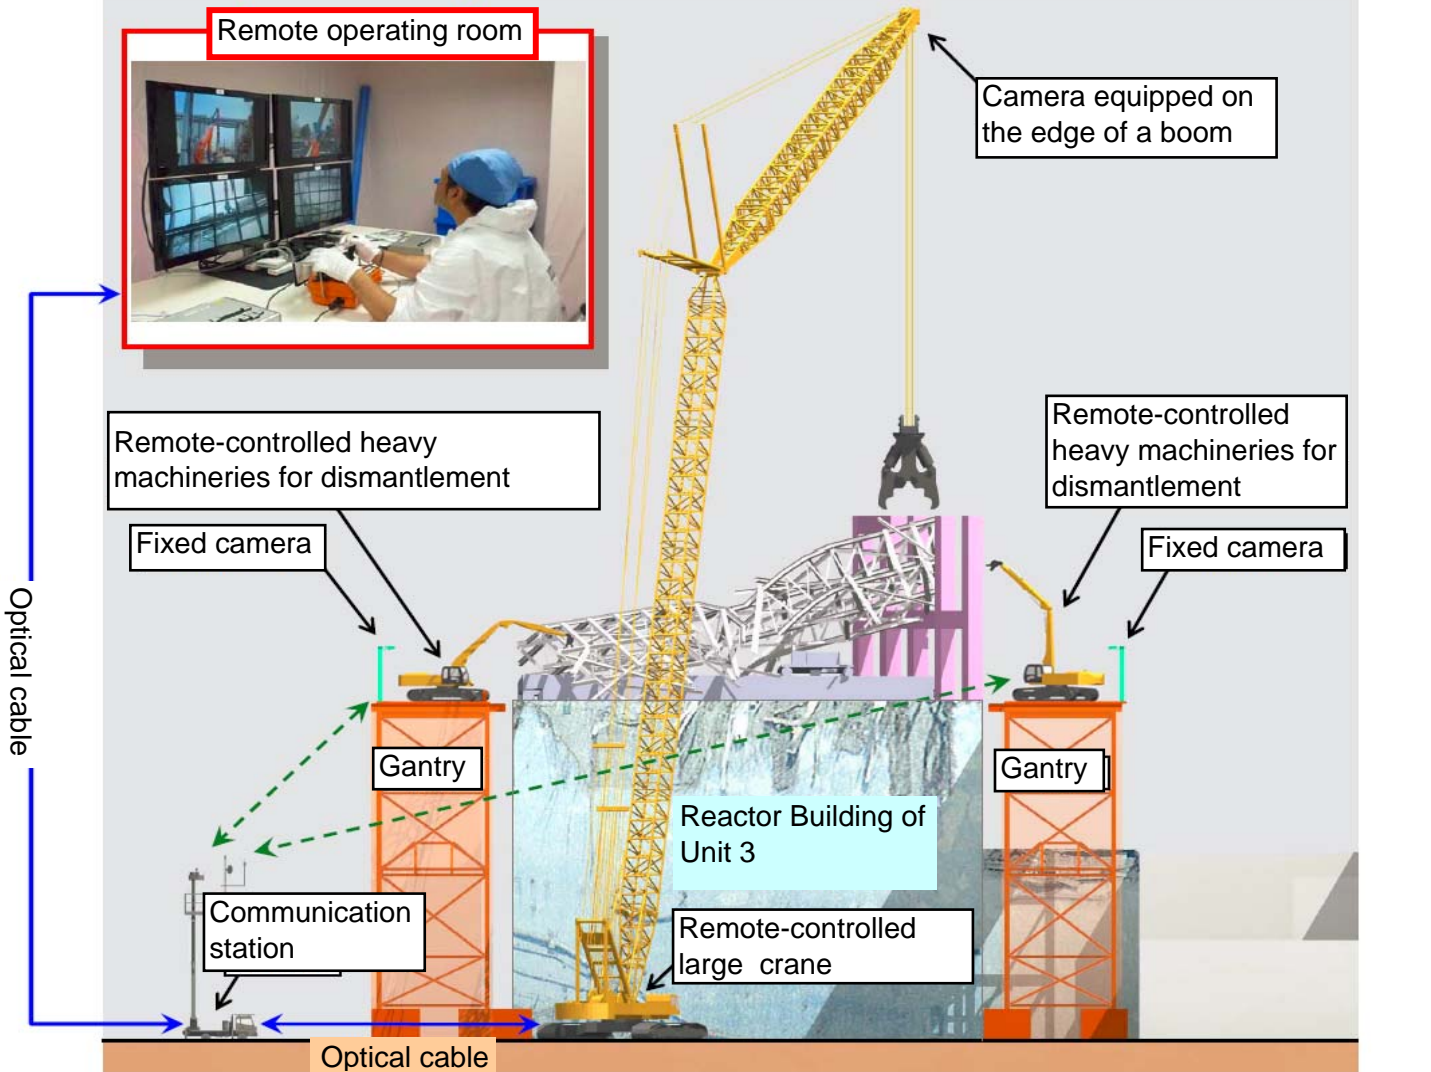
<p style="text-align: center;">Image of removal of debris on top of the reactor</p> <div style="display: flex; justify-content: space-around;"> <div data-bbox="1424 1386 2003 1837">

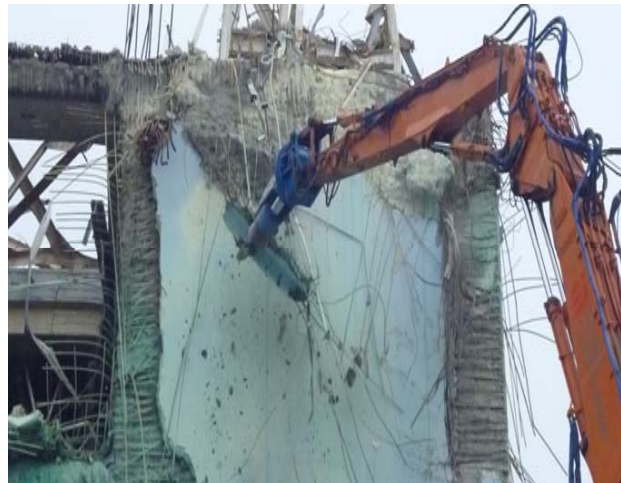
<p>Status of removal of debris on top of the reactor building (Demolition of pendant pillar at west side)</p> </div> <div data-bbox="2077 1386 2760 1837">

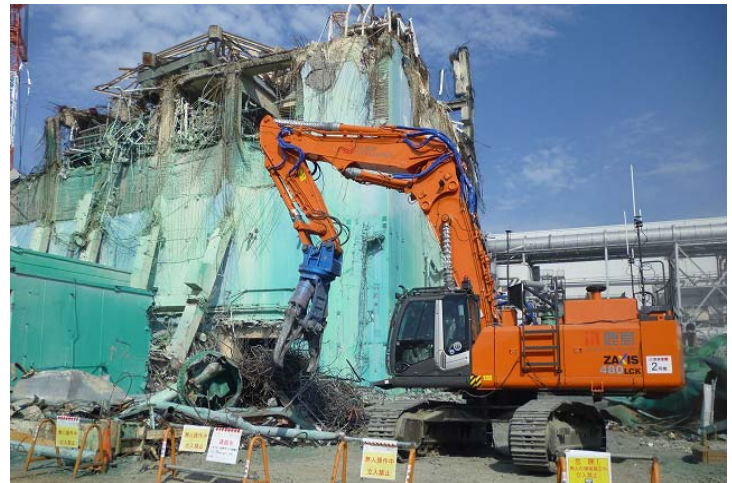
<p>Clearance of fallen debris at the south side and around the building</p> </div> </div>

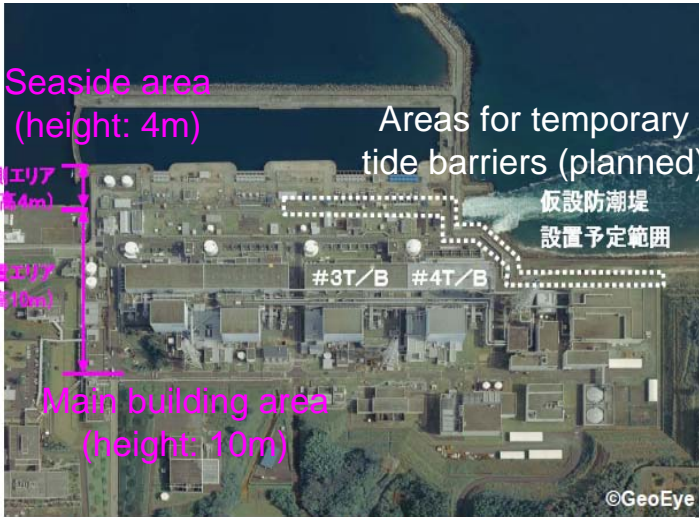
<p>Planned temporary tide barrier (white dotted line)</p> </div> <div style="text-align: center;">

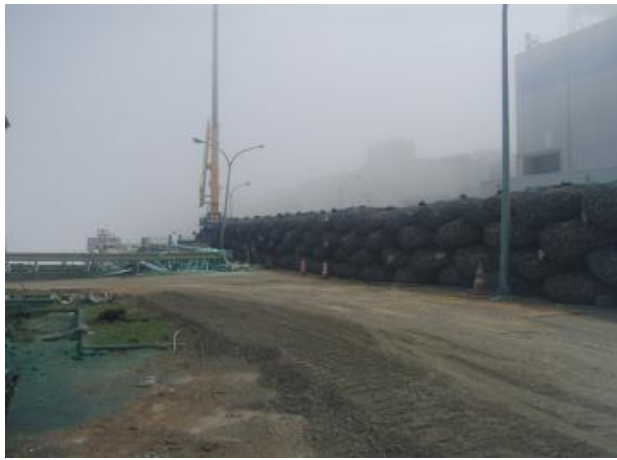
<p>Temporary tide barrier (1)</p> </div> <div style="text-align: center;">

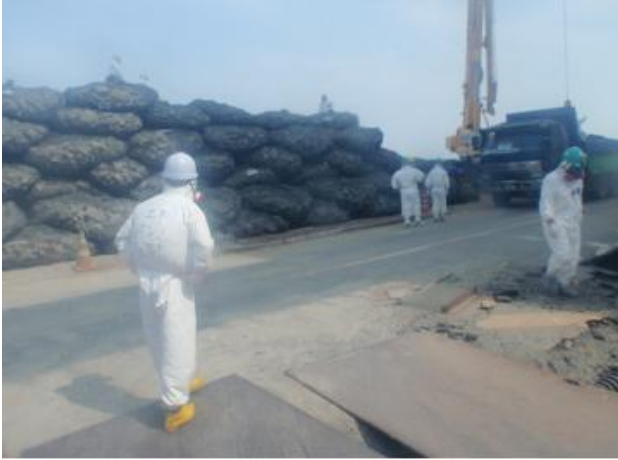
<p>Temporary tide barrier (2)</p> </div> <div style="text-align: center;">

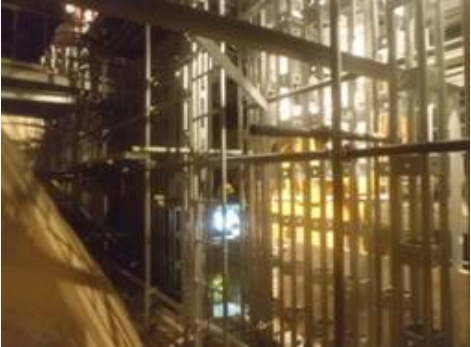
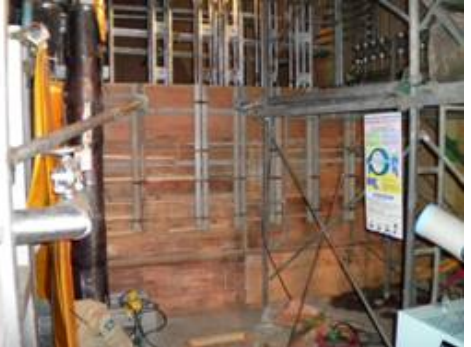
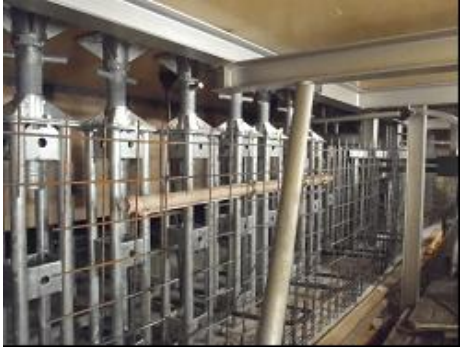
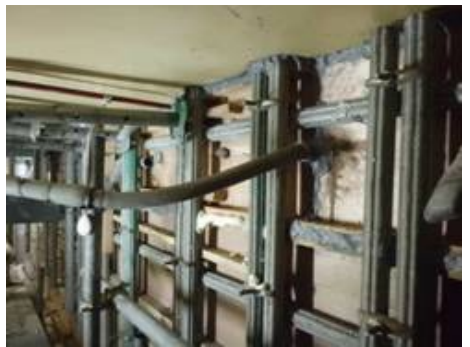
<div style="border: 1px solid black; padding: 5px; text-align: center; margin-bottom: 10px;"> Installation of supporting structure under the bottom of spent fuel pool </div> <div style="display: flex; justify-content: space-around;">

</div> <div style="display: flex; justify-content: space-around; margin-top: 10px;"> <div style="text-align: center;"> <p>Completion of steel pillar installation (Jun. 20)</p> </div> <div style="text-align: center;"> <p>Installation of concrete shuttering</p> </div> <div style="text-align: center;"> <p>Installation of reinforcing mesh</p> </div> <div style="text-align: center;"> <p>Completion of pouring grout (Jul.30)</p> </div> </div>

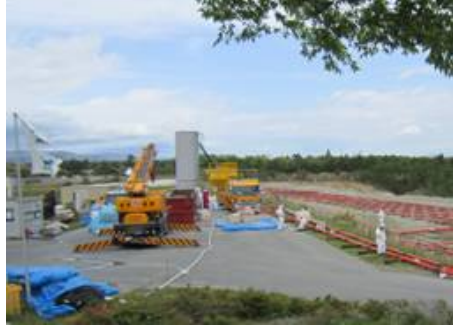
<p>Overview of the facility</p> </div> <div style="text-align: center;">

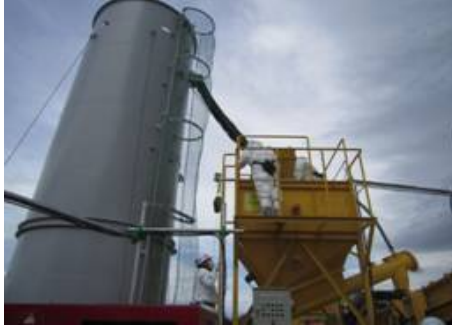
<p>Slurry production facility</p> </div> </div> <div style="display: flex; justify-content: space-around; margin-top: 10px;"> <div style="text-align: center;">

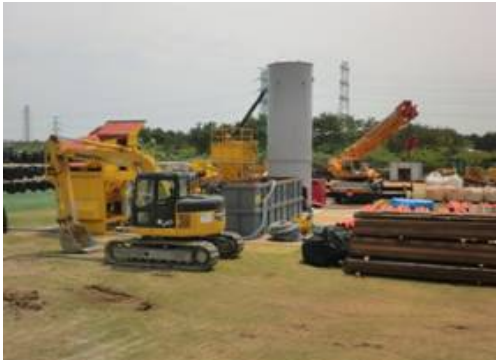
<p>Installation of slurry plant at Fukushima Daiichi</p> </div> <div style="text-align: center;">

<p>- Continue maintenance of equipment - Implemented water injection training by connecting the slurry production facility and concrete pumping vehicle "Elephant-3" (Jun. 16 and 17) - Developed procedure documents and confirmed organizational structure (Jun. 30)</p>	<div style="display: flex; justify-content: space-around; margin-top: 10px;"> <div style="text-align: center;">

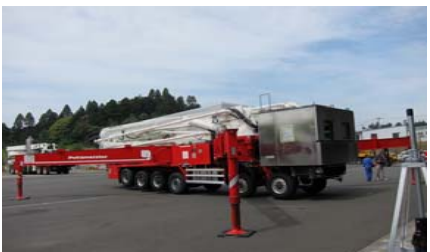
<p>"Elephant-3"</p> </div> <div style="text-align: center;">

<p>High pressure concrete pumping vehicle</p> </div> </div> <div style="display: flex; justify-content: space-around; margin-top: 10px;"> <div style="text-align: center;">

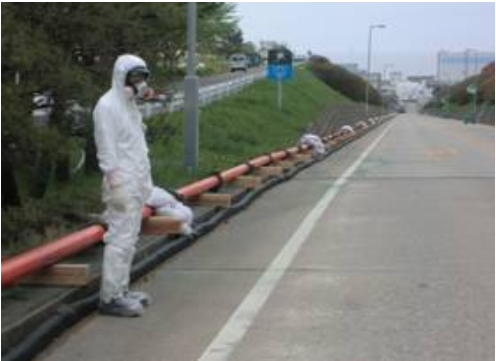
<p>Transfer pipe</p> </div> <div style="text-align: center;">

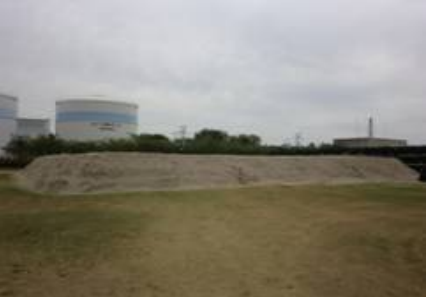
<p>Preparation of equipment (sand)</p> </div> <div style="text-align: center;">

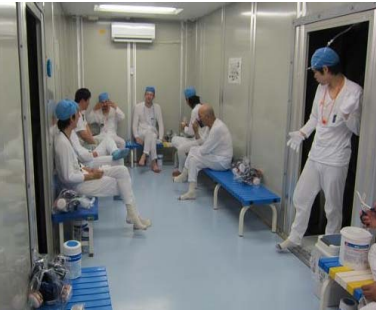
<p style="text-align: center;">Inside</p>

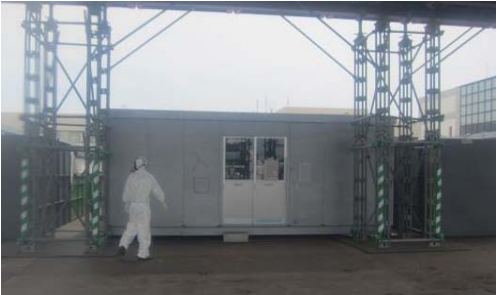
<p style="text-align: center;">Outside</p> <div style="border: 1px solid black; padding: 5px; text-align: center; margin: 10px auto; width: fit-content;"> Rest station at Main Anti-Earthquake Building (2nd phase) </div>

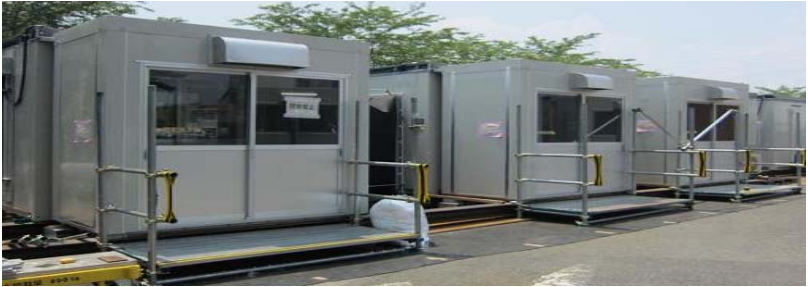
<p style="text-align: center;">Outside</p> <div style="border: 1px solid black; padding: 5px; text-align: center; margin: 10px auto; width: fit-content;"> Rest station for an affiliated company (Hitachi-GE) </div>

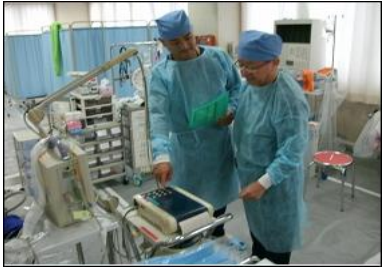
<p>Operation check of medical devices (doctor and nurse)</p> </div> <div style="width: 50%; text-align: center;">

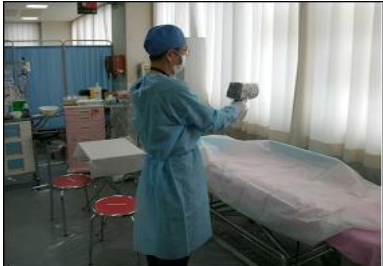
<p>Radiation dose measurement in the room (radiation technologist)</p> </div> <div style="width: 50%; text-align: center;">
