Arrival times of tsunami at the Fukushima Daiichi Nuclear Power Station site

1. Overview

In the “Fukushima Nuclear Accidents Investigation Report,” TEPCO used the time of about 15:27 on March 11th, 2011, as the time of the first wave arrival and about 15:35 as the time of the second wave arrival. These are the times when the waves arrived at the wave height meter, about 1.3 km off the site. But this wave height meter had no time correction function in its built-in clock. There was a possibility of incorrect time recording; thus it was not possible to specify the exact times of the tsunami waves arriving at the Fukushima Daiichi Nuclear Power Station site.

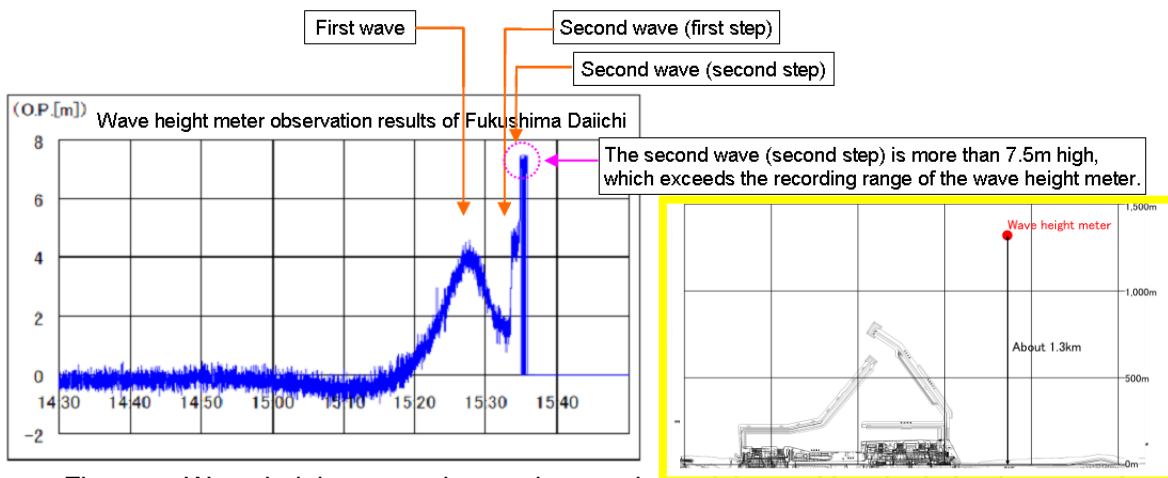
To analyze the wave height meter records and photos in detail, the following definitions were used for the terms related to the tsunami that hit the Fukushima Daiichi Nuclear Power Station.

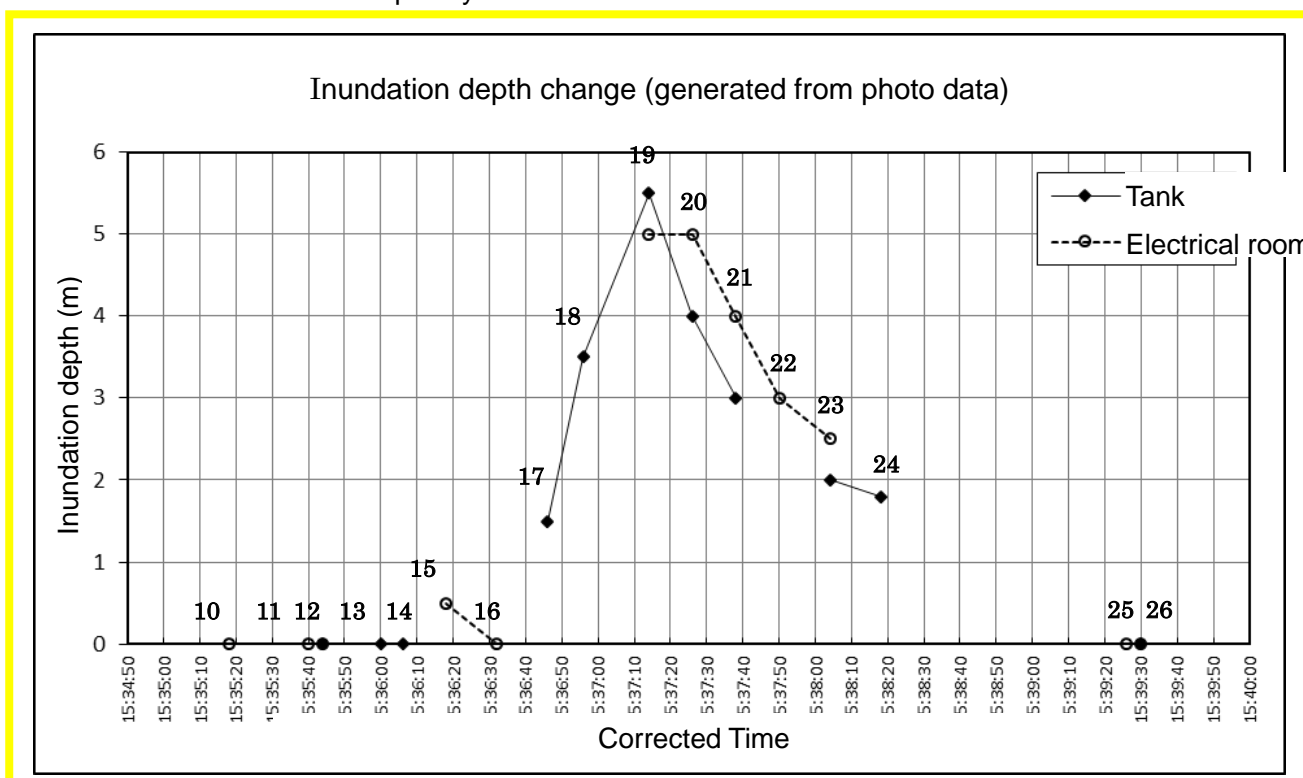
- (f) The following figure shows the inundation situations of the tanks, etc. with the same time correction.
- (g) Run-up of the second wave (first step) to the 10-m ground level remained as a limited one, but it can be understood that the second wave (second step) ran up to the 10-m ground level and almost completely covered the breakwaters and seawall bank.

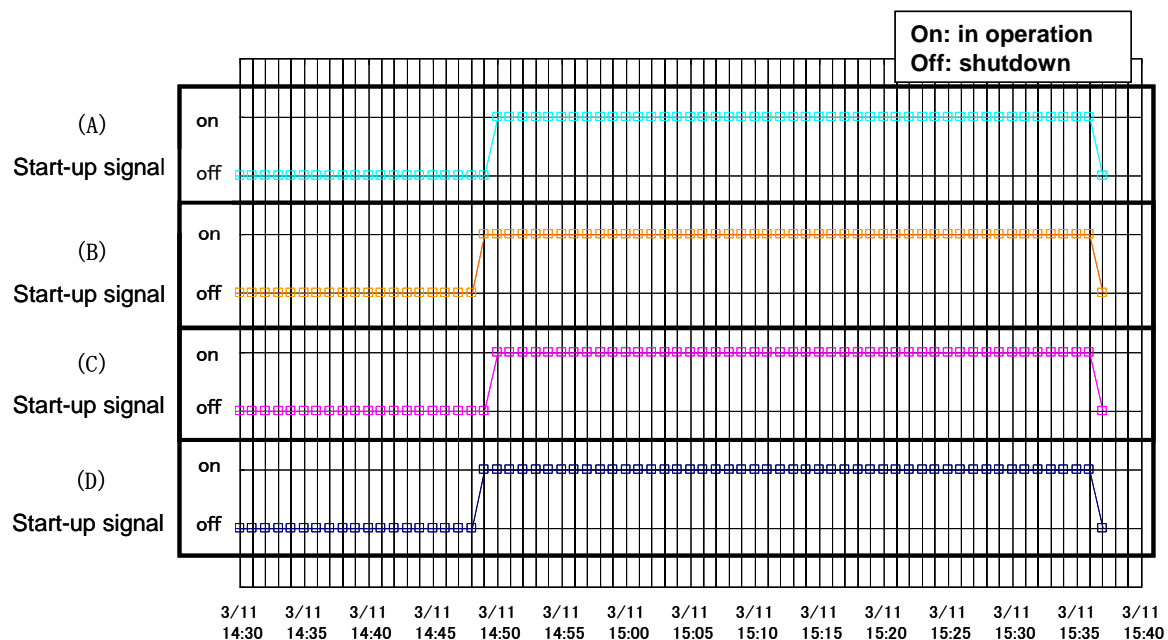
The CCSW pumps (A) to (D) had anomalies between 15:35:59 and 15:36:59 and lost their functions, according to the one minute cycle data recorded on the transient recorder.

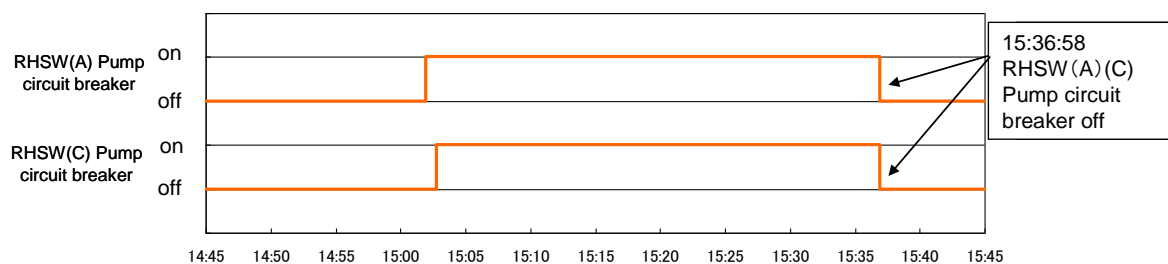
- ✓ Residual heat removal sea water system(RHSW) pumps of Unit-2

The circuit breakers of RHSW pumps (A) and (C) were opened and lost their operating functions at 15:36:58, according to the records in the process computer.

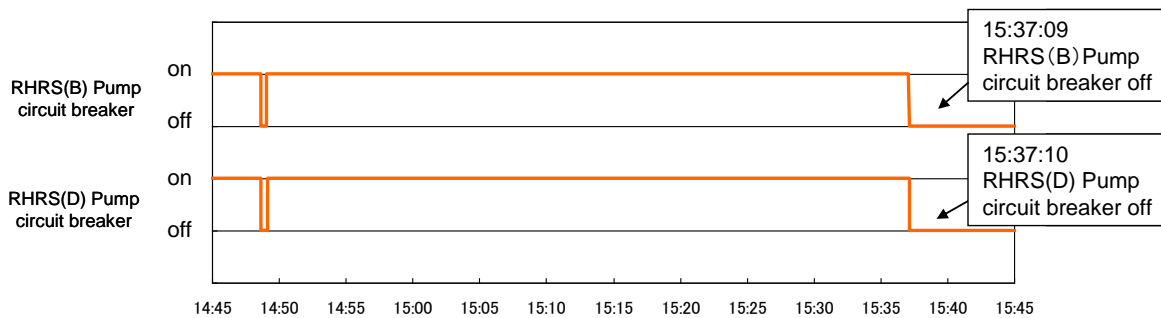
- ✓ Residual heat removal sea water system (RHRS) pumps of Unit-5

The RHRS pumps (B) and (D), which had started operation after the earthquake, had anomalies and lost operating functions at 15:37:09 and 15:37:10 according to the records in the process computer.

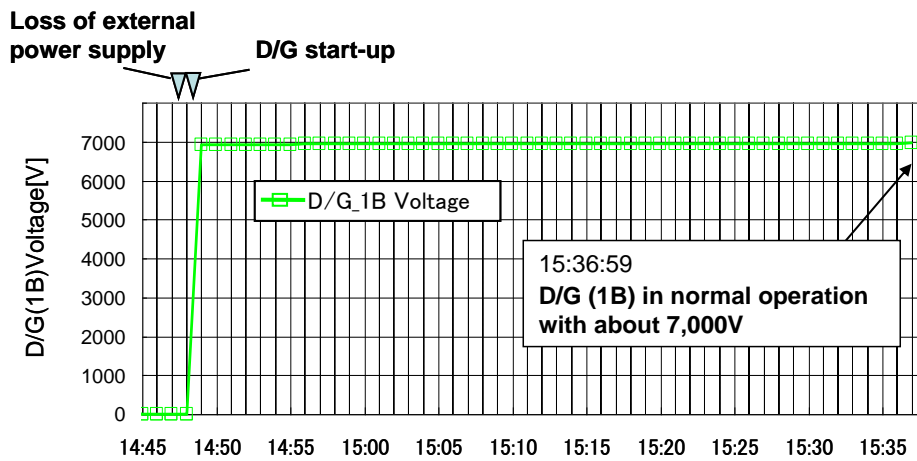
✓ D/Gs (1A) and (1B) of Unit-1

The voltage of the D/Gs (1A) (1B) of Unit-1 had been established until 15:36:59 while the transient recorder was recording data. This confirms their function losses were sometime after 15:36:59.

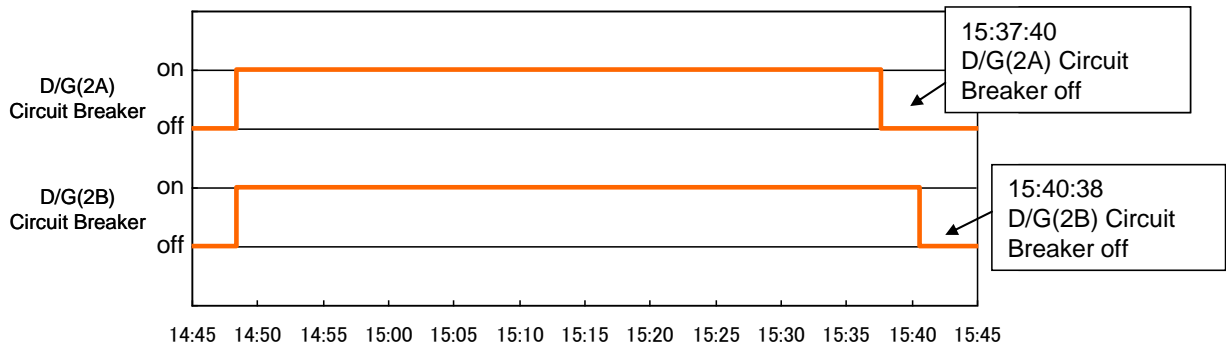
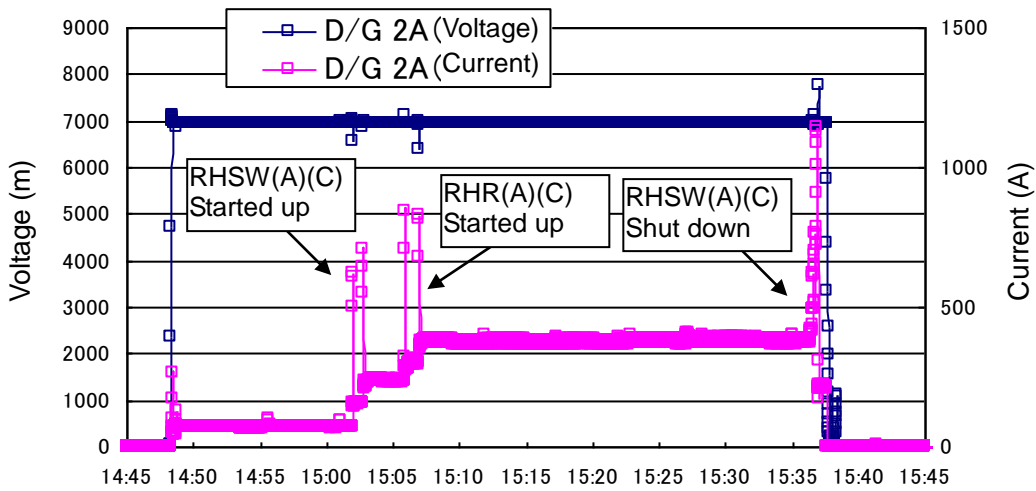
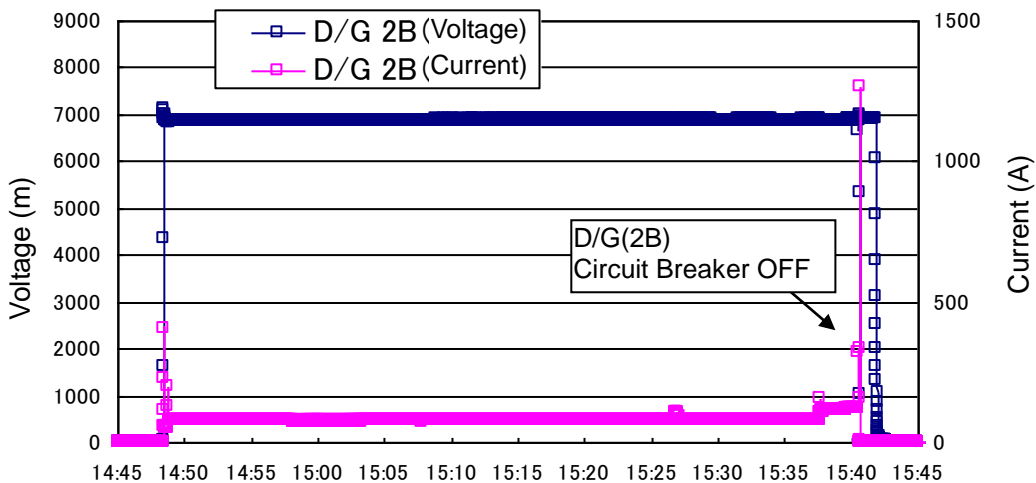
✓ D/Gs (2A) and (2B) of Unit-2

The power receiving circuit breaker of D/G (2A) opened at 15:37:40, according to the data recorded on the process computer.

The D/G (2B) was installed in another building (the common pool building) and its body was not damaged. But its breaker opened at 15:40:38. The function is assumed to have been lost due to the effect of damage to its related facilities or flooding of the emergency power panels to which the D/G (2B) was supplying power.

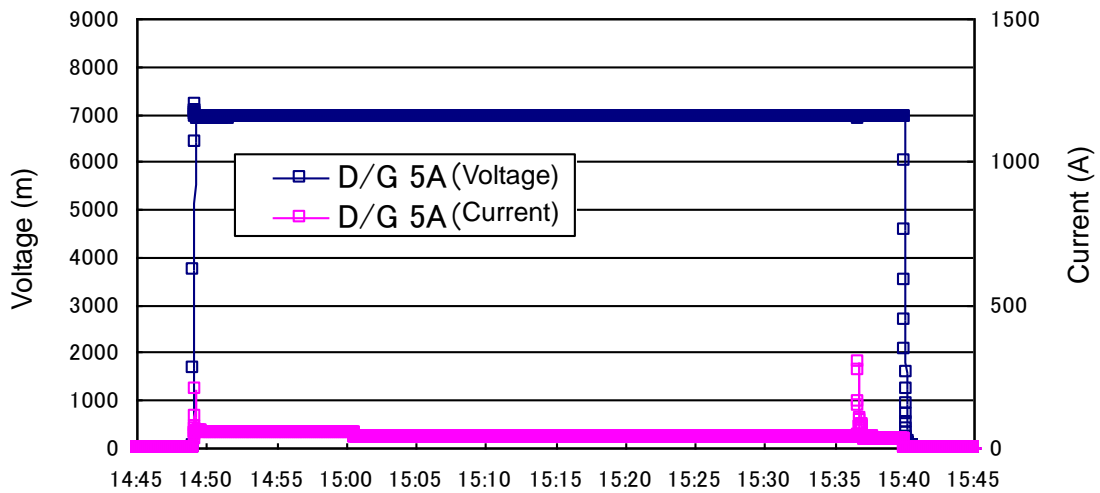
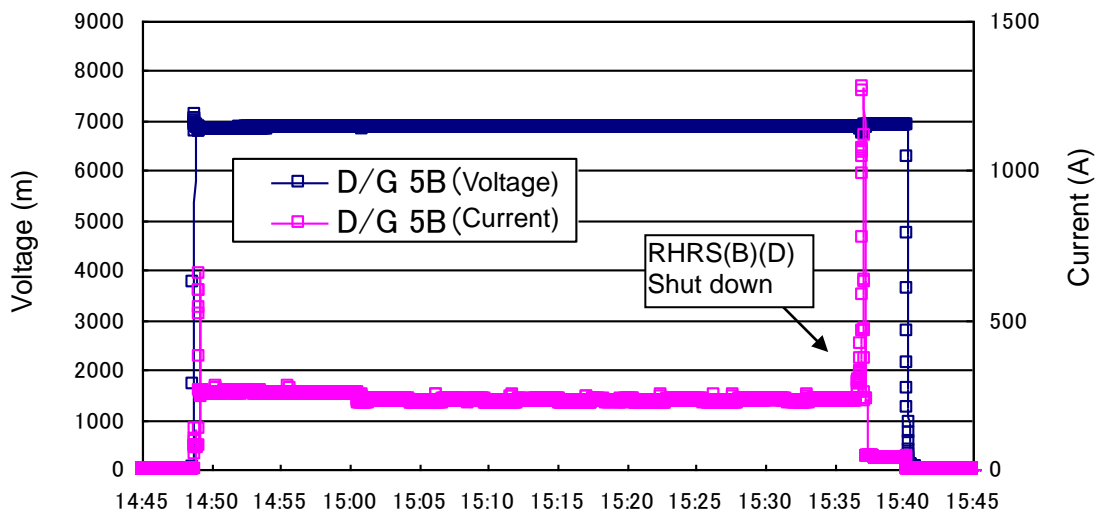
✓ D/Gs (5A) and (5B) of Unit-5

The D/Gs (5A) (5B) had anomalies at around 15:40 and lost their function, according to the data recorded on the process computer.

The bodies of D/Gs (5A) (5B) were confirmed in later investigation to have had no damage by flooding. The function is assumed to have been lost due to damage of their related facilities or flooding of the emergency power panels.

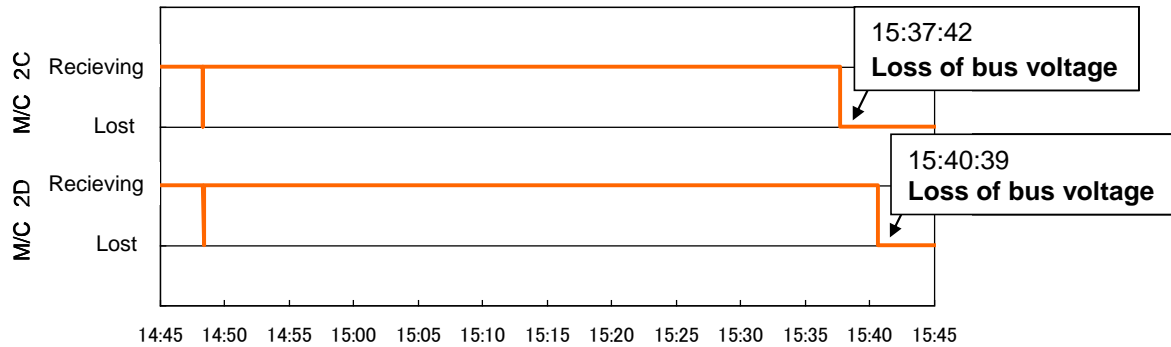
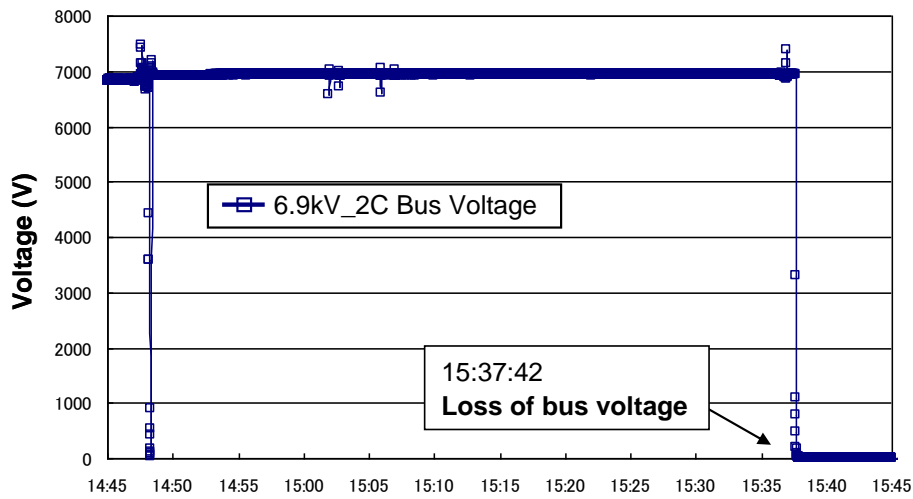
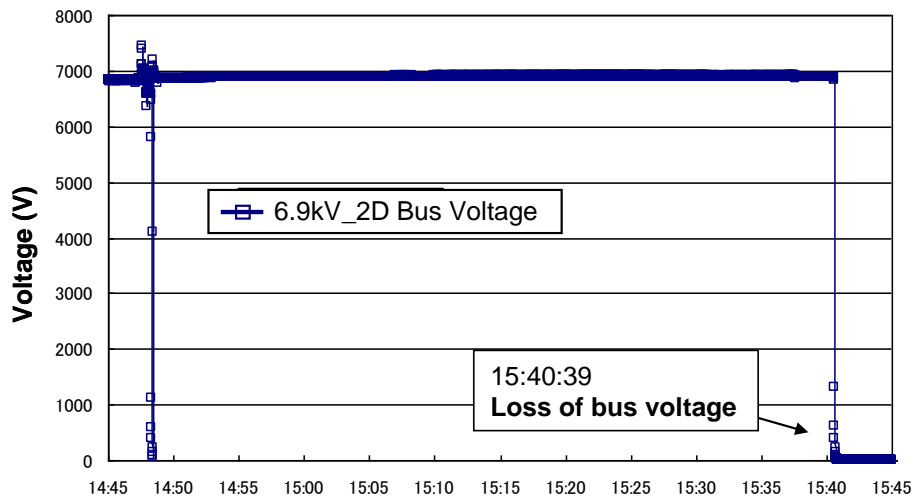
✓ Emergency power panels 2C and 2D of Unit-2

The emergency power panel 2C lost the emergency bus voltage at 15:37:42, while the emergency power panel 2D lost it at 15:40:39, according to the data recorded on the process computer for emergency power panels.

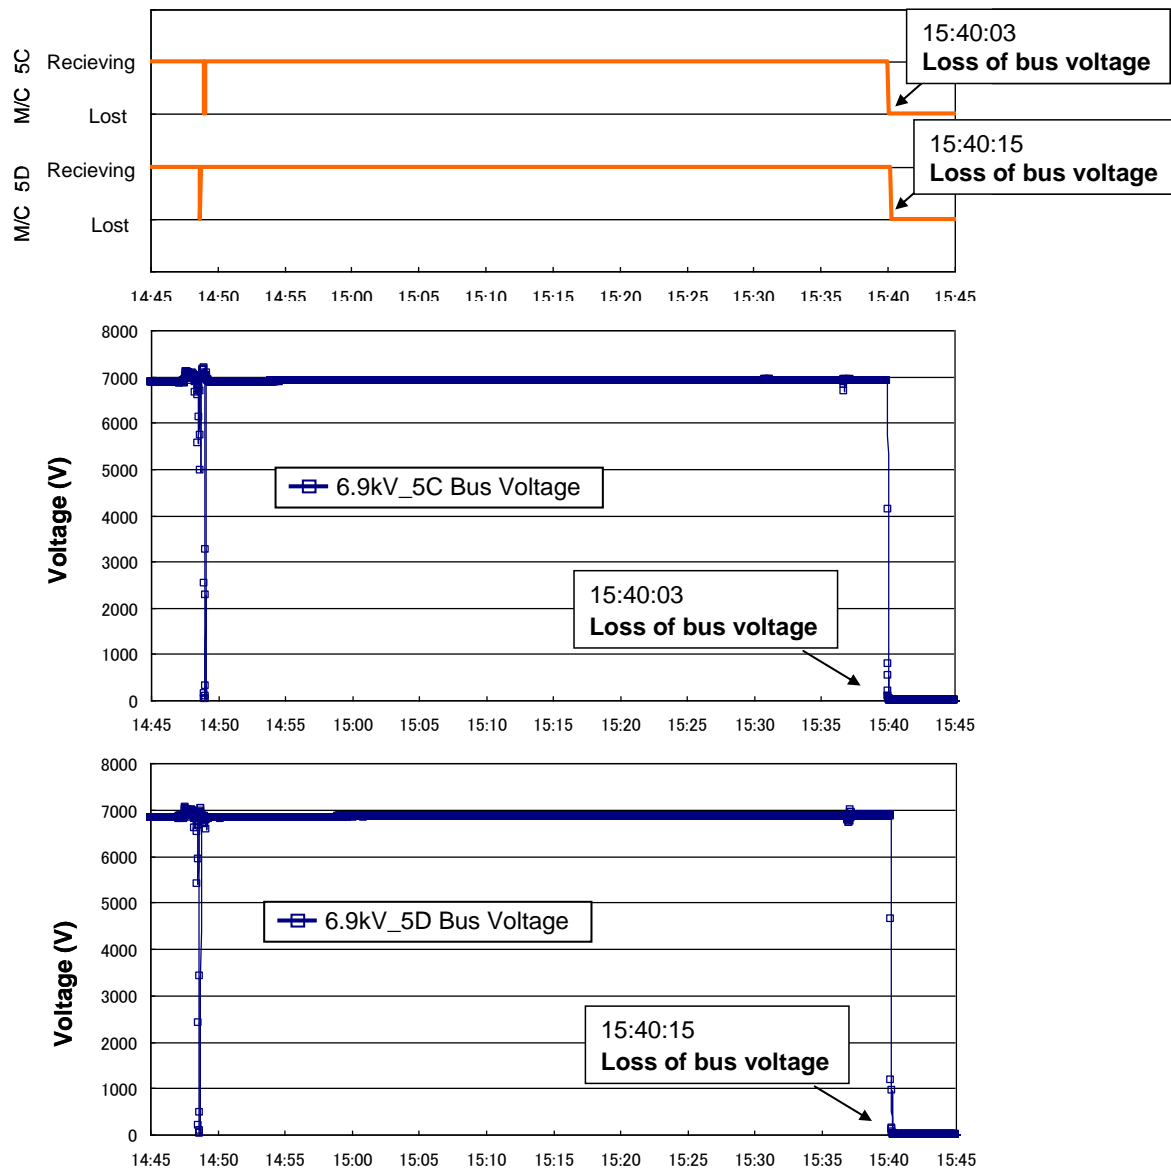
- ✓ Emergency power panels 5C and 5D of Unit-5

The emergency power panel 5C lost the emergency bus voltage at 15:40:03, while the emergency power panel 5D lost it at 15:40:15, according to the data recorded on the process computer.

The D/Gs showed no anomalies in a post-accident investigation. The loss of function is assumed to have been caused by that of the metal-clad switchgear (M/C) or D/G related facilities, which were flooded.

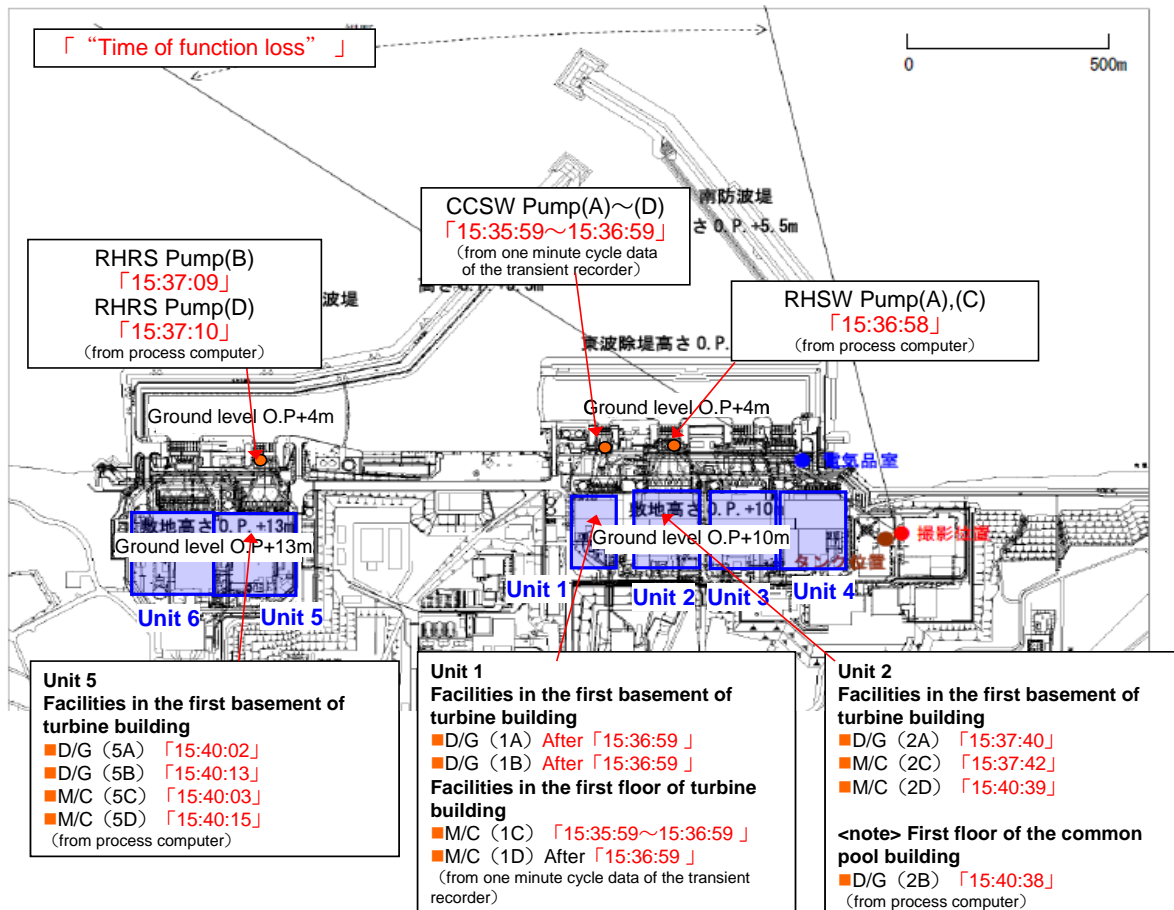
Seawater pumps closest to the sea (installed on the 4-m ground level) lost their function mostly at the 15:36 level, which is thought to be due to the arrival of tsunami second wave at the site.

In other main buildings, the timing of function loss varied depending on the installed locations, but the emergency bus function was lost mostly at around 15:40 caused by tsunami, resulting in the loss of all AC power supplies.

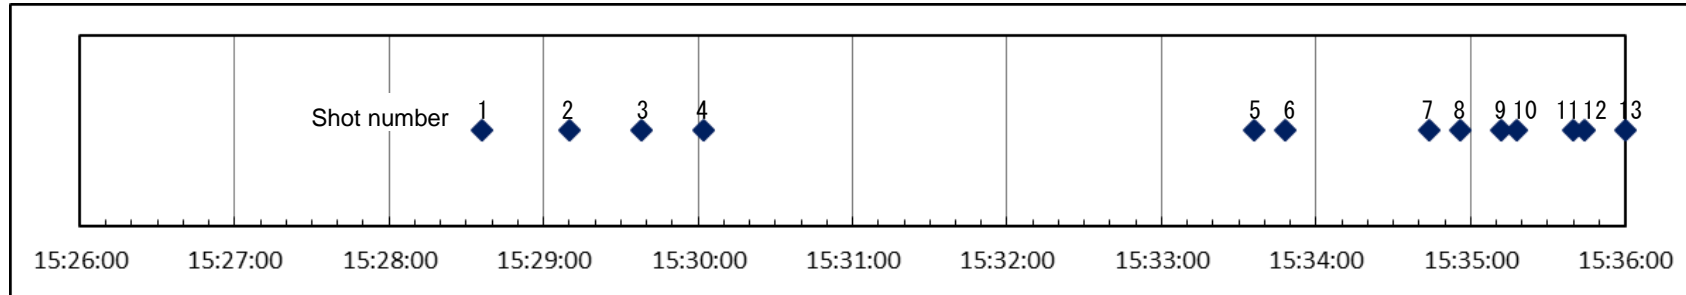
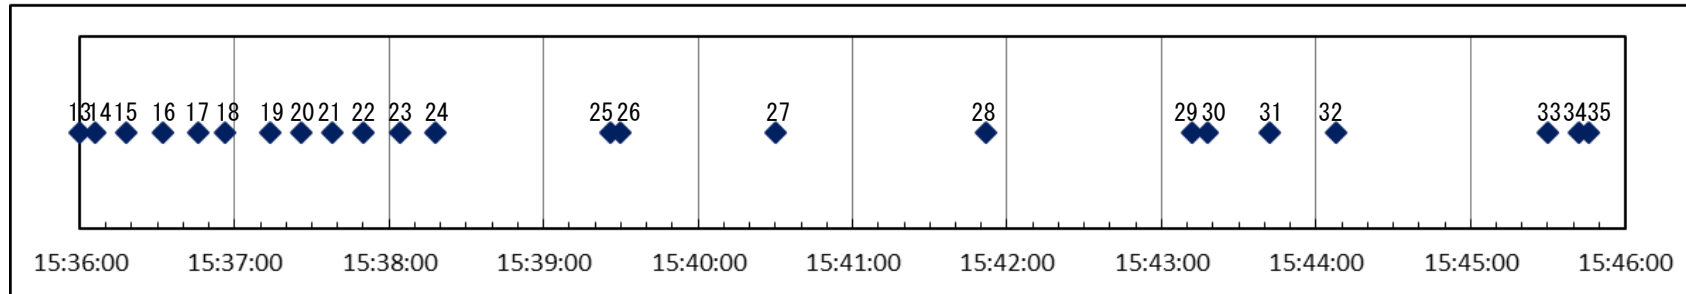
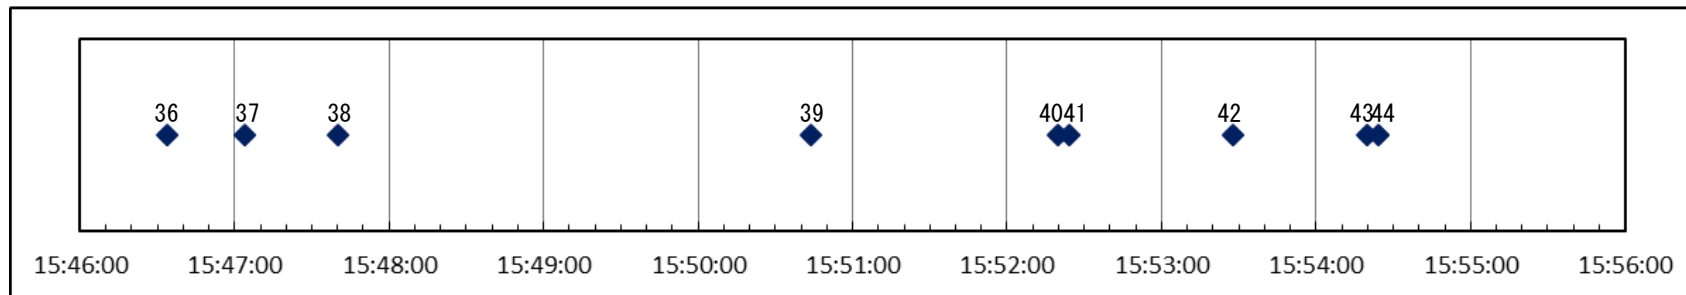
Time point of photos (after correction)

Camera built-in clock time was 6 min 31 s to 6 min 50 s fast.
 In the graph below, time points of photos are corrected for 6 min 40 s, the average value of the above
 (Example: Camera timing of 15:35:36 was corrected to 15:28:36.)

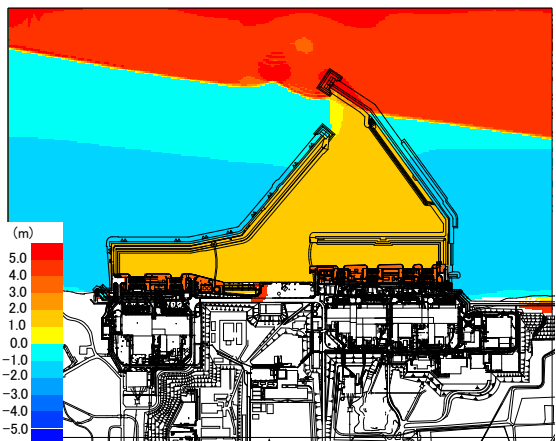
The wave-front obtained by a simulation for tsunami reproduction has the angles shown in the figure below.

In the simulation, wave forms and the arrival timing cannot be precisely reproduced, but the direction of the simulated wave-front can be considered to be close to the real one, because the wave-front is controlled by the seabed topography.
