<Seventh Press Conference for Overseas Media>  
Update on the Status of the Discharge of ALPS Treated Water  
into the Sea and Decommissioning Work  
at the Fukushima Daiichi Nuclear Power Station

**TEPCO**

November 21, 2024

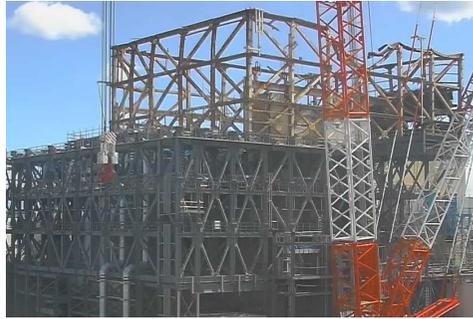
Unit 1

In preparation for the removal of fuel from the spent fuel pool, construction of a large cover began in September 2021 (To be completed around the summer of 2025).

Internal investigations of the primary containment vessel are being conducted in preparation for fuel debris retrieval.

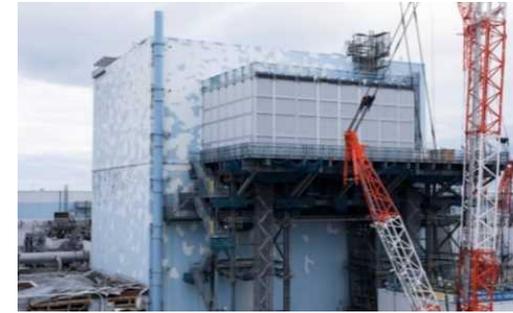
Unit 2

A fuel removal work platform and a front chamber is being constructed on the south side of the reactor building in preparation for the removal of fuel from the spent fuel pool.

This is the first unit from which fuel debris has been retrieved. Retrieval via a telescopic device has been completed (November 7, 2024)

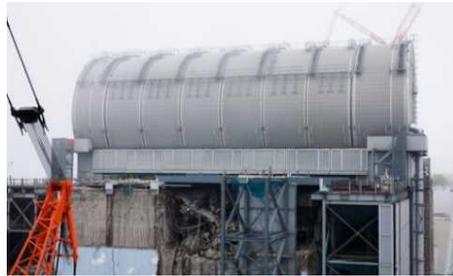
Fuel removal completed: February 28, 2021 (566 assemblies)

Removal of the fuel from the spent fuel pool (566 assemblies) was completed on February 28, 2021. The need for additional internal investigations of the primary containment vessel in preparation for the retrieval of fuel debris is being deliberated.

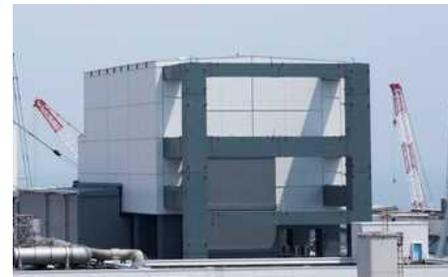
Fuel removal completed: December 22, 2014 (1,535 assemblies)

The removal of fuel from the spent fuel pool (1535 assemblies) was completed on December 22, 2014 thereby eliminating risks associated with fuel.

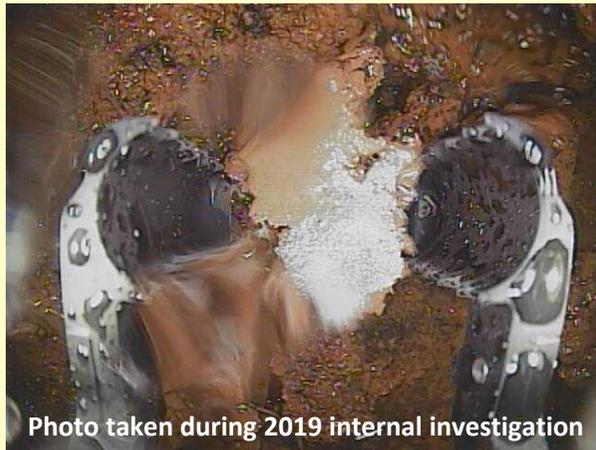
Photo taken during 2019 internal investigation

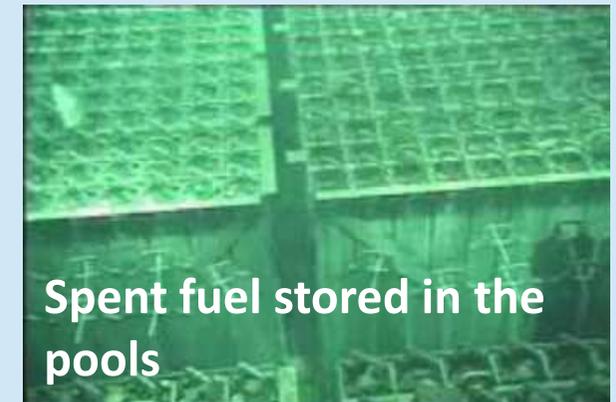
Spent fuel stored in the pools

Fuel in the pools is relocated to a common pool on site where it is appropriately stored and kept stable.

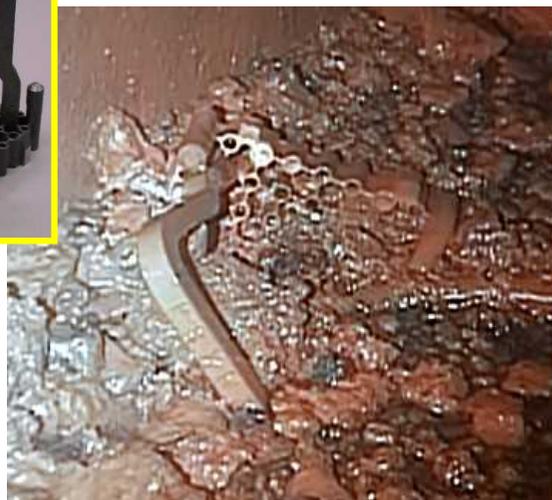
- ① The fuel could not be cooled and the pellets melted (Melting point: Approximately 2800°C)
- ② The fuel melted into fuel rod cladding material and fuel assembly structures, and some of it fell to the bottom of the pedestal
- ③ As this melted material fell, it cooled and solidified thereby forming **the various multi-composition fuel debris that now exists inside the primary containment vessels**

← Fuel assembly structures melted along with the fuel and then solidified resulting in fuel debris (photographed during 2018 internal investigation)

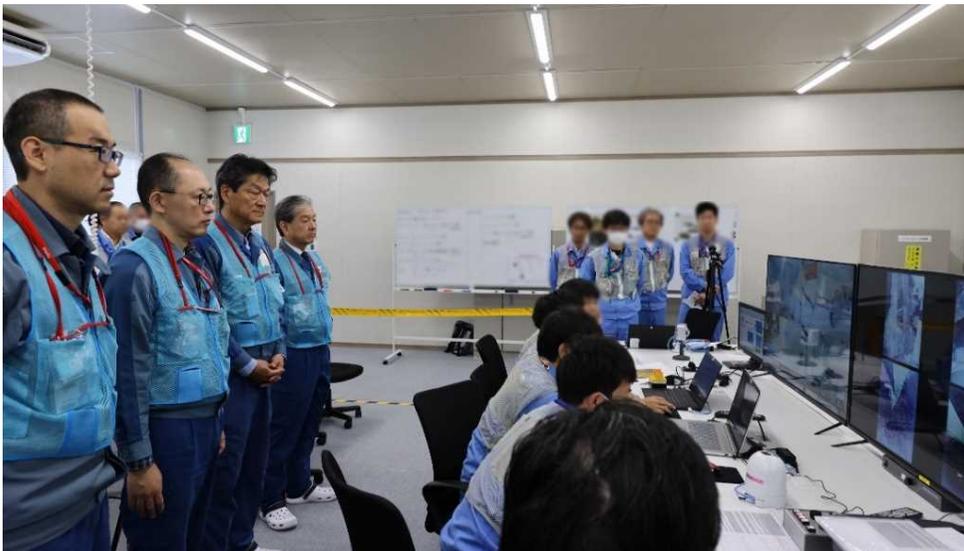
At the remote operations room

- ◆ In September 2024, the trial retrieval of fuel debris was started.
- ◆ On October 30 2024, the end jig of the telescopic device was lowered to perform a fuel debris grasping work at the bottom of the pedestal.
- ◆ The fuel debris was grasped by the gripper of the end jig, and the first fuel debris was retrieved since the accident. Approximately 5 mm in size and weighing approximately 0.7 g.
- ◆ The fuel debris retrieved was stored in a transportation container on November 7, completing the trial removal work.
- ◆ No significant changes were observed in the surrounding dust monitors or the monitoring posts at the site boundary, and the work was completed safely.
- ◆ The cause of the camera malfunction that occurred during the work will be investigated.

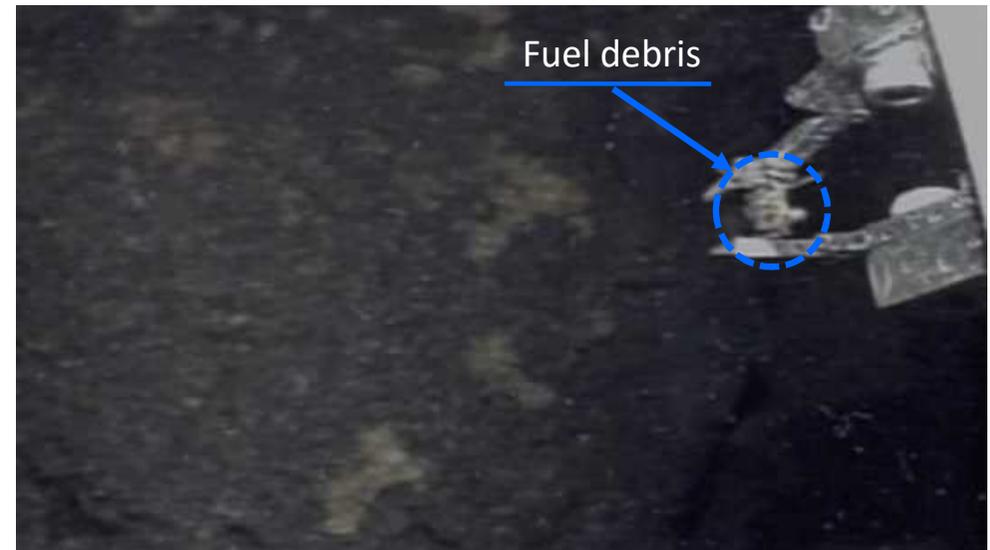
End jig grasping fuel debris

Photographed on October 30, 2024

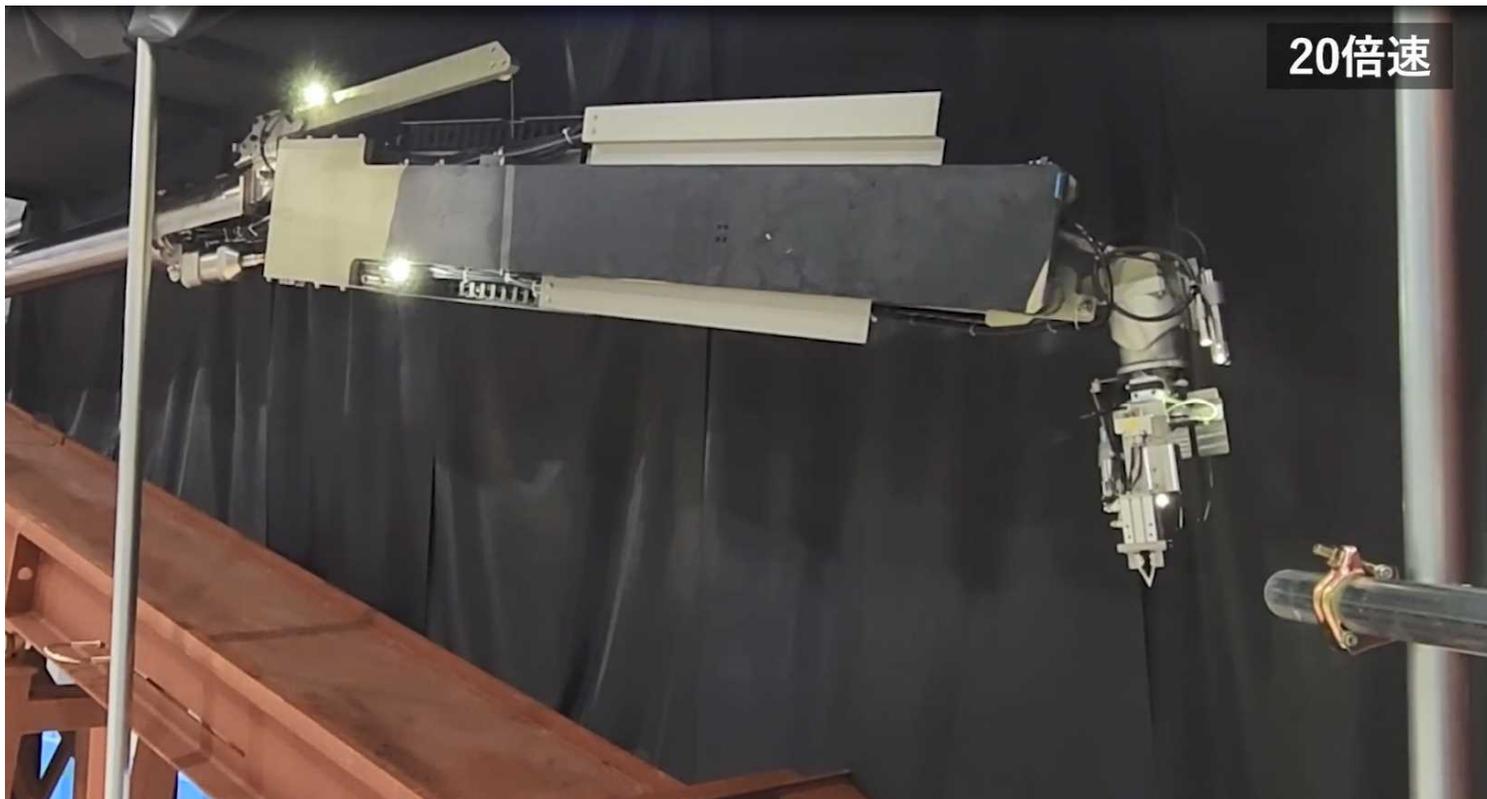
<Video introducing the telescopic device>

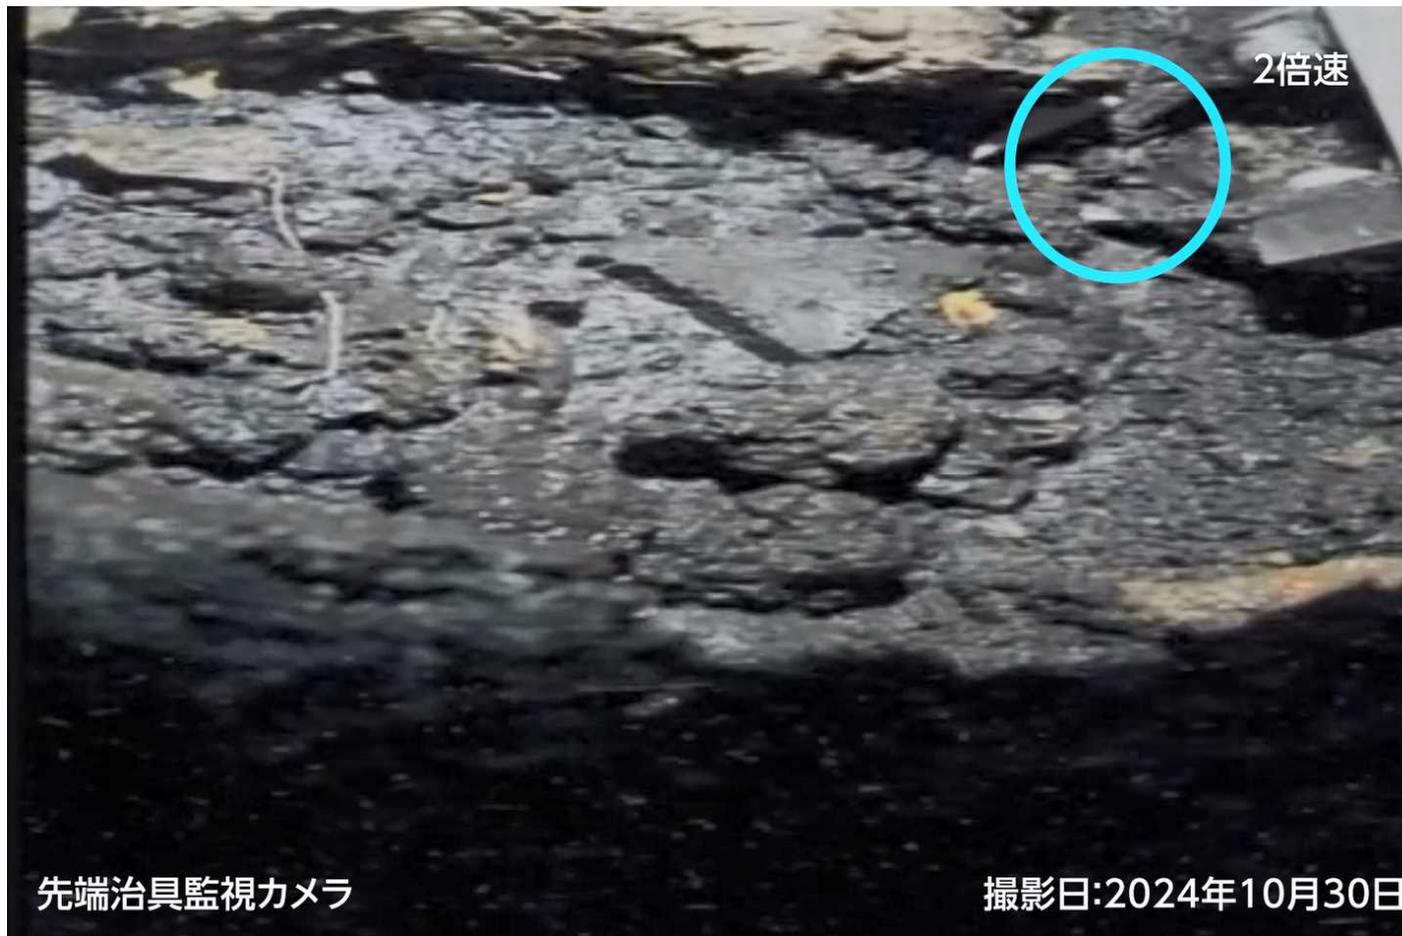
<Video showing how fuel debris was grasped>

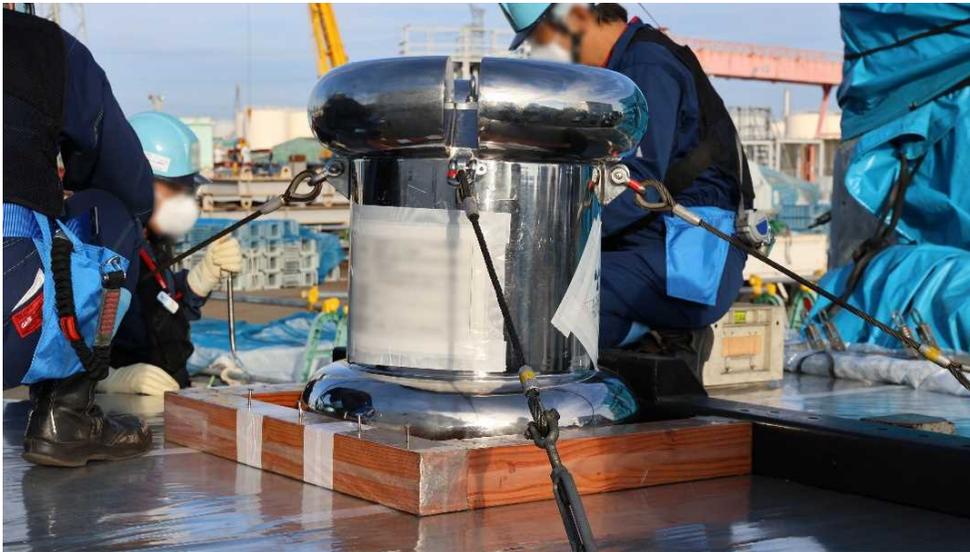
Off-site transportation container loaded onto an off-site transfer vehicle

- ◆ The fuel debris sampled from Unit 2 was transported to the Japan Atomic Energy Agency (JAEA) Oarai Nuclear Engineering Institute in order to be analyzed. (November 12, 2024)
- ◆ Before the fuel debris was transported to an off-site analysis facility, a spectrum analysis was carried out at the Fukushima Daiichi Nuclear Power Station, and a peak estimated to be europium 154 was detected, confirming the possibility that the material contained components derived from the fuel.

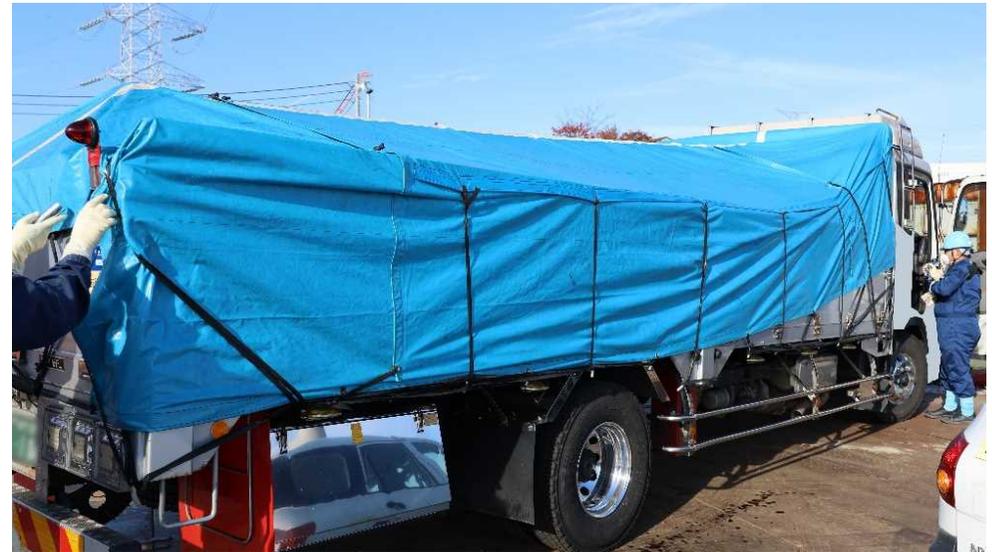
Final check of the off-site transfer vehicle prior to departure from Fukushima Daiichi

Photographed on November 12, 2024

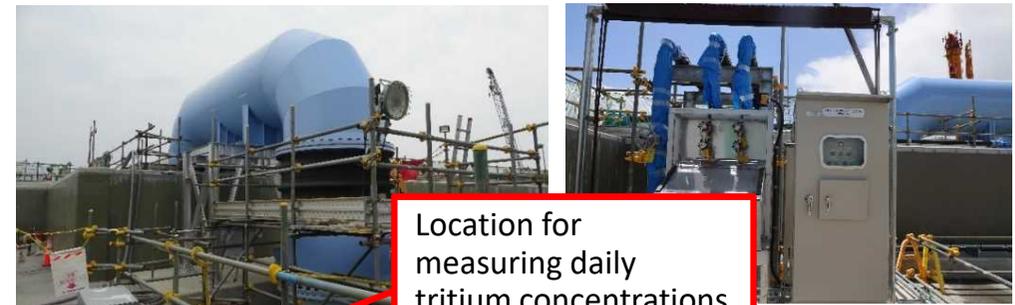
\*"ALPS treated water tritium concentrations after dilution" is calculated by the following formula, and is the conservative value considering the uncertainty of measured concentration, etc.

"ALPS treated water tritium concentrations after dilution"

"ALPS treated water tritium concentrations prior to dilution × ALPS treated water transfer flow"

Seawater transfer flow + ALPS treated water transfer flow

Treated water discharge volume	7,837m <sup>3</sup>
Treated water flow	Approx. 460m <sup>3</sup> /day
Flow of seawater used for dilution	Approx. 340,000m <sup>3</sup> /day
Post-dilution tritium concentration	Max: 436Bq/l
Discharge period	17 days

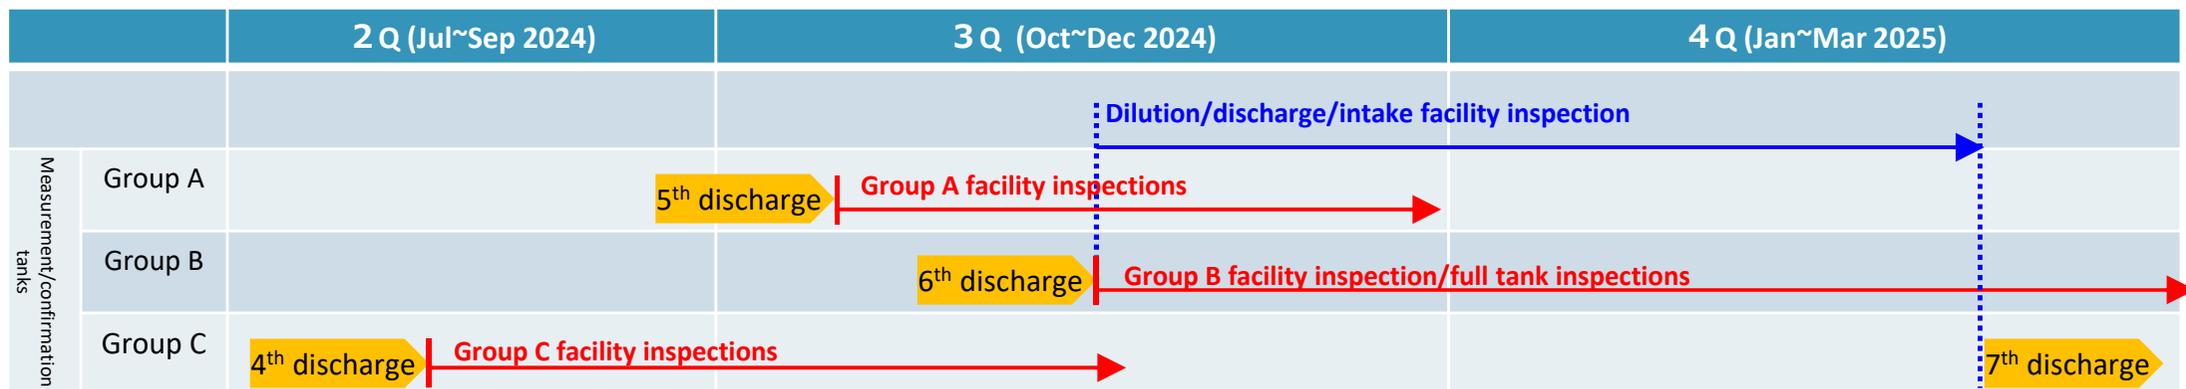
- After the completion of the fourth discharge of ALPS treated water in FY2024 (24-4-8), sequential inspections of each facilities began in accordance with the long-term inspection plan
  - After completion of the fourth (24-4-8) and fifth (24-5-9) discharges, Group C facilities and Group A facilities were inspected, respectively
  - After completion of the sixth discharge (24-6-10), the facilities were stopped to perform inspections of Group B facilities (including a full inspection of the tanks) and common facilities (transfer/dilution/discharge/water intake facilities)
