Measures for treated water

1/10

Progress status

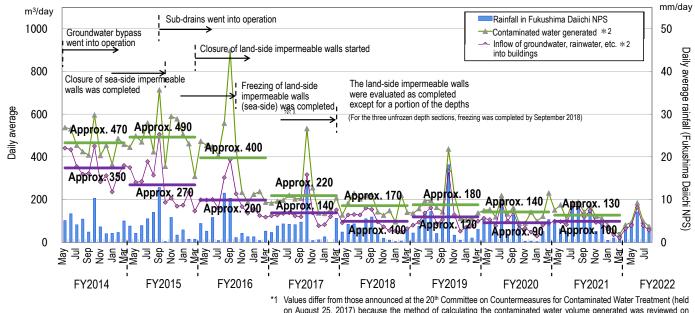
Figure 1: Changes in contaminated water generated and inflow of groundwater and rainwater into buildings

- Multi-layered measures, including pumping up by sub-drains and land-side impermeable walls, which were implemented to control the continued generation of contaminated water, suppressed the groundwater inflow into buildings.
- After implementing "redirecting" measures (groundwater bypass, sub-drains, land-side impermeable walls and others) and rainwater prevention measures, including repairing damaged portions of building roofs, the amount of contaminated water generated within FY2021 declined to approx. 130 m³/day.
- Measures will continue to further reduce the amount of contaminated water generated.

- Aulues differ from those announced at the 20th Committee on Countermeasures for Contaminated water reatment (near on August 25, 2017) because the method of calculating the contaminated water volume generated was reviewed on March 1, 2018. Details of the review are described in the materials for the 50th and 51st meetings of the Secretariat of the Team for Countermeasures for Decommissioning and Contaminated Water Treatment.
- *2: The monthly daily average is derived from the daily average from the previous Thursday to the last Wednesday, which is calculated based on the data measured at 7:00 on every Thursday.

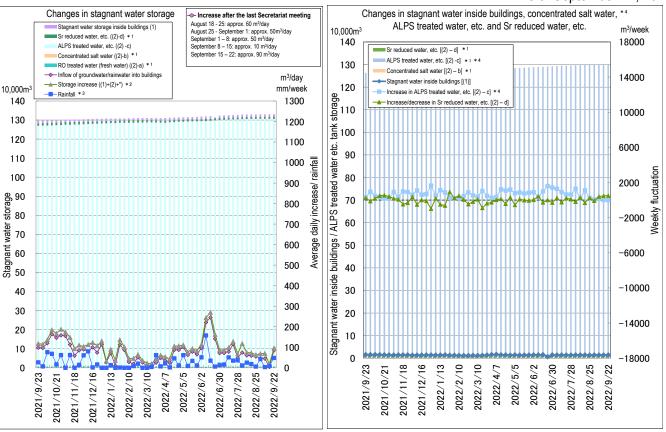
As of September 22, 2022

- Water amount for which the water-level gauge indicates 0% or more
 To detect storage increases more accurately, the calculation method was reviewed as follows from February 9, 2017: (The revised method was applied from March 1, 2018)

[(Inflow of groundwater/rainwater into buildings) + (other transfer) + (chemical injection into ALPS)] Changed from December 13, 2018 from rainfall in Namie to that within the site.

To reduce the risks of strontium-reduced water, treatment using existing, additional and high-performance multinuclide removal equipment is underway. Up until September 22, 2022, approx. 852,000 m³ had been treated.

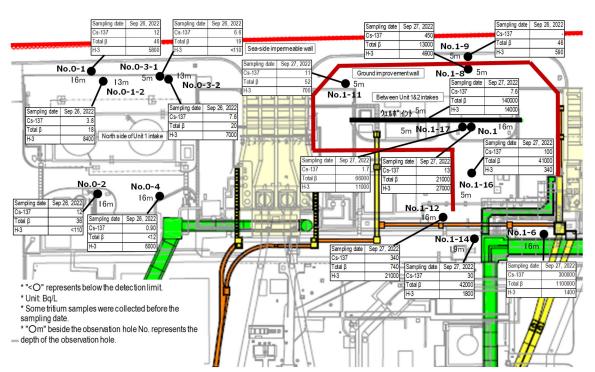
<Unit 1 intake north side, between Unit 1 and 2 intakes>

- The concentration of radioactive materials in drainage channels has remained constant overall, despite increasing during rainfall.
- In the open channel area of seawater intake for Units 1 to 4, the concentration of radioactive materials in seawater has remained below the legal discharge limit and been declining long term, despite temporary increases in Cs-137 and Sr-90 noted during rainfall. They have also been declining following the completed installation and the connection of steel pipe sheet piles for the sea-side impermeable walls. The concentration of Cs-137 has remained slightly higher in front of the south-side impermeable walls and slightly lower on the north side of the east breakwater since March 20, 2019, when the silt fence was transferred to the center of the open channel due to mega float-related construction.

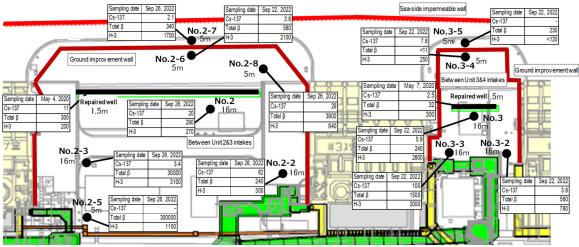
<Between Unit 2 and 3 intakes, between Unit 3 and 4 intakes>

Figure 4: Groundwater concentration on the Turbine Building east side

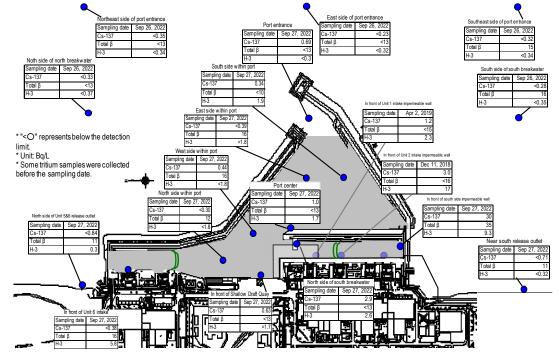
Figure 5: Seawater concentration around the port

- In the port area, the concentration of radioactive materials in seawater has remained below the legal discharge limit and been declining long term, despite temporary increases in Cs-137 and Sr-90 observed during rainfall. They have remained below the level of those in the Units 1-4 intake open channel area and been declining following the completed installation and connection of steel pipe sheet piles for the sea-side impermeable walls.

- In the area outside the port, regarding the concentration of radioactive materials in seawater, those of Cs-137 and Sr-90 declined and remained low after steel pipe sheet piles for the sea-side impermeable walls were installed and connected. Regarding the concentration of Cs-137, a temporary increase was sometimes observed on the north side of the Unit 5 and 6 outlets and near the south outlet due to the influence of weather, marine meteorology and other factors. Regarding the concentration of Sr-90, variation has been observed in FY2021 in the area outside the port (north and south outlets). Monitoring of the tendency continues, including the potential influence of the weather, marine meteorology and others.
