## Main decommissioning work and steps

## Progress status

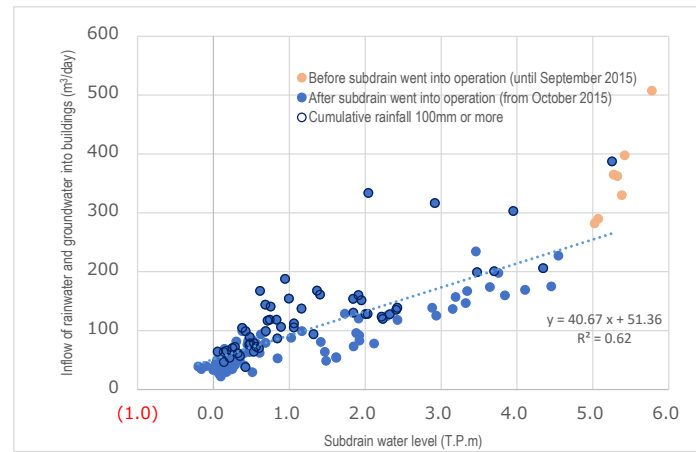
Figure 2: Correlation between inflow such as groundwater and rainwater into buildings and the water level of Units 1-4 subdrains

- At the Water-Treatment Facility Special for Subdrains & Groundwater drains, releases started from September 14, 2015, and up until March 17, 2026, 2,885 releases had been completed.
