# Commencement of Investigation at the Fukushima Daiichi Nuclear Power Station Using a Boat-shaped Remote Operated Vehicle in Preparation for the Removal of Zeolite bags from Building Subfloors

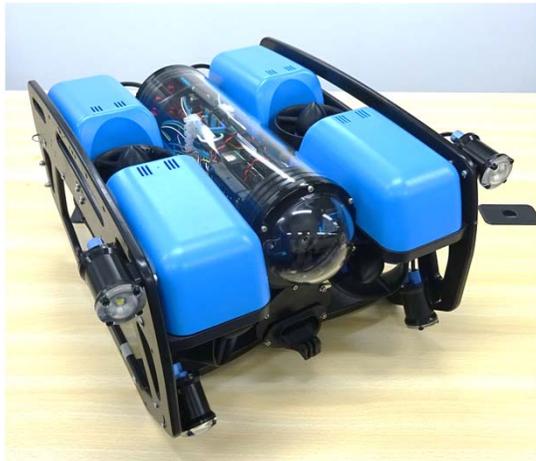
Commercially available submersible robot used as the platform

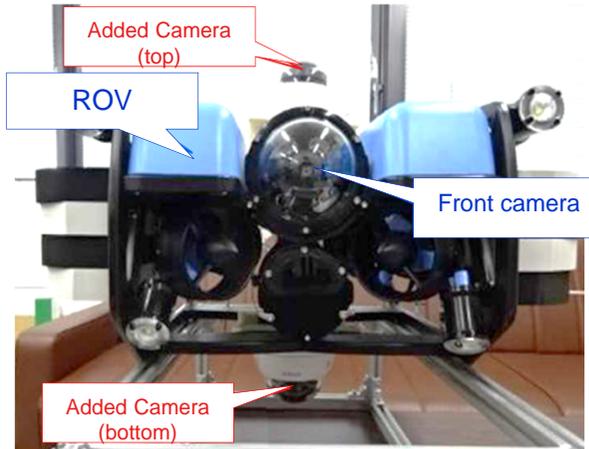
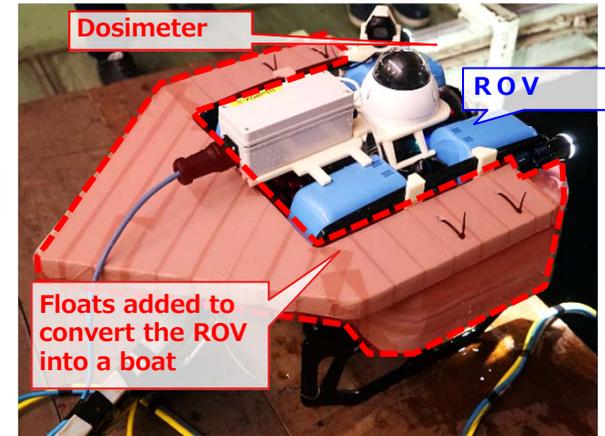
Boat-shaped ROV to be used for this investigation

- During the previous investigation ※<sup>1</sup> a submersible remote operated vehicle (ROV) was used to investigate the subfloors and for this investigation a submersible ROV that has been converted into a boat will be used to investigate the area in which removal work will take place, and also to identify the exact position of bags ※<sup>2</sup>.

- In preparation for this investigation final improvements were made to the boat-shaped ROV upon performing tests on a mockup at the Fukushima Robot Test Field (Minami Soma City) in December 2020.

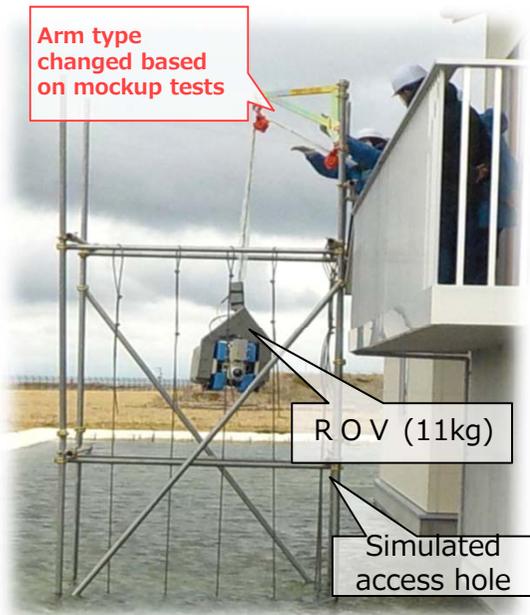
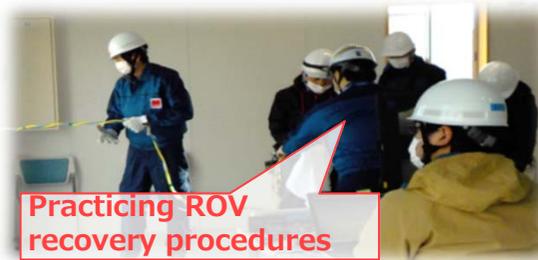
Practicing ROV recovery procedures

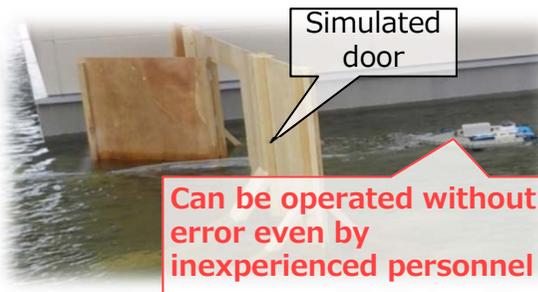
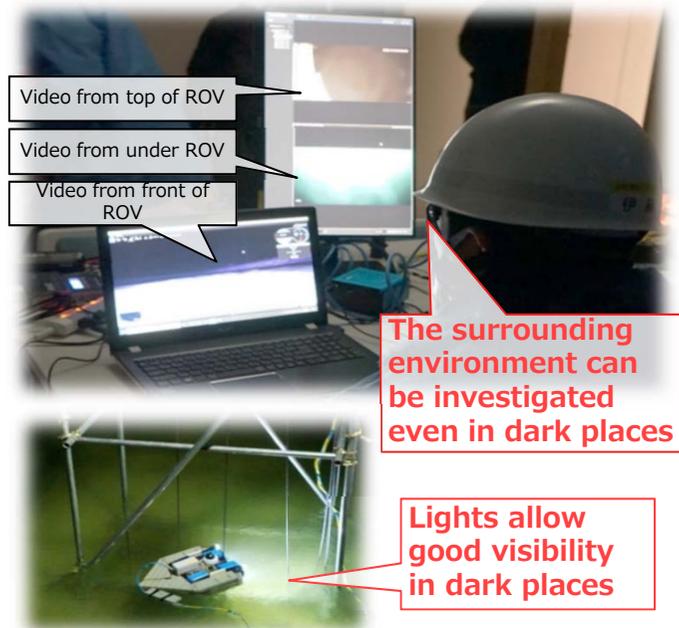
Overview of mockup tests
