Implementation Status of the Fukushima Daiichi Nuclear Power Station Unit 1 Primary Containment Vessel Internal Investigation (ROV-A2) (Preliminary report)

< Reference Material >
March 14, 2022
Tokyo Electric Power Company Holdings,
Inc.
Fukushima Daiichi D&D Engineering
Company

Location of the detailed visual inspection of the perimeter of the pedestal and inspection schedule

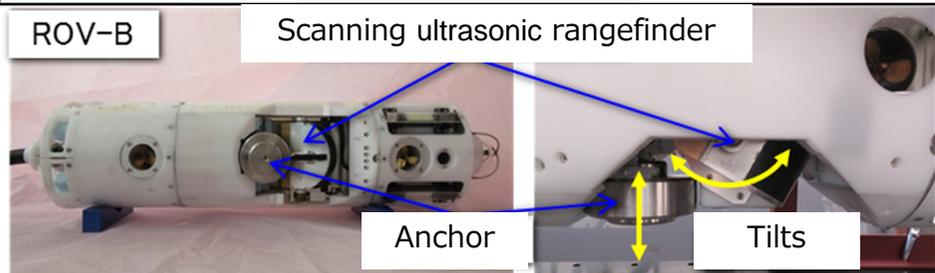
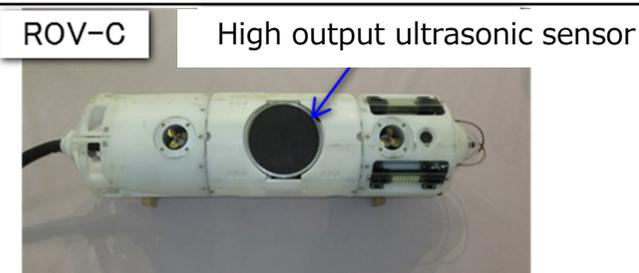
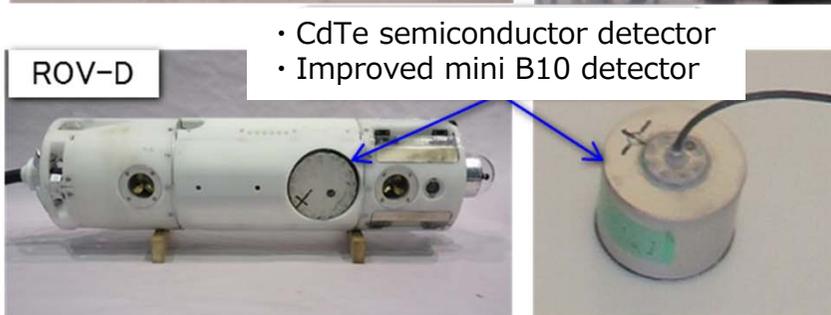
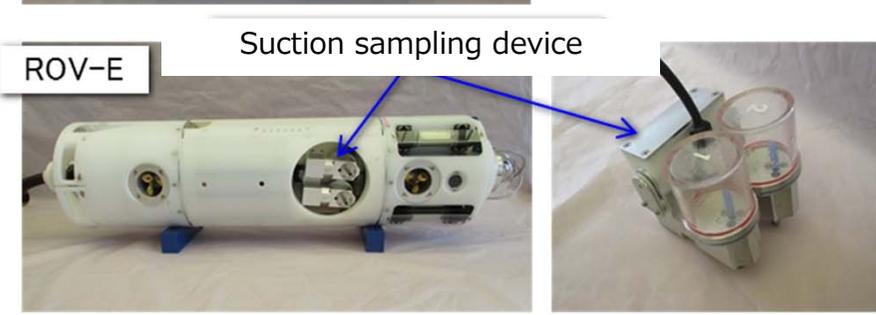
ROV-B~E for different investigations

Investigation device	Instruments	Details
ROV-B 3-D mapping of deposits	<ul style="list-style-type: none"> • Scanning ultrasonic rangefinder • Water temperature gauge 	Scanning ultrasonic rangefinder used to examine the height distribution of deposits.
ROV-C Deposit thickness measurements	<ul style="list-style-type: none"> • High output ultrasonic sensor • Water temperature gauge 	High output ultrasonic sensor used to measure the height of deposits and examine objects underneath them in order to estimate debris height and distribution.
ROV-D Deposit debris detection	<ul style="list-style-type: none"> • CdTe semiconductor detector • Improved mini B10 detector 	Debris detection sensors will be dropped on the surface of the deposits to analyze nuclides and measure neutron flux in order to examine if debris exists inside the deposits.
ROV-E Deposit sampling	<ul style="list-style-type: none"> • Suction sampling device 	The deposit sampling device will be dropped on the surface of the deposits to take samples from the surface of the deposits.

Quantity: 2 each; Cruising time: Approx. 80 hours/unit Since the units need to be agile for the investigations flexible PVC cables (ROV-B : φ33mm, ROV-C : φ30mm, ROV-D : φ30mm, ROV-E : φ30mm) will be employed
