Status of Progress of the installation of ALPS treated water dilution/discharge facility and related facilities

January 26, 2023 Tokyo Electric Power Company Holdings, Inc.

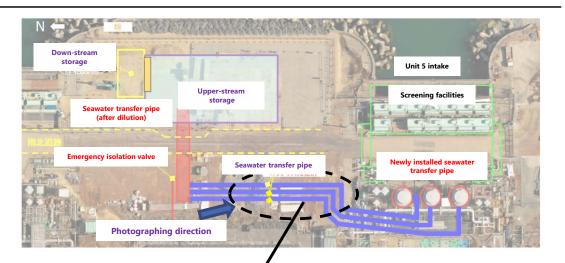
Building the seawater transfer pipe foundation

The foundation shafts for the seawater transfer pipes have been installed. The frame of the foundation is currently being built.

[Dilution facilities]
Installing the foundation shafts for pipe foundation 65 out of 65 complete
Support facility 0 out of 320 m complete
Pipe facility 0 out of 320 m complete < as of Jan. 20>

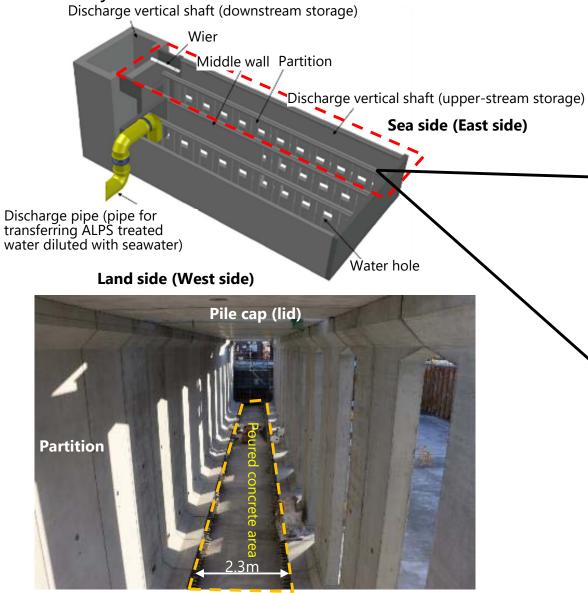
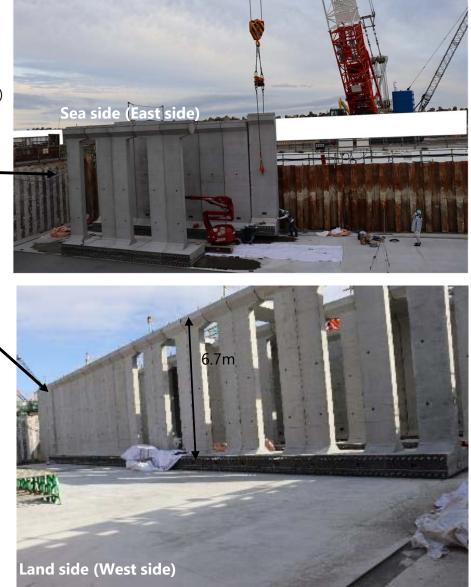
- Dilution facility: Discharge vertical shaft (upper-stream storage)
 - The installation and assembly of the block (manufactured outside of the premises) was started on January 12.

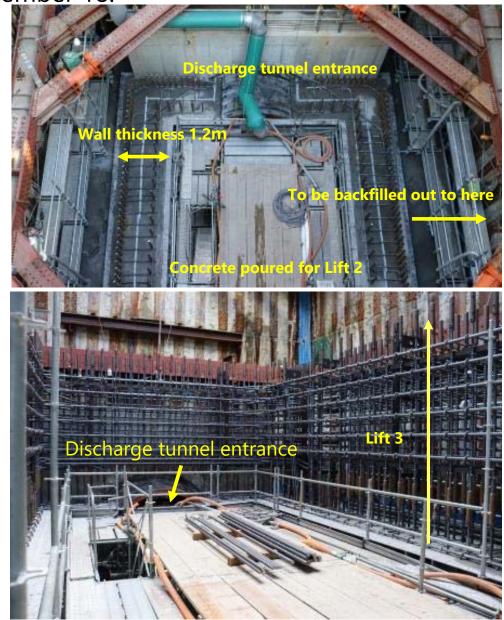
Discharge facility: Discharge vertical shaft (down-stream storage) Construction of the frame was started on December 18.

[Discharge facility] Down-stream storage: Frame building 2 out of 8 lifts complete Height Lift 1 : 1.2m <as of Jan. 20> Lifts 2 through 6 : 2.7m Lift 7:1.8m 10200 7000 Lift 8:2.0m 4600 ▼TP+4,500 8128 Lift 8 ±0=TP+P.5 7928 Lift 7 6.928 Lift 6 VTP-2.620v VTP-3.000 5974 Lift 5 Lift 4 4975 VTP-6.600 21100 22100 Lift 3 Being built 3978 Lift 2 2976 Lift 1 1978 **∀TP-14.000** ΔTF=14.400 Completed VTP-19.60 Backfilled with slurry (lean-mixed concrete)

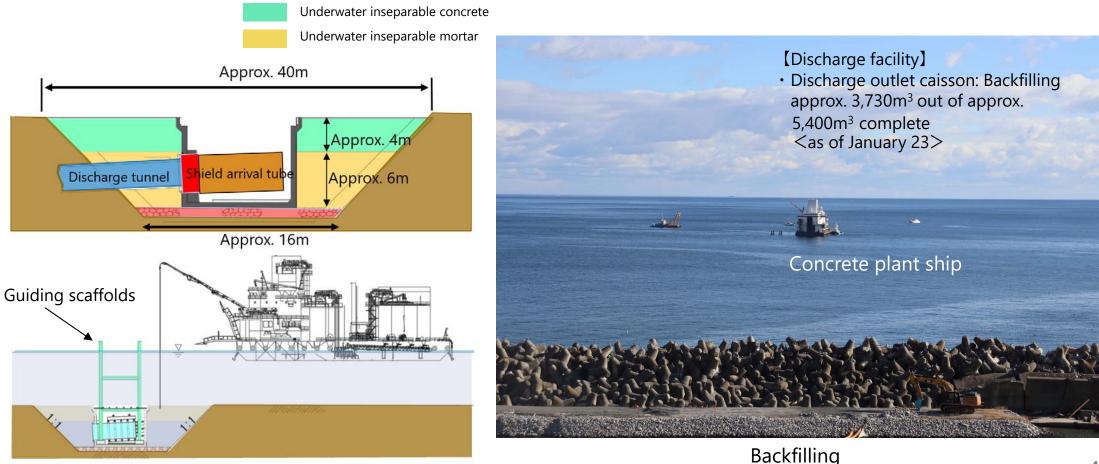
Cross section figure for back filling work

Underwater inseparable mortar (area where the shield machine passes) and underwater inseparable concrete will be poured in the area around the discharge outlet caisson. The pouring of underwater inseparable mortar started on December 8 and was completed on January 7. The underwater inseparable concrete is currently being poured. Once the area is backfilled, the temporary guiding scaffolds equipped with the caisson (see diagram on the bottom left) will be removed.

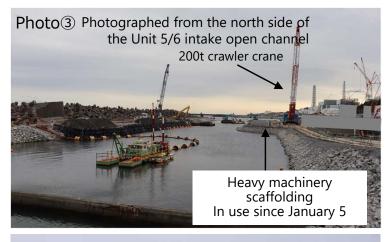
Photo ④ Building the partition weir

Other (building a partition weir, etc.) In the Units 5 and 6 sea-side construction area, the heavy machinery scaffolding was completed on December 29. The scaffolding has been in use for building the upper-stream storage since January 5. The removal of silt from the open intake channel (dredging) and the building of the partition weir are being done simultaneously. Once the partition weir is complete, the permeation prevention wall will be removed.

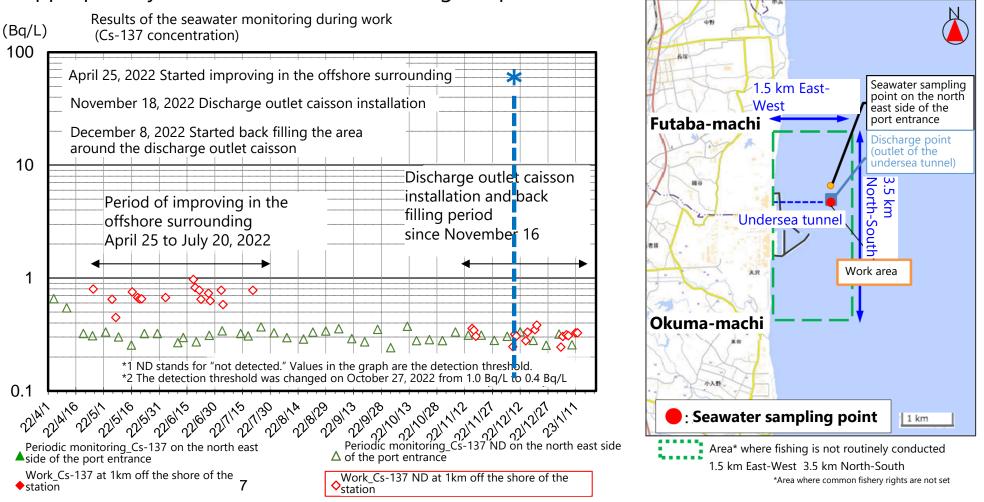
Seawater was sampled during the discharge outlet caisson installation, etc. *1 conducted offshore, and results confirmed that cesium concentration had not risen due to the work.

Cesium up to the most recent samples taken January 12, 2023 have not been detected (ND) and there have been no significant fluctuations in seawater cesium concentrations. We will continue to appropriately monitor the seawater during the plant offshore work.

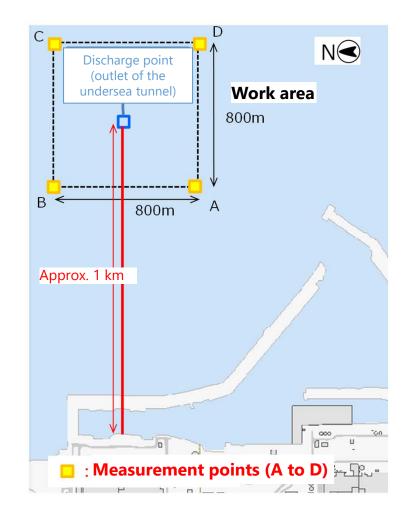
Turbidity measurements were taken using a turbidity meter at four locations at the work area boundary during the discharge outlet caisson installation, etc. *1 conducted offshore, and results confirmed that turbidity had not increased due to the work outside of the work area. *1 Discharge outlet caisson installation, work to remove the seabed sediment before installation

The turbidity measurements taken until January 12, 2023 were all below the control value*2. Visual inspection of turbidity has found that turbidity had not increased due to the work outside of the work area. We will continue to measure turbidity during the plant offshore work appropriately.

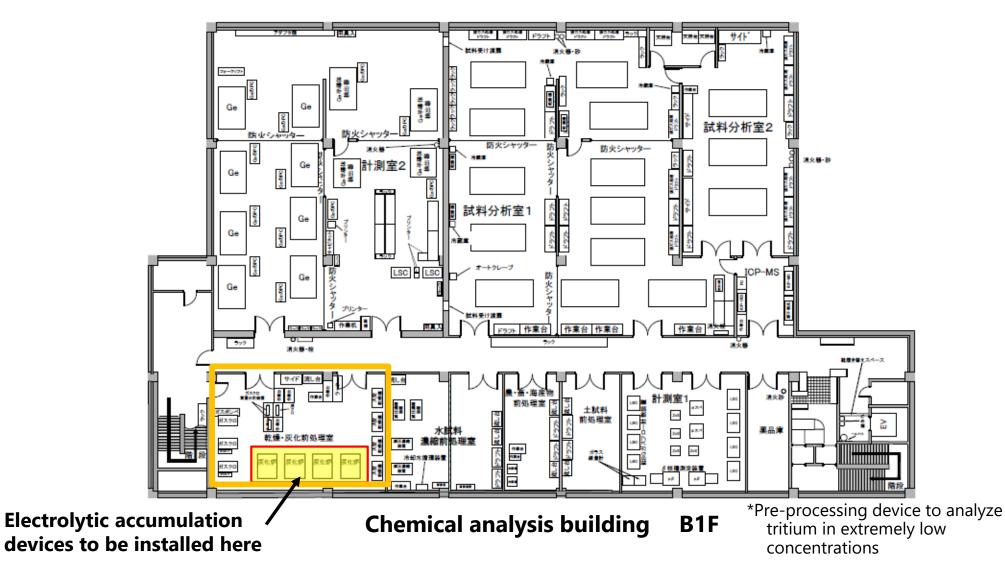
- The four incinerators in the drying and incineration pre-processing room in the chemical analysis building were removed to install the electrolytic accumulation devices*.
- 8 electrolytic accumulation devices have been delivered to the site as of December 2022. Their operation will start by March 2023 after accumulation tests.

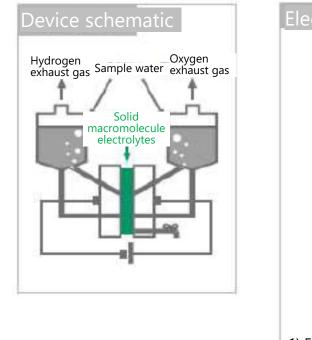
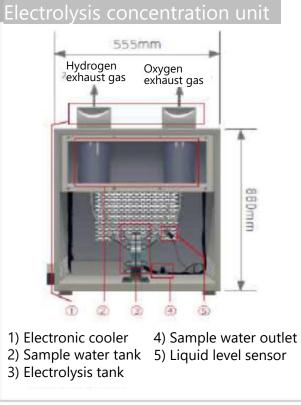
- To detect tritium that may exist in background levels in surface seawater, the tritium needs to be concentrated through electrolysis of the water*.
- The number of days required for analysis takes a month to 45 days more because of the electrolysis but this allows measurement with a lower detection limit.
- This method will be introduced in tritium analysis conducted at Fukushima Daiichi NPS (analysis of free water tritium in marine organisms).

Water releases hydrogen and oxygen gas through electrolysis. The reaction rate of becoming hydrogen gas is as follows: $^{1}H > ^{2}H > ^{3}H$ (tritium)

This means that tritium water is less easily electrolyzed. Tritium is concentrated through electrolysis using this characteristic.

- It can concentrate 1,000 mL of distilled sample water to 50 mL with around 60 hours.
- Hydrogen and oxygen are released as the electrolysis products.

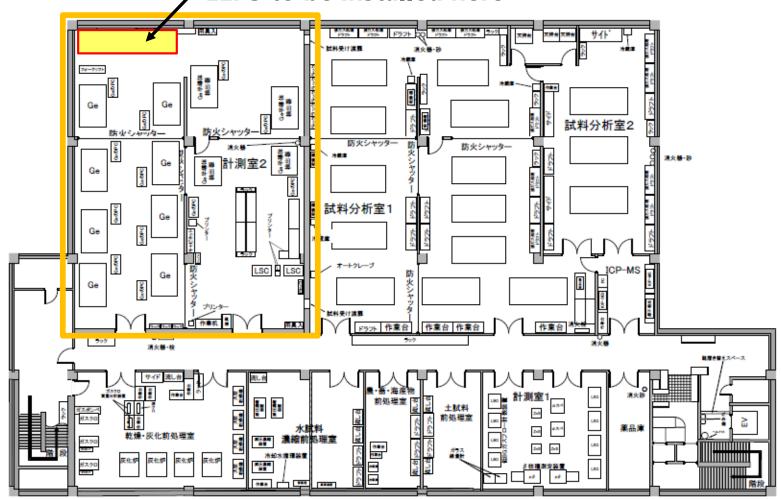
Chemical analysis building B1F

A low-energy photon germanium semiconductor detector (LEPS) will be installed in the measurement room in the chemical analysis building. Set up of two LEPS was completed in December 2022, and the operation will start by March 2023 after verification tests.

/ LEPS to be installed here

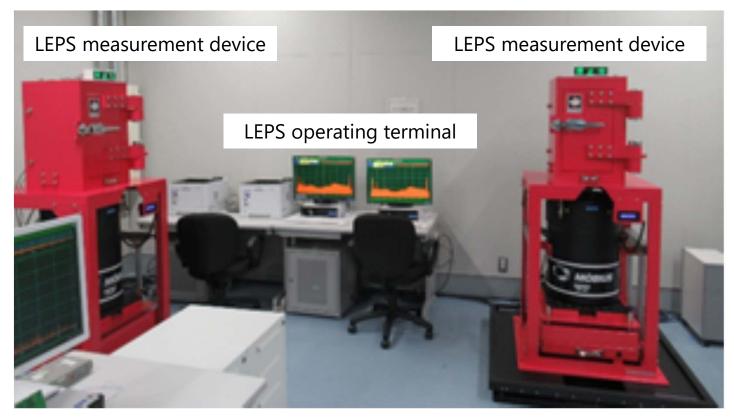
- A new type of analysis for analyzing the nuclides that emit low-energy radiation such as Fe-55 (nuclides other than the 62 nuclides subject to removal by ALPS) is required in analyzing ALPS treated water analysis.
- To conduct this nuclide analysis on Fukushima Daiichi premises, LEPSs will be installed.

LEPS (device in the chemical analysis building measurement room)

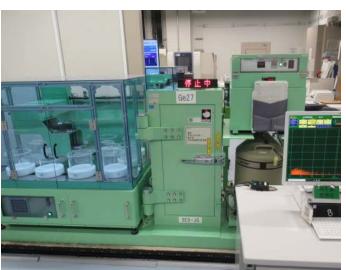
Reference: existing germanium semiconductor detector (Photo of the device in the chemical analysis building measurement room)
