Status of Progress of the installation of ALPS treated water dilution/discharge facility and related facilities

February 22, 2023

Tokyo Electric Power Company Holdings, Inc.

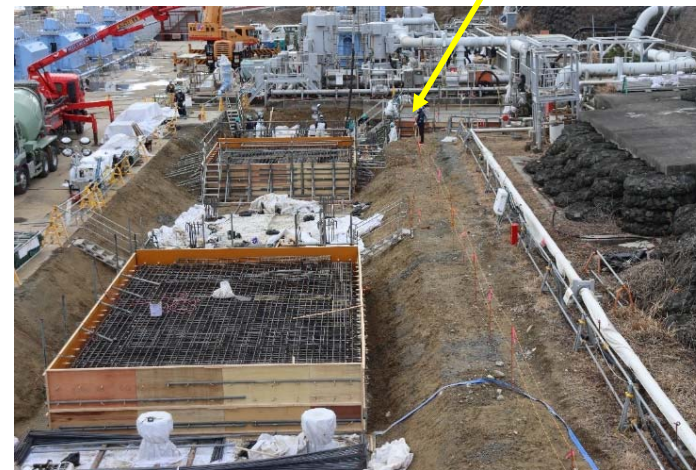
The foundation shafts for the seawater transfer pipes have been installed. The frame of the foundation is currently being built.

Building the seawater transfer pipe foundation

【 Dilution facilities 】
・ Constructing the foundation of pipe foundation
1 out of 11 complete
・ Support facility
0 out of 320 m complete
・ Pipe facility
0 out of 320 m complete
<as of February 20>

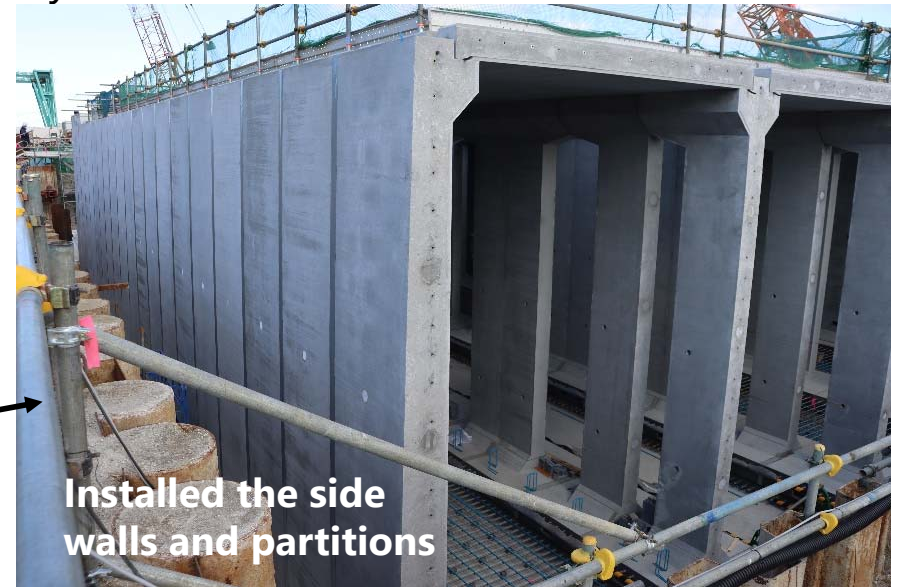
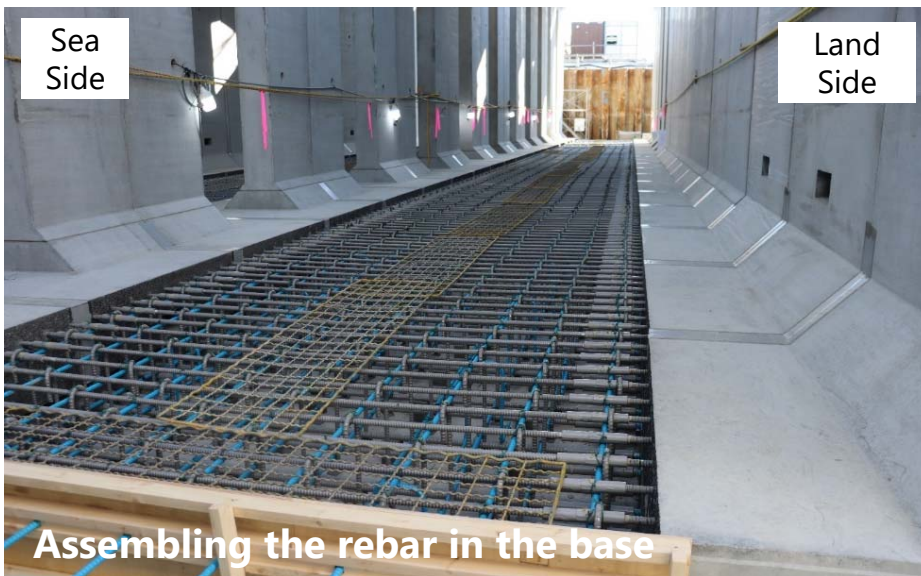
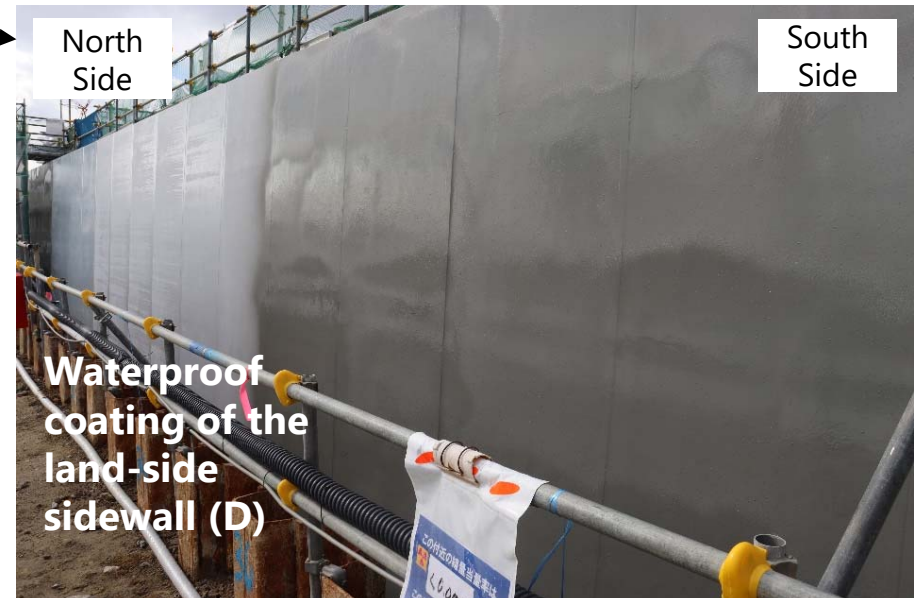
- Dilution facility: Discharge vertical shaft (upper-stream storage)
The installation and assembly of the block (manufactured outside of the premises) was started on January 12. Concrete casting for the base began on February 9.

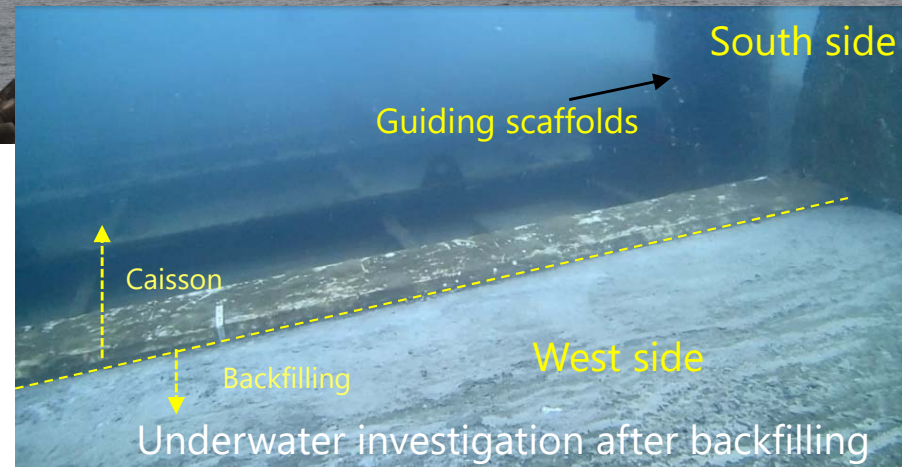
Underwater investigation after backfilling

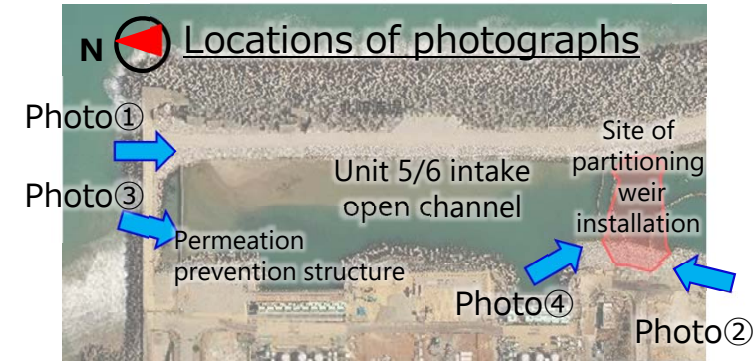
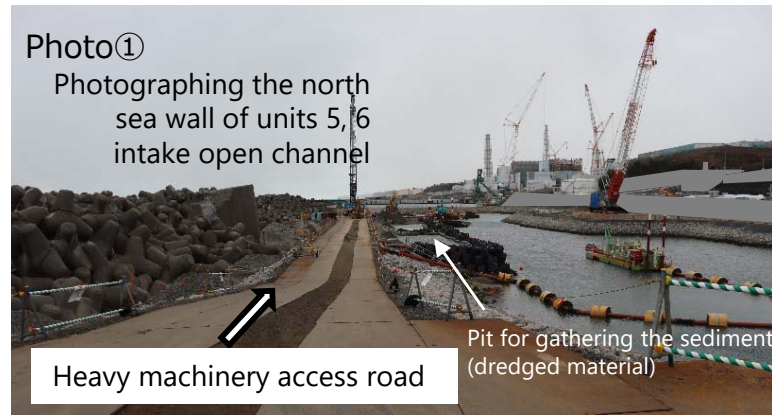
Work area on the sea side of Units 5/6

In the Units 5 and 6 sea-side construction area, the heavy machinery scaffolding was completed on December 29. The scaffolding has been in use for building the upper-stream storage since January 5. The removal of silt from the open intake channel (dredging) and the building of the partition weir are being done simultaneously. Once the partition weir is complete, the permeation prevention wall will be removed.

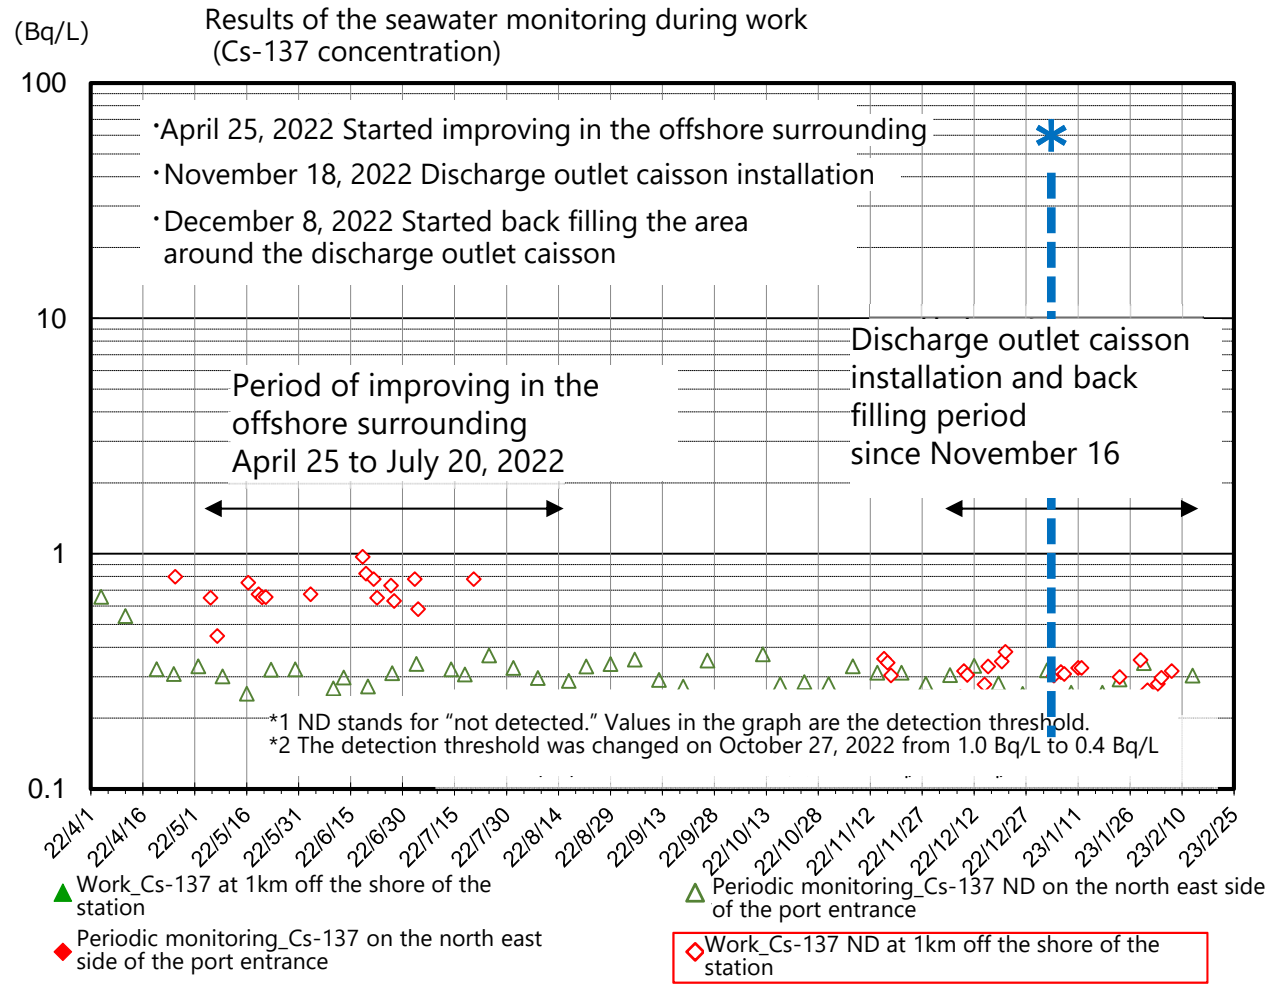
Seawater was sampled during the discharge outlet caisson installation, etc. *1 conducted offshore, and results confirmed that cesium concentration had not risen due to the work.

Cesium up to the most recent samples taken February 16, 2023 have not been detected (ND) and there have been no significant fluctuations in seawater cesium concentrations. We will continue to appropriately monitor the seawater during the plant offshore work.

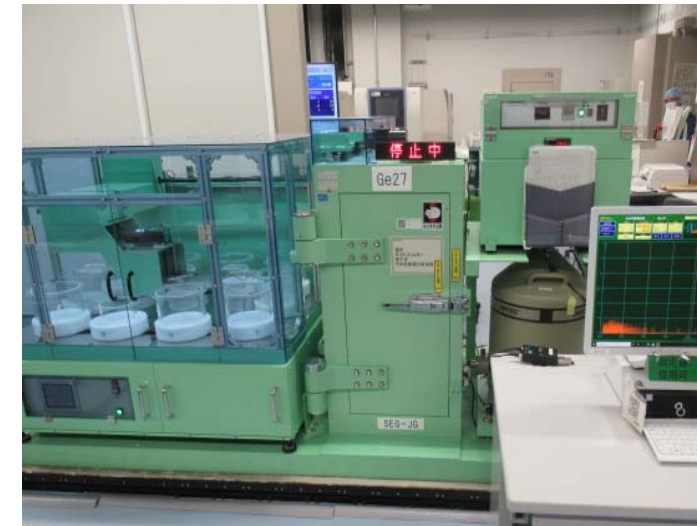
Reference: existing germanium semiconductor detector
(Photo of the device in the chemical analysis building measurement room)
