Status of Progress of the installation of ALPS treated water dilution/discharge facility and related facilities

March 30, 2023

Tokyo Electric Power Company Holdings, Inc.

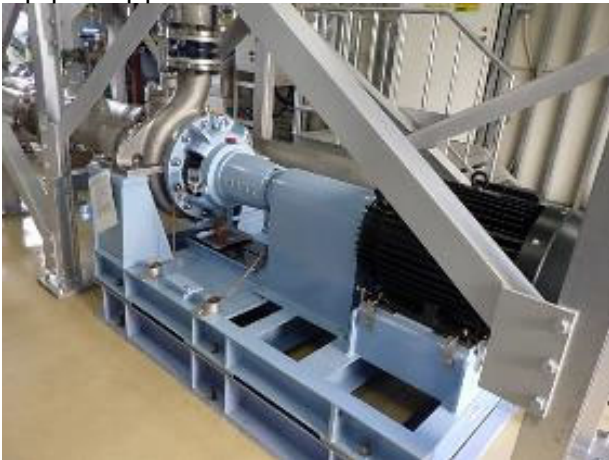
Circulation pump

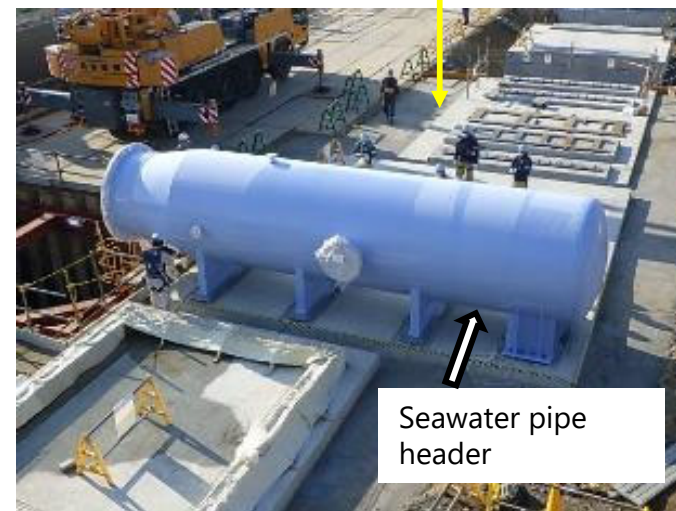
Seawater pipe header

Building the seawater transfer pipes foundation and installing the seawater pipe header

The foundation shafts for the seawater transfer pipes have been installed. The frame of the foundation is currently being built.

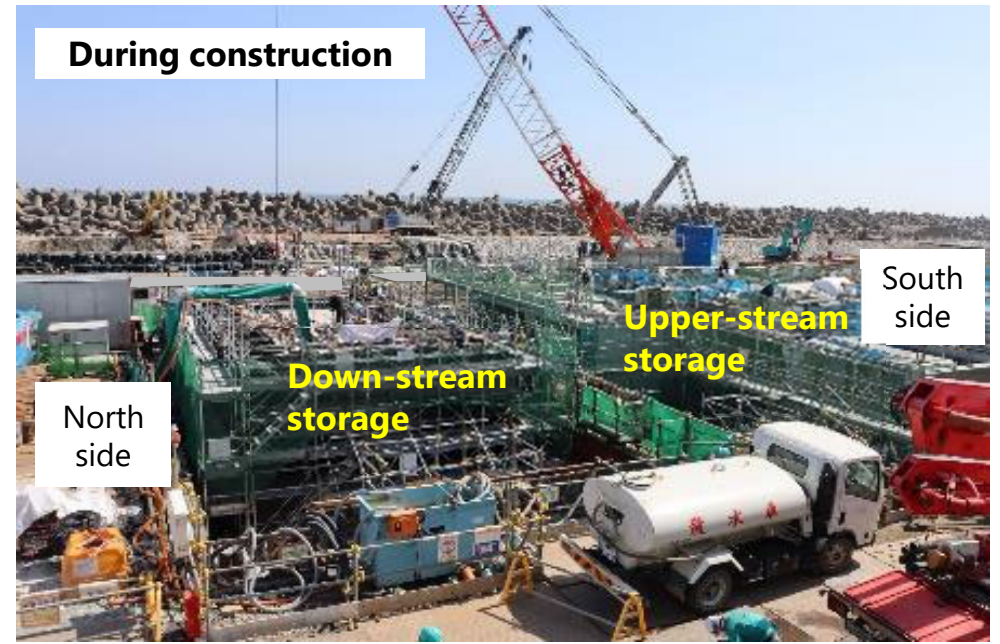
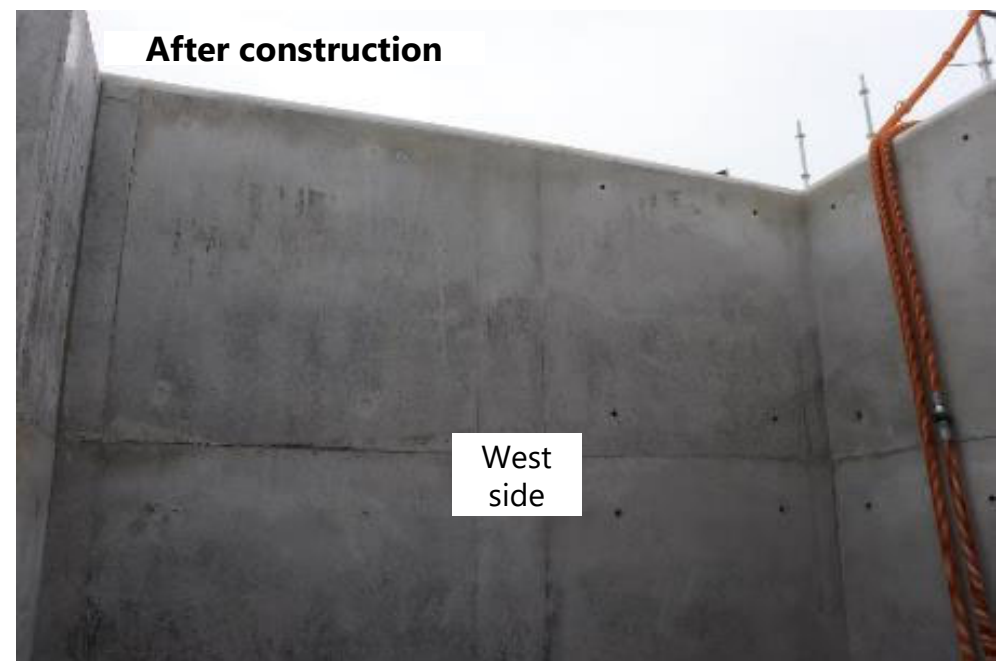
- Discharge facility: Discharge vertical shaft (down-stream storage)
Construction of the frame was started on December 18 and completed on March 23.

- Down-stream storage: Frame building
8 out of 8 lifts complete
<as of March 27>

Height
Lift 1 : 1.2m
Lifts 2 through 6 : 2.7m
Lift 7 : 1.8m
Lift 8 : 2.0m

Completed

Backfilled with slurry (lean-mixed concrete)

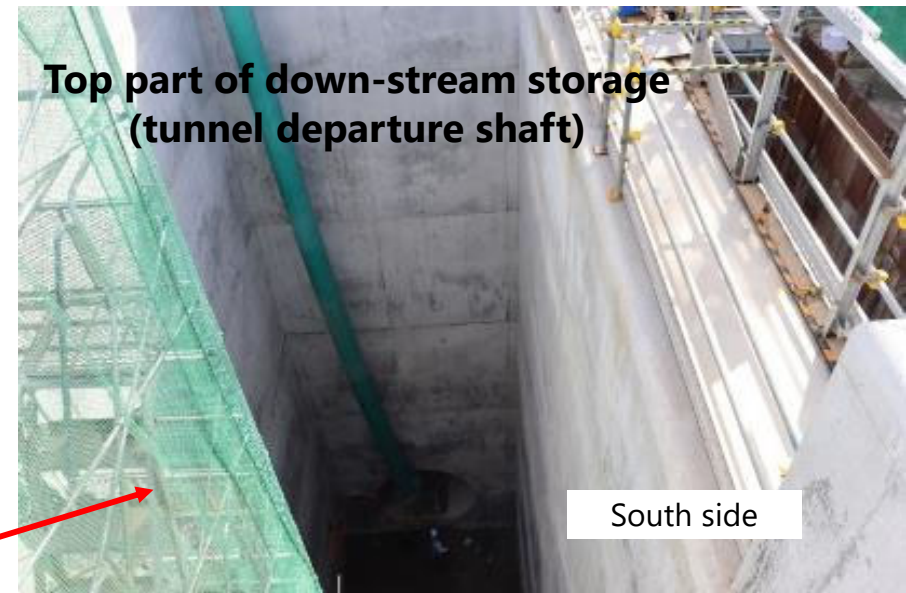
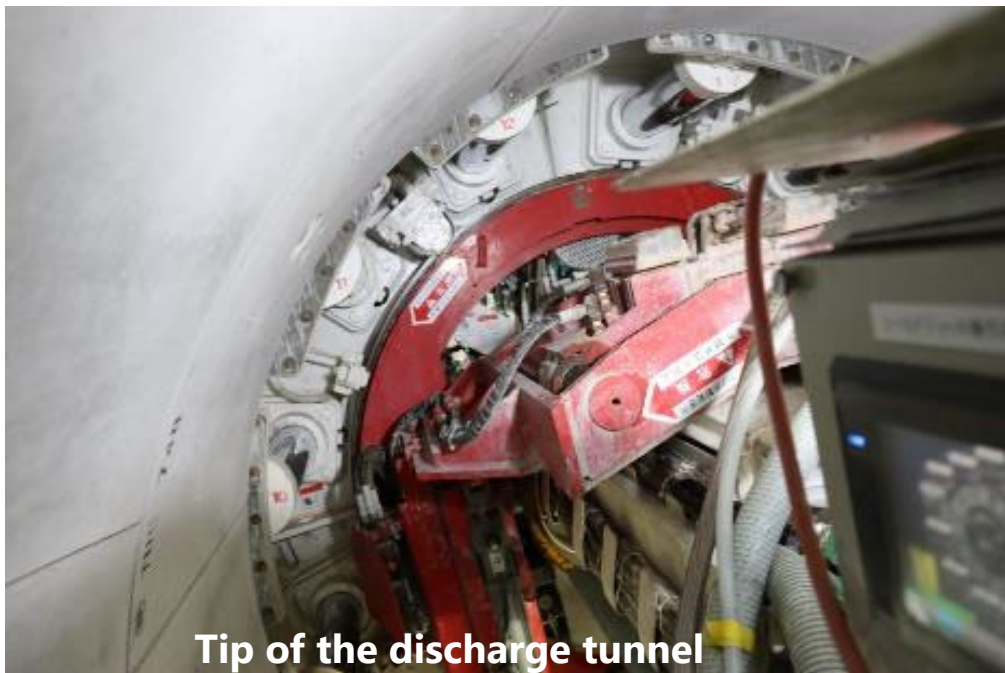
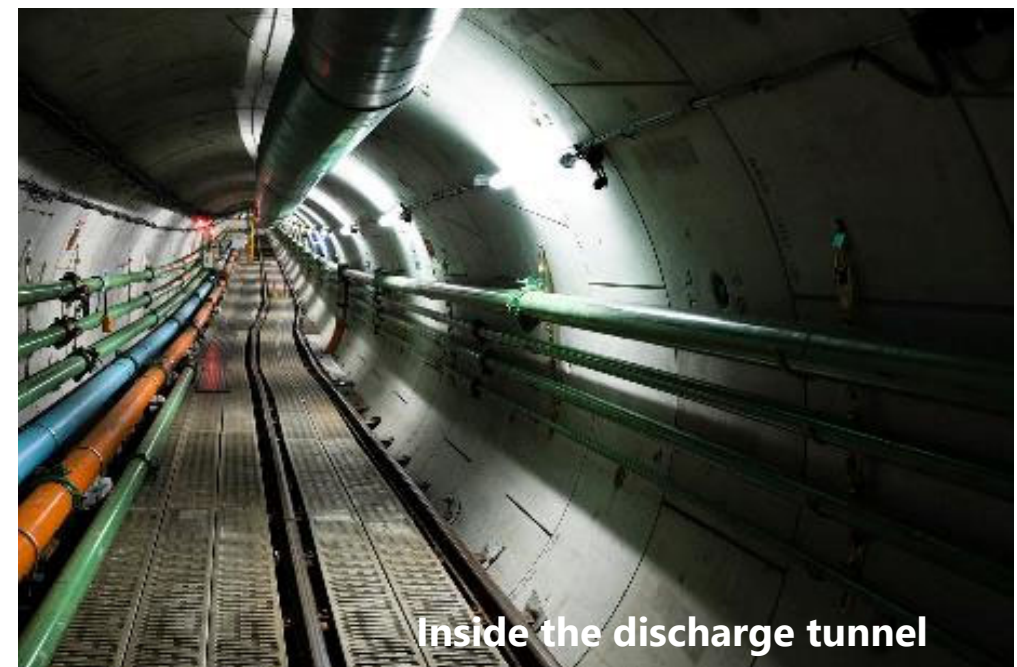
Elevator used in tunnel work

- Discharge facility: discharge tunnel
Trial operation of the shield machine will be started on April 1. If there are no problems then, excavation will be restarted.
Tunnel excavation work includes work to connect the tunnel with the discharge outlet caisson and requires care. As such, we will continue to carefully calculate the time it will take to complete the excavation work.

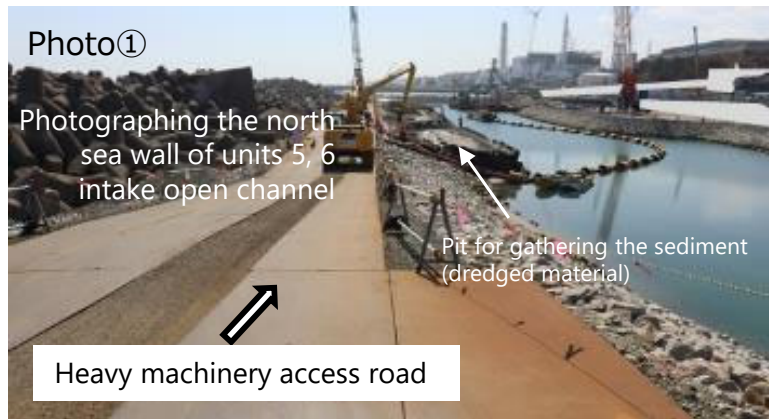
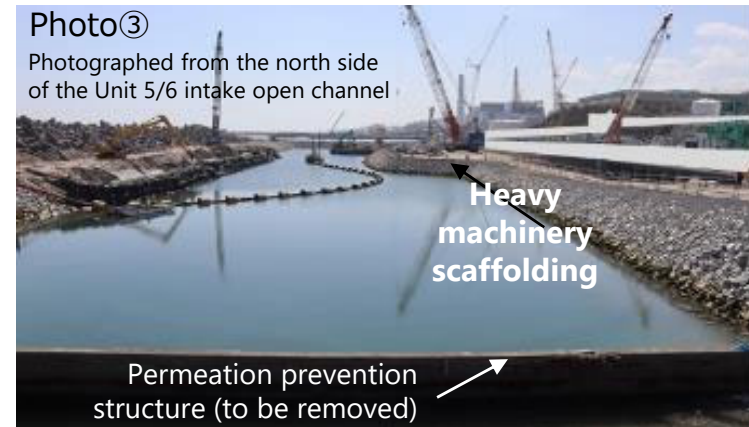
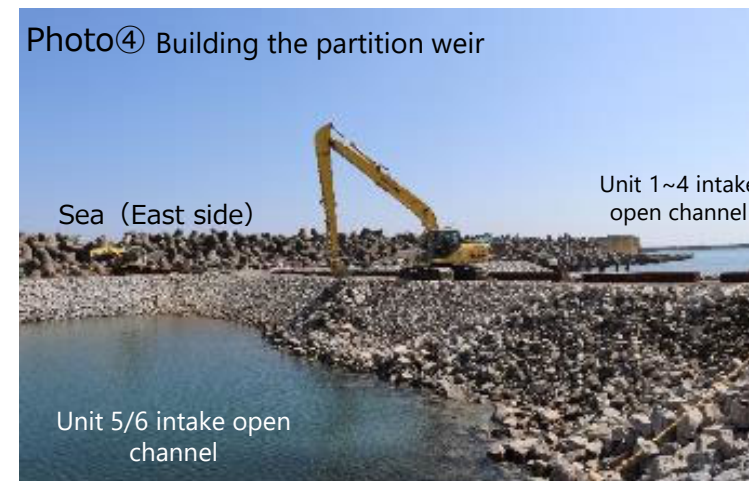
Work area on the sea side of Units 5/6

In the Units 5 and 6 sea-side construction area, the heavy machinery scaffolding was completed on December 29. The scaffolding has been in use for building the upper-stream storage since January 5. The removal of silt from the open intake channel (dredging) and the building of the partition weir are being done simultaneously. Once the partition weir is complete, the permeation prevention wall will be removed.

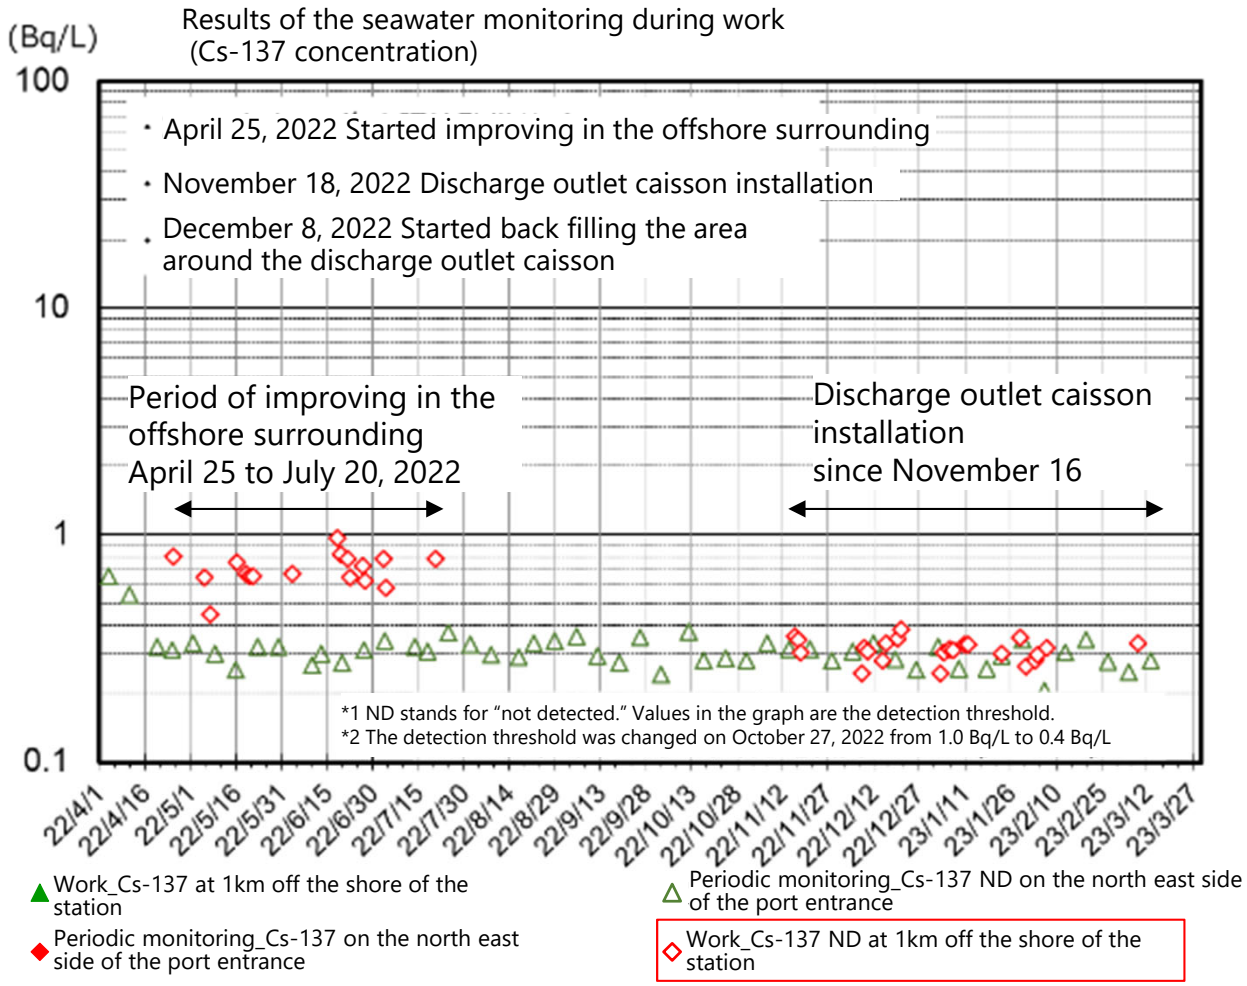
Cesium up to the most recent samples taken March 27, 2023 have not been detected (ND) and there have been no significant fluctuations in seawater cesium concentrations. We will continue to appropriately monitor the seawater during the plant offshore work.

Area* where fishing is not routinely conducted
 1.5 km East-West 3.5 km North-South

Seawater was sampled during the discharge outlet caisson installation, etc. *¹ conducted offshore, and results confirmed that cesium concentration had not risen due to the work.

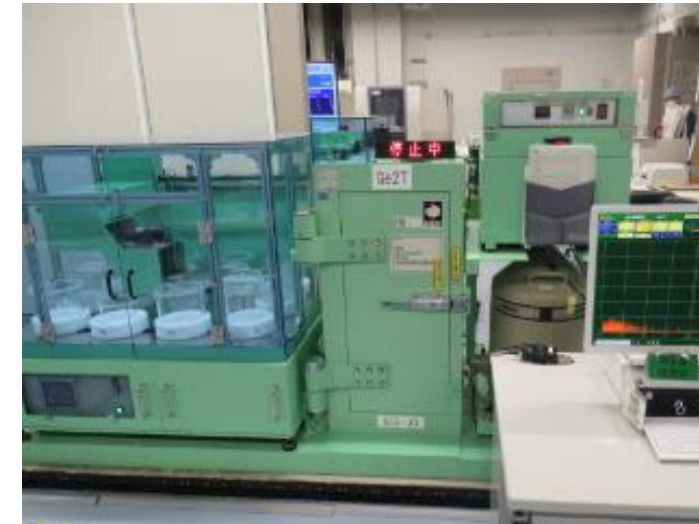
Reference: existing germanium semiconductor detector
(Photo of the device in the chemical analysis building measurement room)

LEPS
(Device in the chemical analysis building measurement room)

- Nuclide analysis for those emit low-energy radiation such Fe-55 (nuclides other than the 62 nuclides subject to removal by ALPS) is required in ALPS treated water analysis.
- To conduct the nuclide analysis on Fukushima Daiichi premises, low-energy photon germanium semiconductor detectors (LEPS) will be newly installed.
