Fukushima Daiichi Nuclear Power Station Unit 2 PCV Internal Investigation/ Status of Fuel Debris Trial Retrieval

July 31, 2025

International Research Institute for Nuclear Decommissioning
Tokyo Electric Power Company Holdings, Inc.

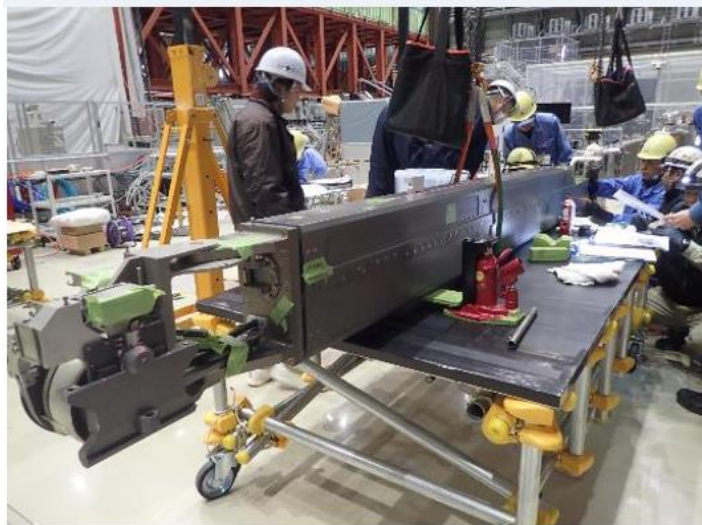
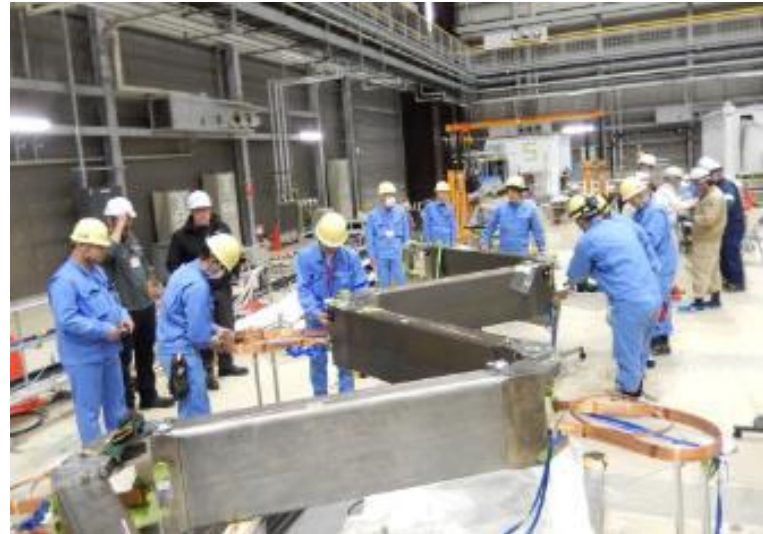
- Cables inside the robotic arm are being replaced.
- Cables inside the robotic arm are being removed and replaced with new cables after which connectors are installed (underway).

Arm maintenance/internal cable replacement

- In light of the age-related deterioration of certain components found during testing, a comprehensive inspection of all the internal cables of the robotic arm including replacement of all similar components, etc. is underway. The replacement of internal cables is currently underway.

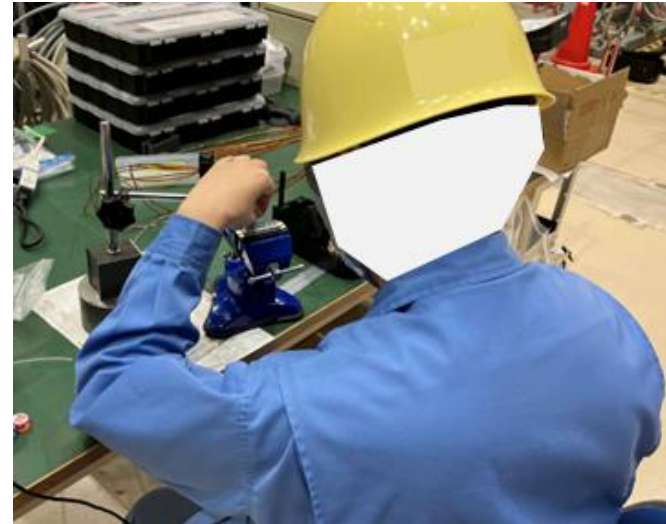
- In order to waterproof and fix the cables inside the arm and connectors connected to the motor cables, they have been put in connector cases, and after they have been soldered, the cases are being filled with resin.
- After the cables have been replaced, the arm will be assembled and movement checks performed.

Internal cable-connector treatment

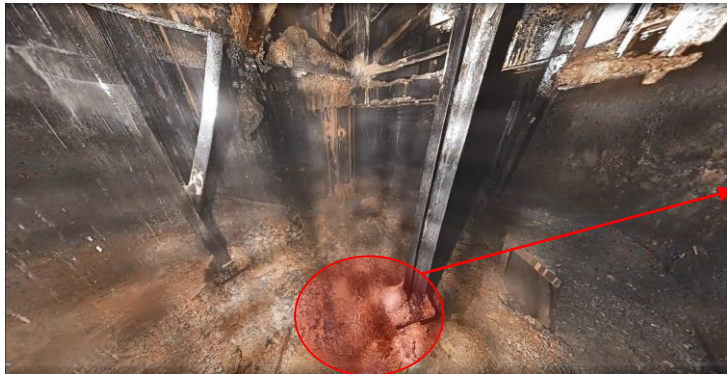
Panorama photo of the bottom of the pedestal

※ Camera images have been stitched together
