Fukushima Daiichi Nuclear Power Station Unit 1 Progress of Fuel Removal from Spent Fuel Pool

September 25, 2025

Tokyo Electric Power Company Holdings, Inc.

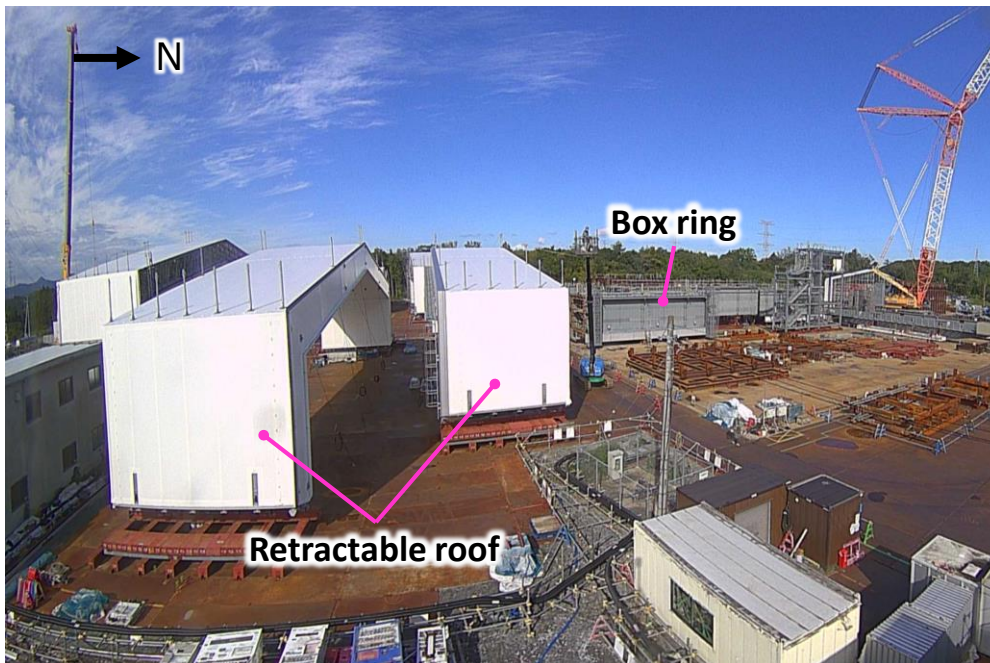
- Semi-assembly of the retractable roof completed on July 30, 2025. And the overhead crane for rubble removal is currently underway.
 - Retractable roof : 7/8 blocks completed (Previous performance + 2 blocks)

Off-site west gate yard (photographed on September 19, 2025)

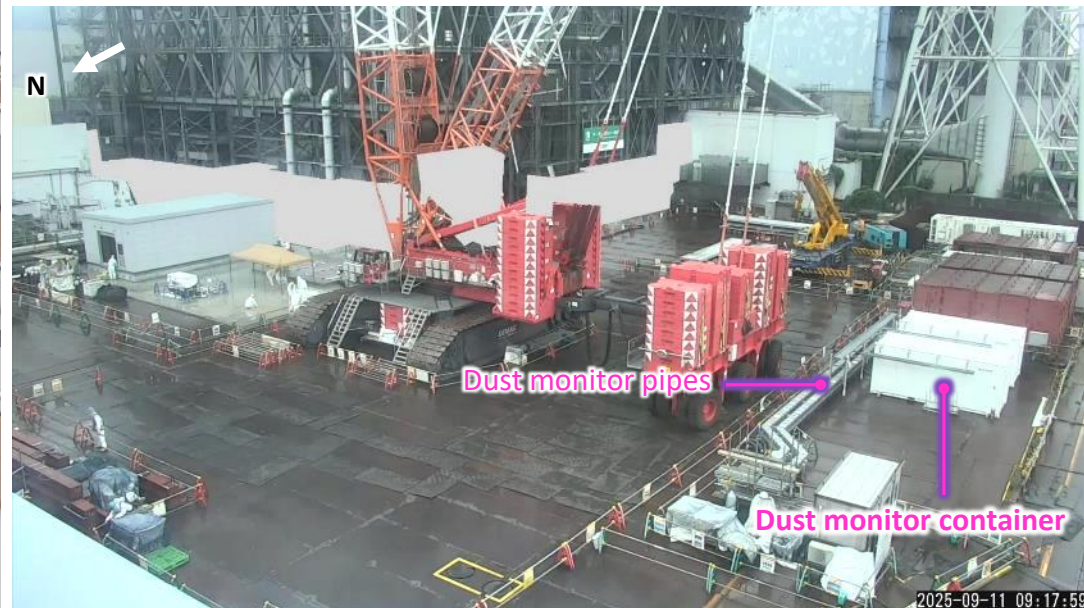
Unit 1 Reactor Building NW Yard (photographed on September 11, 2025)

- Dust radiation monitor (hereinafter referred to as, “dust monitors”) container installation began on July 15, 2025. Dust monitor container installation was completed on July 16, 2025. Dust radiation monitor pipe laying is underway
 - Dust monitor pipe laying: 420m/1600m completed
