Fukushima Daiichi Nuclear Power Station Unit 3 PCV Internal Investigation (non-submerged area) using a Micro-drone

September 25, 2025

Tokyo Electric Power Company Holdings, Inc.

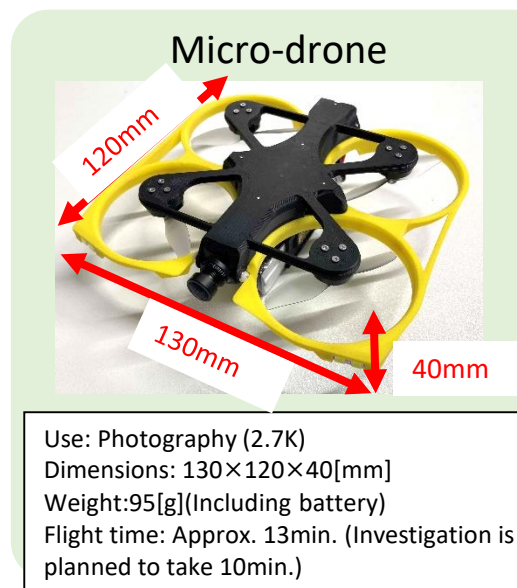
Concept diagram of Unit 3 micro-drone investigation

- Therefore, the investigation devices that have proved successful at other units cannot be used and a new larger diameter access route must be constructed. However, this would require time so **our current plan is to conduct a PCV internal investigation using a small "micro-drone."**

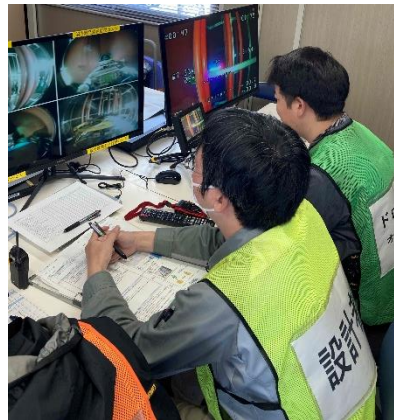
Operation of installation equipment

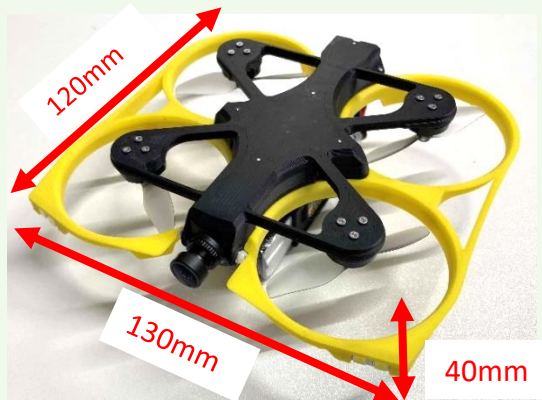
Micro-drone

Held in the palm of the hand for size comparison

Use: Photography (2.7K)
Dimensions: 130×120×40[mm]
Weight: 95[g] (Including battery)
Communications method: Radio
Flight time: Approximately 13 minutes (the investigation is planned to take 10 minutes)
Camera performance: Image quality: 2.7K, frame rate: 60fps
Angle of view: diagonal 140°, Horizontal 135°, vertical 107°
Lights: 2 LEDs on the left and right sides (total: 380lm)
Radiation resistance: 200Gy
Notes: Corresponds to IP52

- Since the area inside the PCV is cramped and dark, an extremely small and highly mobile "**micro-drone**" with photographic capabilities will be installed through the small X-53 penetration.
- As with past investigations, **a seal box will be attached to the X-53 penetration so as to allow the micro-drone to be inserted into the PCV while maintaining PCV isolation.**
- The seal box will contain a total of six drones and two drones will be able to be installed inside the PCV simultaneously (how the six drones are to be used will be determined during mockup/training).
