Fukushima Daiichi Nuclear Power Station Units 1 and 2 Progress of Fuel Removal from Spent Fuel Pools

January 29, 2026

Tokyo Electric Power Company Holdings, Inc.

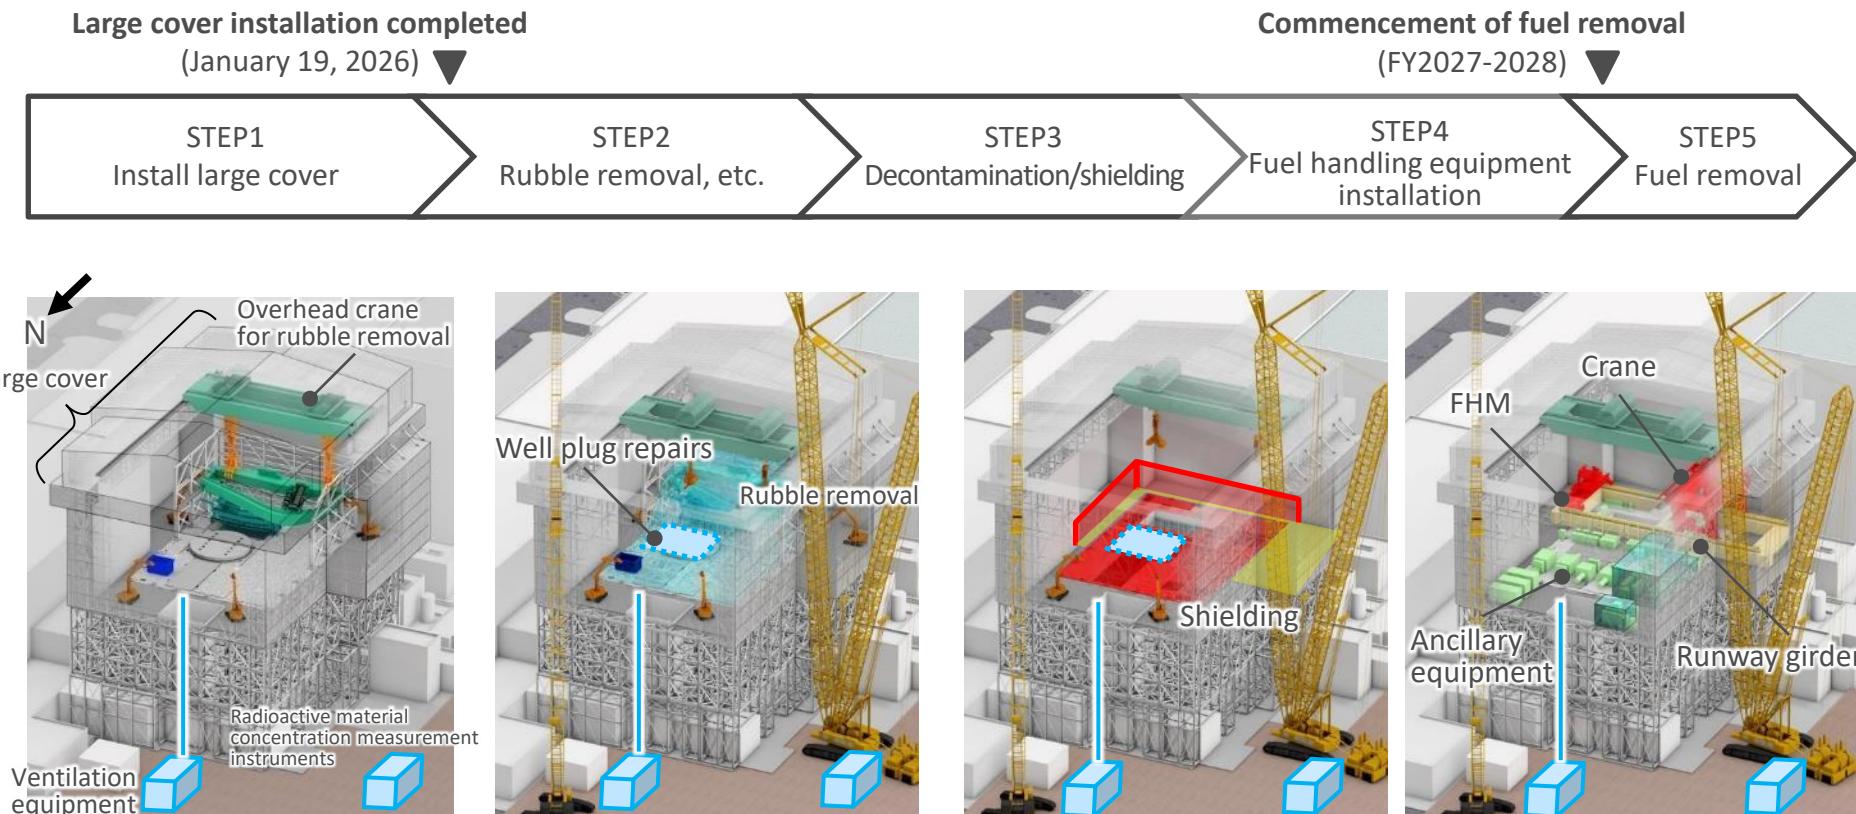
- Prior to fuel removal, a large cover that encompasses the entire reactor building is built, rubble removed from under the large cover, the operating floor decontaminated/shielded, and fuel handling equipment (fuel handling machine (FHM) and crane) installed.

※These are just concept diagrams and actual location may differ.

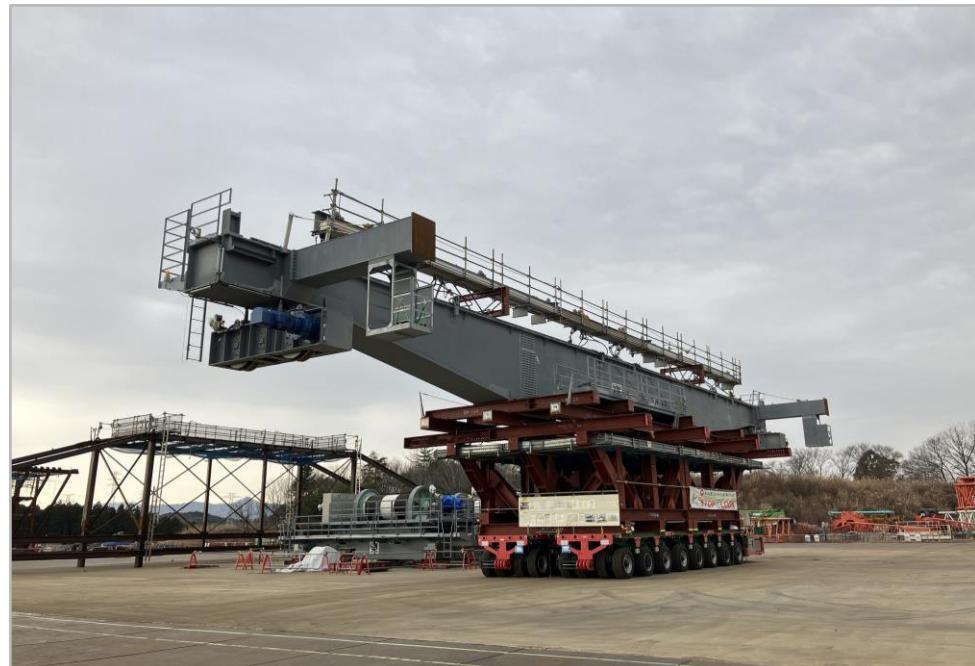
The rubble removal overhead crane loaded onto the super carrier
(Photographed on January 19, 2026)

- Pre-assembly in the off-site west gate yard has been completed, and preparations are underway to move the overhead crane to be used for rubble removal.

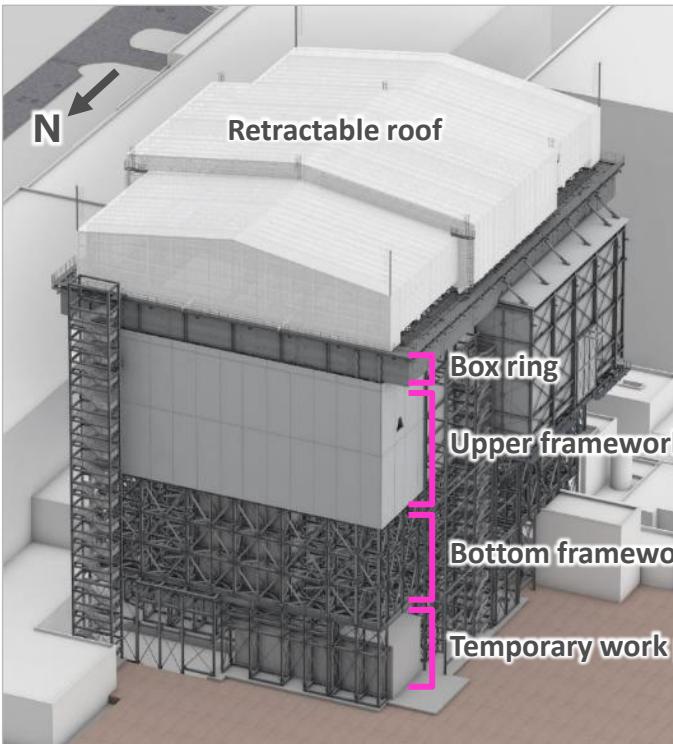
Diagram of the entire large cover

- Transport and installation of retractable roof (block 6/6) was completed on January 13, 2026.
- A function check of the retractable roof was performed on January 19, 2026, thereby marking completion of large cover installation.
- Transport and installation of the components for the overhead crane to be used for rubble removal (block 2/4) was completed on January 22, 2026.

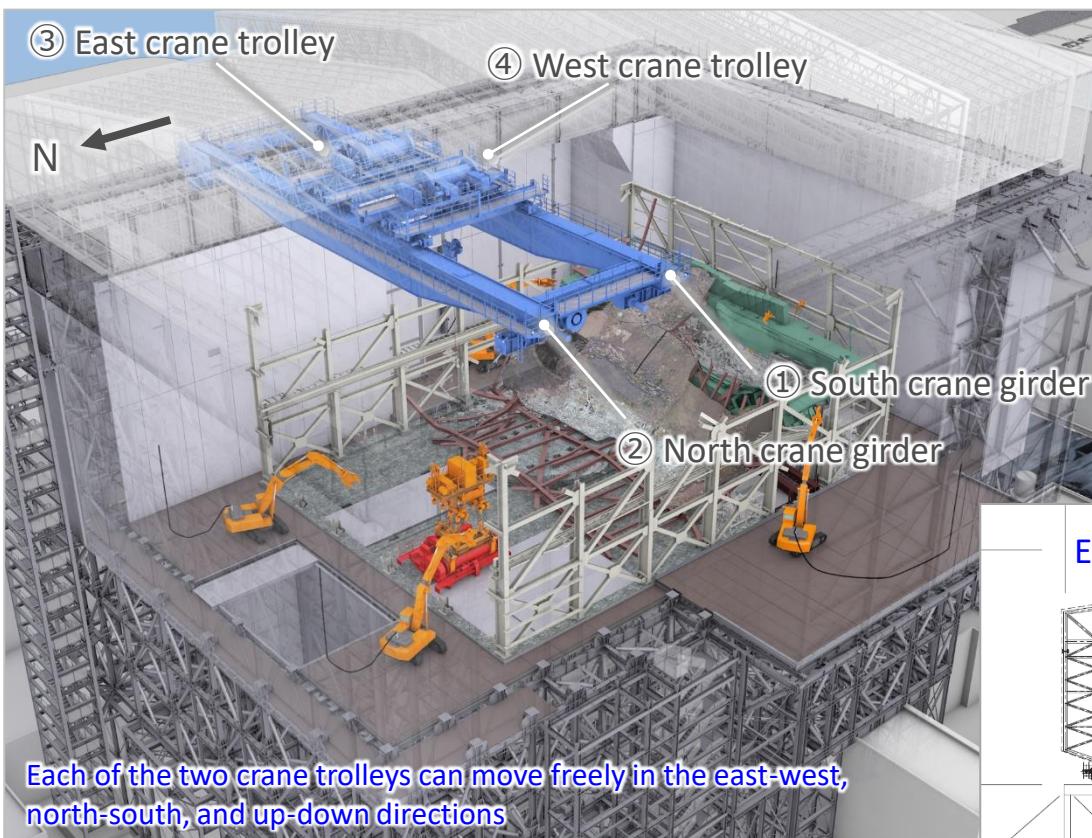
Image diagram of after installation of the rubble removal overhead crane

- A rubble removal overhead crane (overhead crane) will be installed after installation of the retractable roof.
- The overhead crane is comprised of four components; two crane girder blocks and two crane trolley blocks. Each of these blocks will be transported and installed separately.
- After installation and test operation/adjustments, a final inspection will be performed around the middle of February.

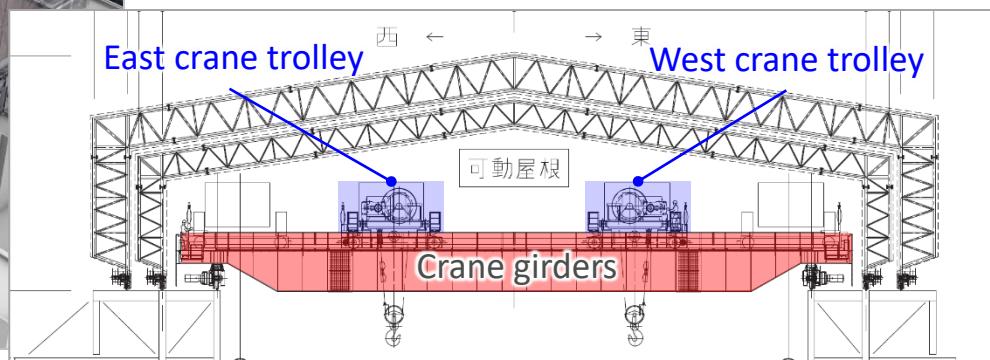
Elevation drawing of the rubble removal overhead crane

Planned date of transport and installation
① South crane girder	January 20 (completed)
② North crane girder	January 22 (completed)
③ East crane trolley	January 29
④ West crane trolley	January 30

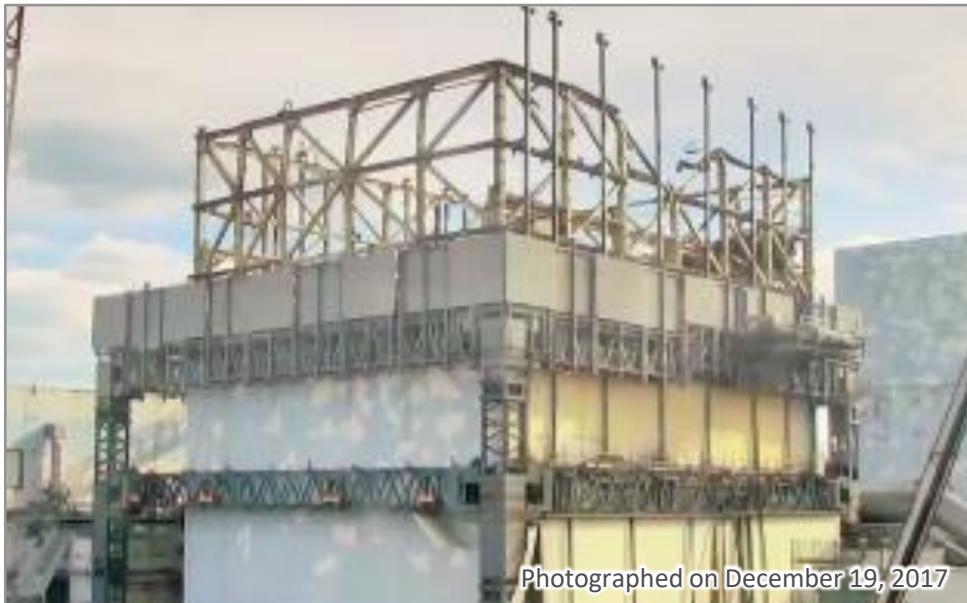
Unit 1 reactor building prior to cover installation

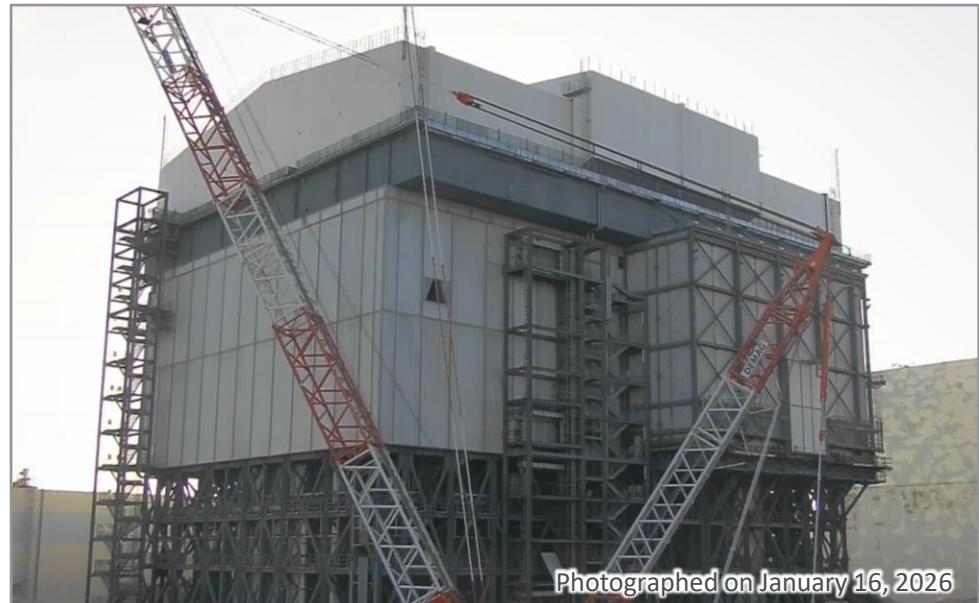
Current Unit 1 reactor building

- Large cover construction was completed on January 19, 2026.
We will continue with rubble removal, overhead crane installation and ancillary work, such as ventilation equipment installation.
- On January 15 we also began an investigation of the floor on the north side of the operating floor by using cameras to examine the conditions there.

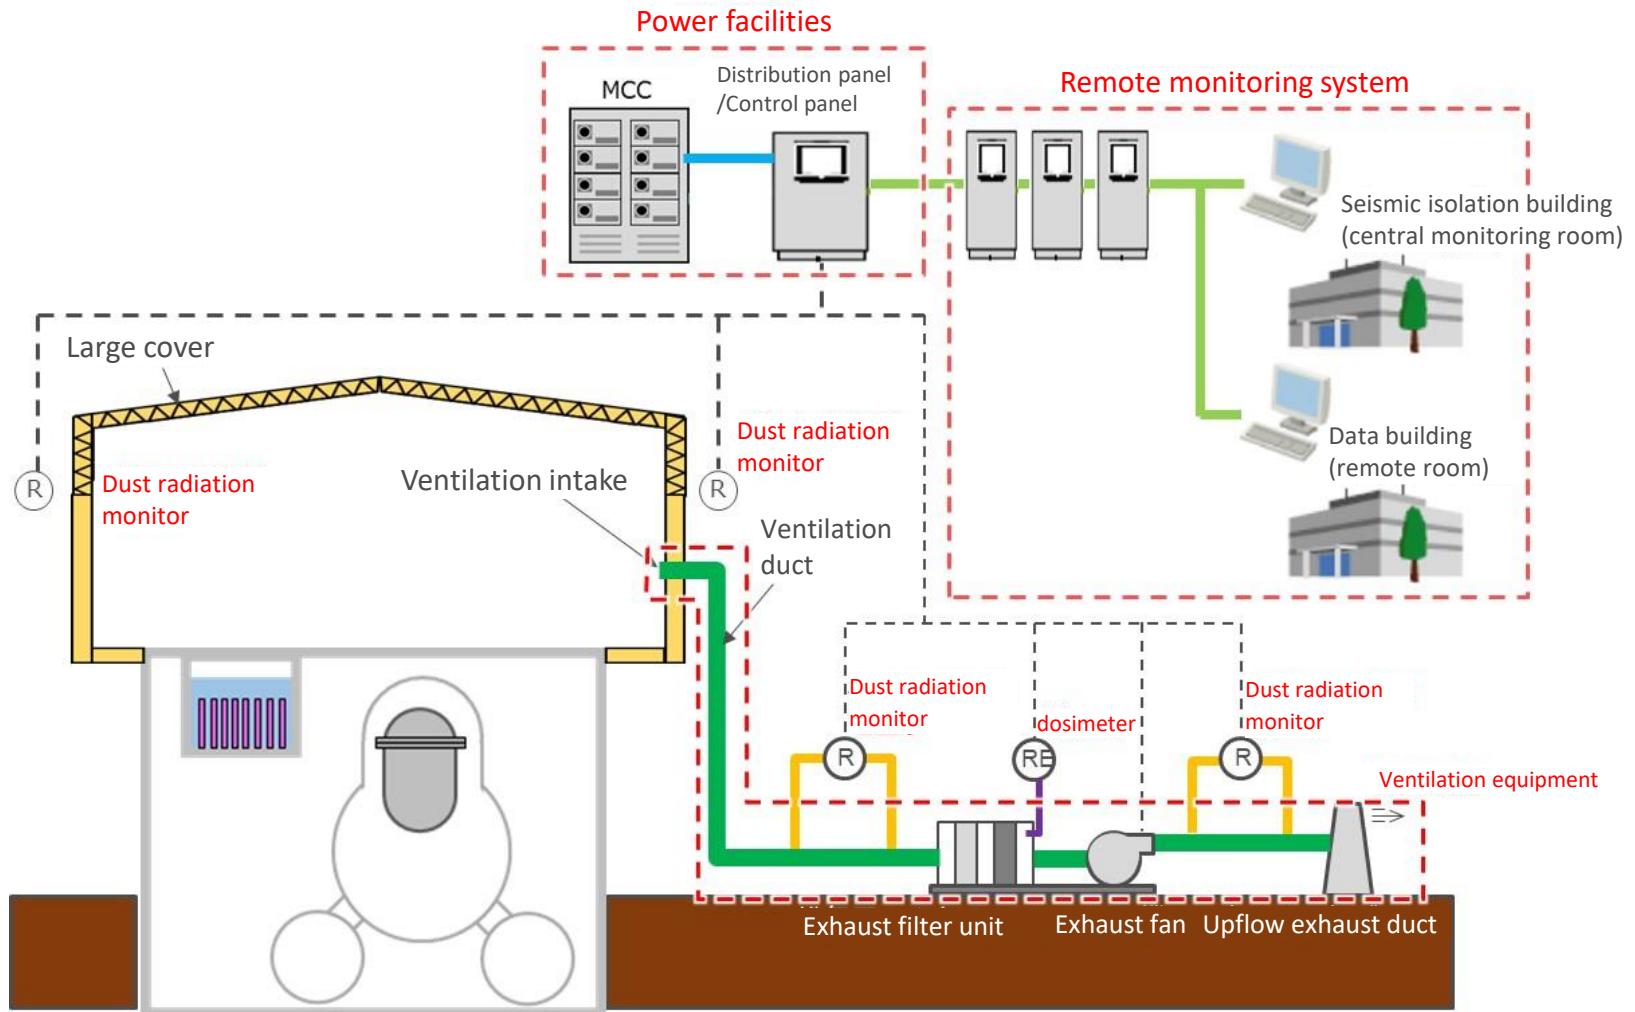
Configuration image of large cover ancillary equipment

- After installation of the large cover, large cover ancillary equipment will be installed to remove rubble, etc.
- Large cover ancillary equipment include ventilation equipment, and dust radiation monitors, etc.

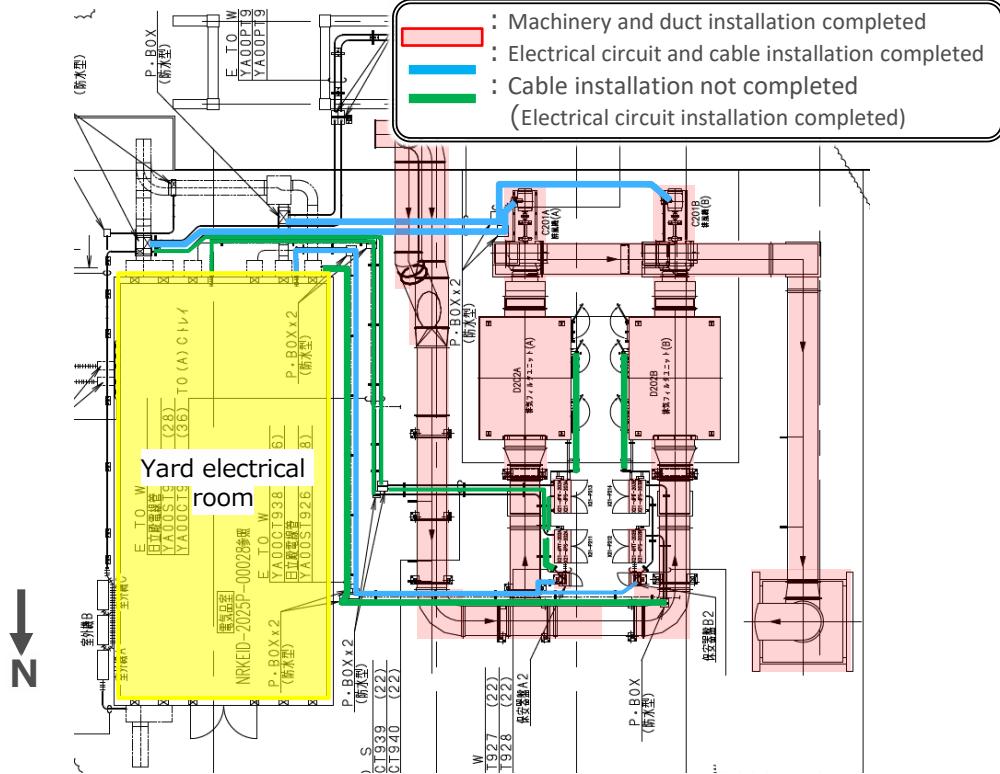
Ventilation facilities progress: floor plan

- Foundation bolt installation began on July 22, 2025. Installation of these foundation bolts was completed on November 17, 2025, and installation of the filter unit (unit 2/2) was completed on December 12. Currently, the duct, duct support and cable installation work is underway.

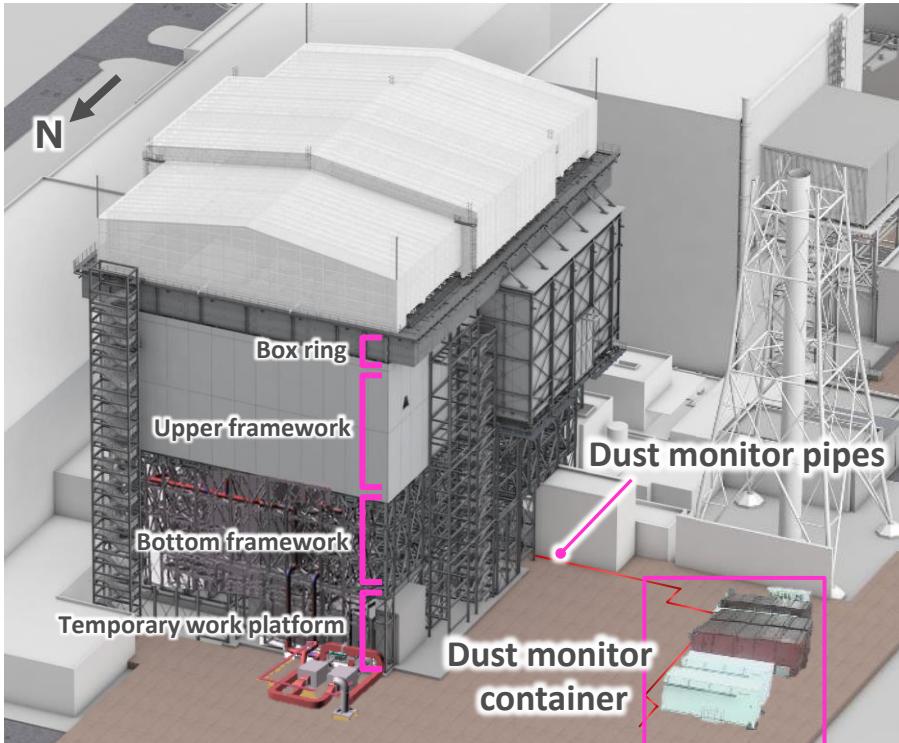
Diagram of large cover ancillary facilities

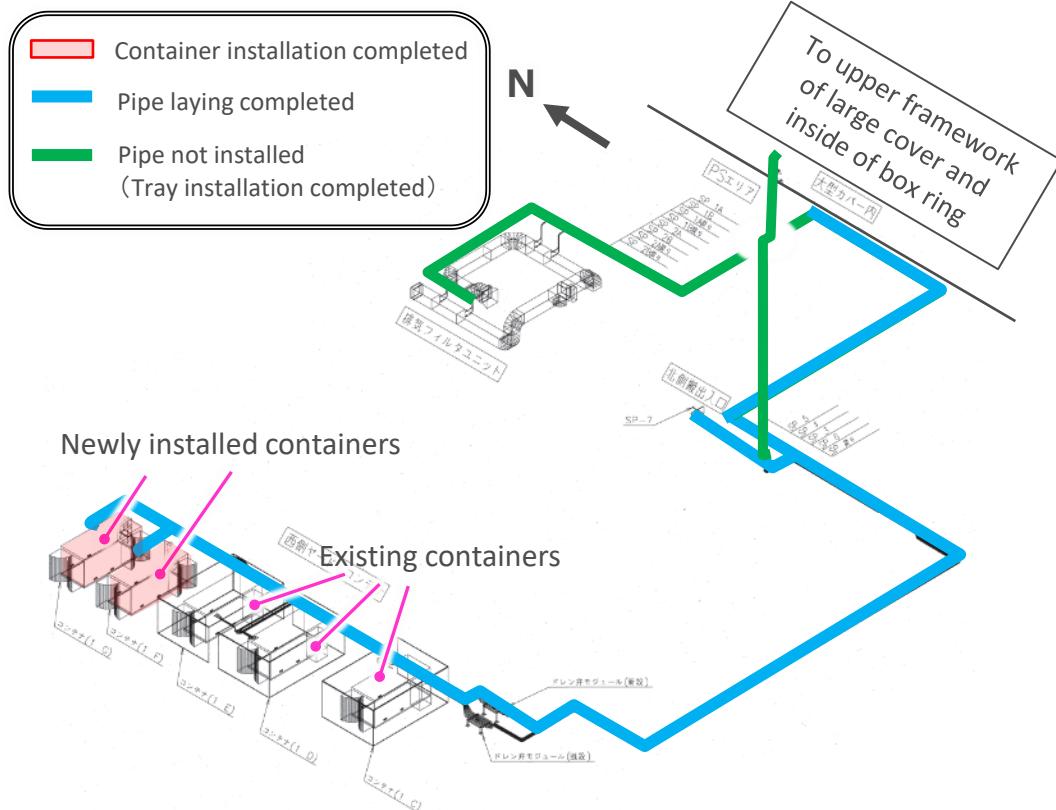
Dust monitor pipe progress: Bird's eye view

- Dust radiation monitor (dust monitors) container installation began on July 15, 2025. Dust monitor container installation was completed on July 16, 2025, and installation of terminals in the seismic isolation building and information wing were completed on December 18. Currently, dust monitor pipe and cable laying are underway.

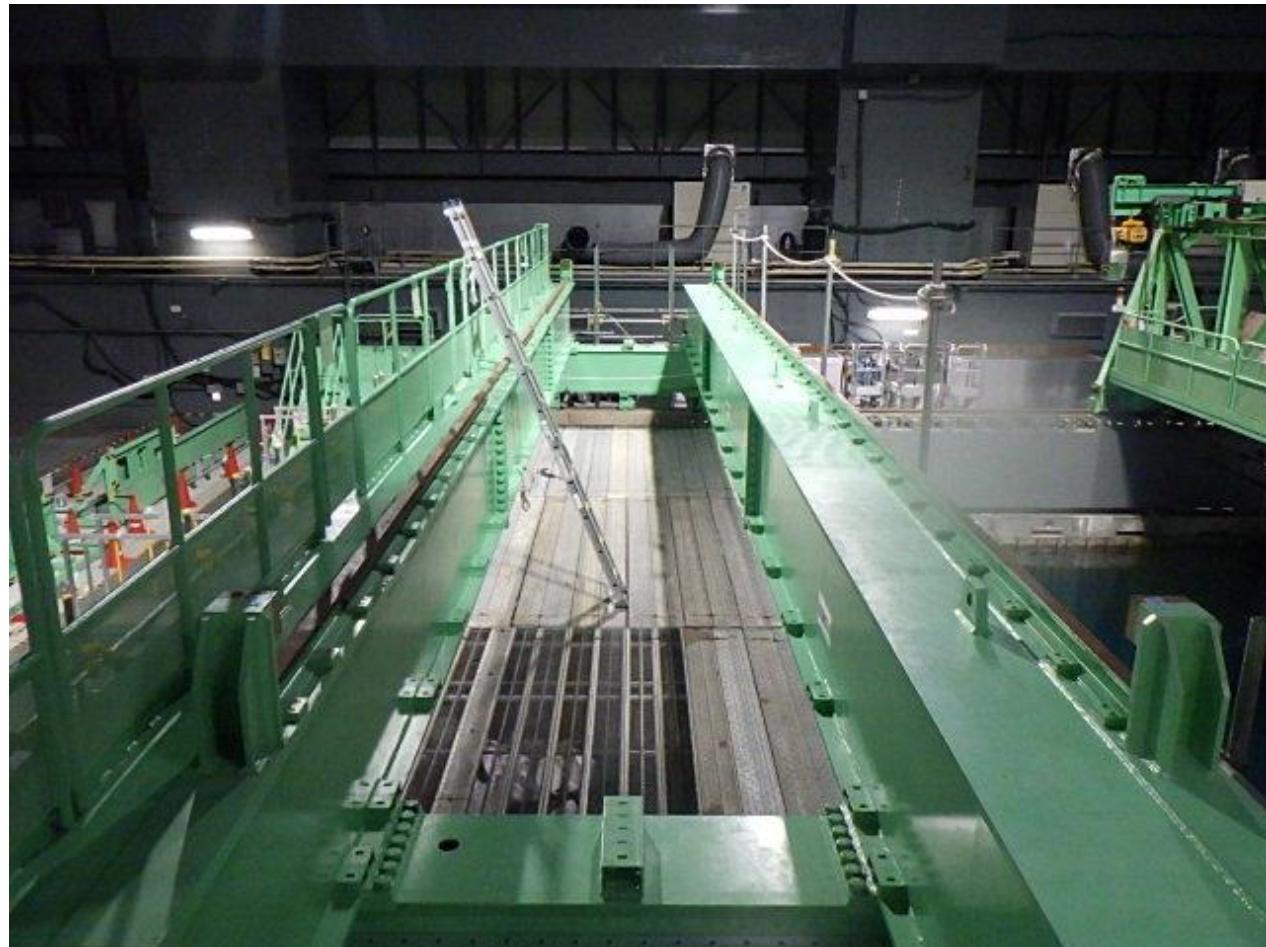
After removal of the platform/gallery
(Photographed on January 14, 2026)

- On November 4, 2025 we began disassembling the Unit 4 fuel handling machine for transport and to date we have completed removal of the platform/gallery.
- We will complete transporting all of the parts and materials to the factory during FY2025.

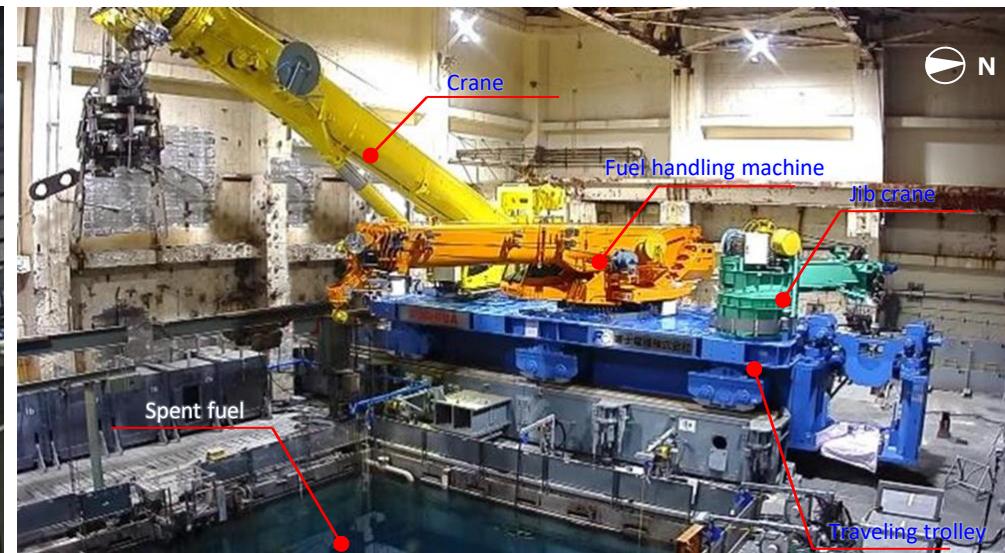
Entire fuel handling equipment inside the reactor building
(photographed with a remotely operated camera)
(Photographed on December 6, 2025)

- A fuel handling equipment is currently being installed with the intent of commencing fuel removal during FY2026.

- Test operation (once-through tests*) has been under way since December 12, 2025.

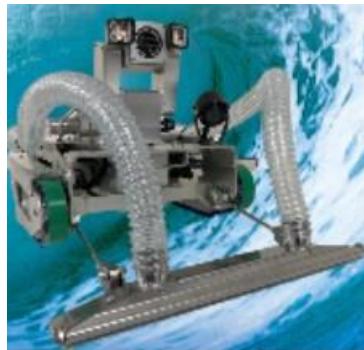
Submersible cleaning robot

<Device specifications>
Dimensions: Approx. 370×620×340 [mm]
Weight: Approx. 18kg

- On October 21, 2025, we began using submersible cleaning robots to clean the bottom of the cask pit.
- There was much fine sediment, therefore this sediment was vacuumed up to the point where it should have no impact on cask installation. The task was completed on November 5, 2025.

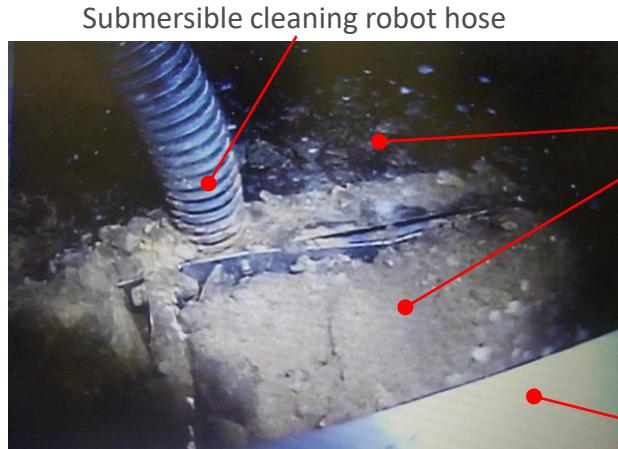
Bottom of the cask pit prior to cleaning
(Photographed on October 22, 2025)

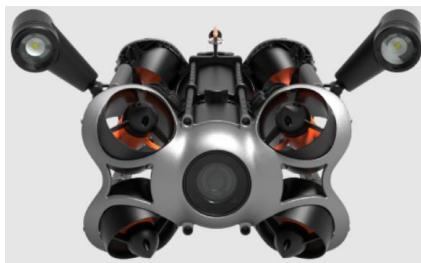
Submersible ROV

<Device specifications>
Dimensions: Approx. 610×290×200 [mm]
Weight: Approx. 8kg

- On November 10, 2025, we began using a submersible ROV to remove pieces of sheet-like debris that may hinder fuel removal. This task was completed on December 12, 2025.
- The sheet-like debris is thin, and we assume that it is the urethane coating used on handrails around the pool that has deteriorated and become thin, as well as sealant fragments from the building roof that have peeled off.
- White corrosion products originating from the aluminum material have been found deposited on the surface of the fuel storage racks as a result of the seawater injection used as coolant. Similar white deposits were also observed on the Unit 3 fuel storage rack, and this will have no impact on fuel removal operations.

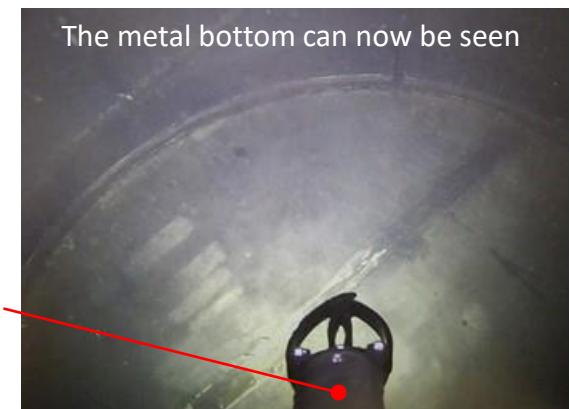
Bottom of cask pit after cleaning
(Photographed on November 5, 2025)

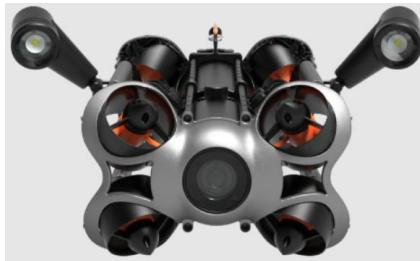
Submersible ROV

<Device specifications>

Dimensions: Approx. 610×290×200 [mm]

Weight: Approx. 8kg

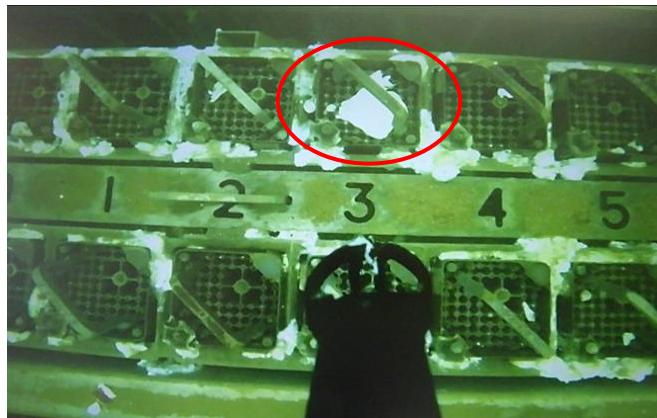
Prior to removal (Photographed on December 10, 2025)

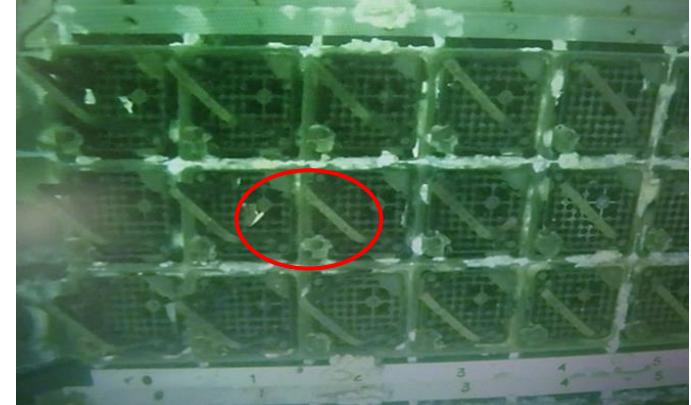
After removal (Photographed on December 12, 2025)

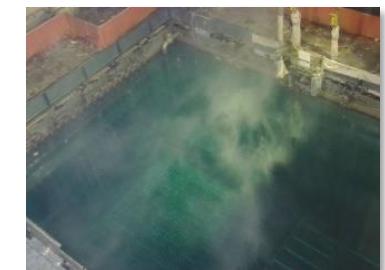
SFP conditions when steam was observed
(October 2024)

- We plan to commence the removal of fuel from Unit 2 during FY2026, and will be shutting down the SFP circulated cooling system. There is a risk that the resulting steam may impact fuel removal operation. (When the system was shut down for approximately 3½ months during FY2024, the difference in temperature between the water and the air generated steam)

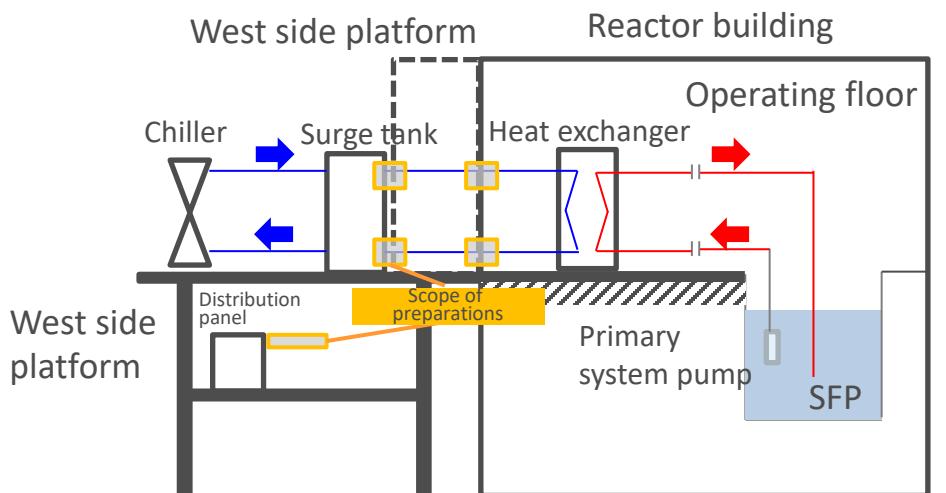
Device configuration and scope of preparations

- SFP water temperature can be lowered by directly taking water from the SFP, cooling it, and returning it to the SFP thereby preventing fog.
- The device has been purchased (currently being stored off-site) and some preparations are being made to enable it to be quickly installed if needed. These preparations will be completed before the commencement of fuel removal from spent fuel pool.
- If it is determined that this device is needed, it can be installed in approximately two months.
- Furthermore, since it will be installed on the operating floor of the reactor building, which is a high-dose environment, a mock-up is being used in an effort to shorten the installation process and reduce exposure.

- ① Boring holes in the reactor building and the west side platform wall
- ② Device installation mock-up that assumes a high-dose work area
- ③ Distribution panel installation and power cable laying
(③Power provided by temporary generator until completion)

— : Primary system line
— : Secondary system line

- Therefore, in order proceed smoothly with fuel removal, we have prepared a device for adjusting the water temperature of the SFP. The device is currently in storage and ready to use in order to prevent the generation of steam resulting from shutdown of the SFP circulated cooling system. As this device can be installed quickly, at current time only preparatory tasks are being performed.
