Fukushima Daiichi Nuclear Power Station Unit 2
RPV internal investigation using the existing reactor
water level instrument pipe

January 29, 2026

Tokyo Electric Power Company Holdings, Inc.

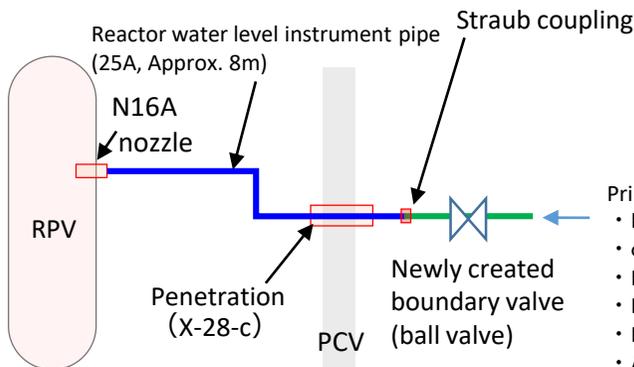
Concept diagram of RPV internal investigation

Primary specifications of the investigation device

- Fiberscope 30m
- φ5mm and φ6mm composite
- Footage acquired through laser illumination
- No pan/tilt functions
- No focus function
- Angle of view:30 degrees
- Dose rate : Approx. 2.35kGy/h(no noise)
- Cumulative dose: Approx. 1.2MGy

- The development and manufacturing of a radiation resistant fiberscope^{※1} (which has a small internal dosimeter) that can pass through obstructions inside the pipe and access the inside of the RPV has been completed.

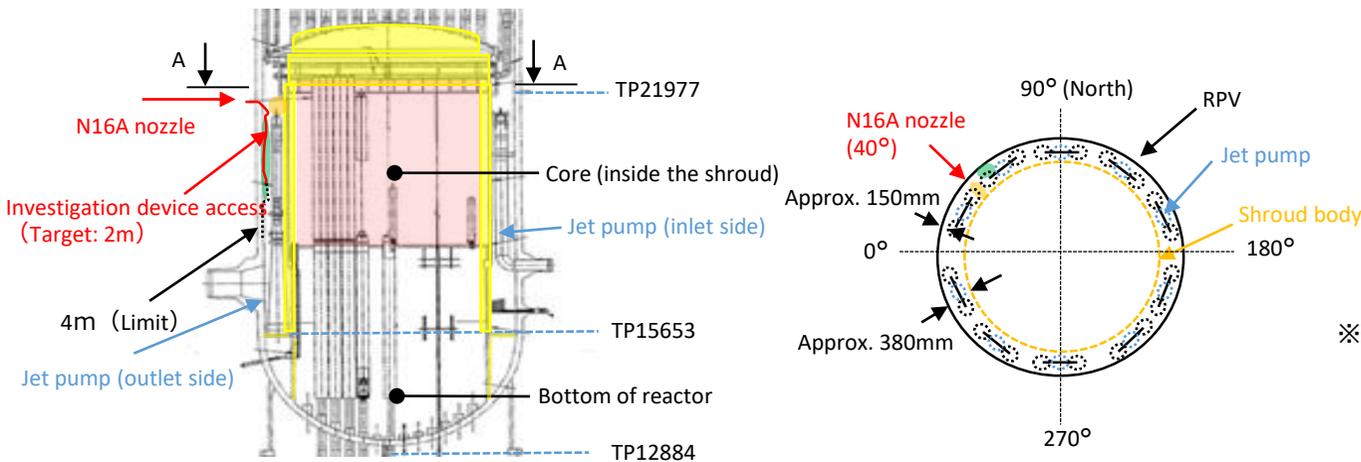
Investigation device access route and scope of visual confirmation (estimated)

- The plan is to check the conditions inside the reactor near N16A nozzle and lower the fiberscope to the bottom of the reactor as far as possible.

- : Scope of visual confirmation (if the tip of the investigation device reaches the vicinity of the N16A nozzle)
- : Scope of visual confirmation (if the tip of the investigation device reaches a point 2 meters below the N16A nozzle)
- : Shroud body (including supports)
- : Core

- ※ Footage confirming the visibility of the investigation device: After the tip of the investigation device reaches the inside of the RPV it will be vertical around the vicinity of the N16A nozzle, but because bends will develop in the fiberscope as it maneuvers around obstructions inside the pipe, at the point two meters below the N16A nozzle, it may bend to face north of the nozzle.

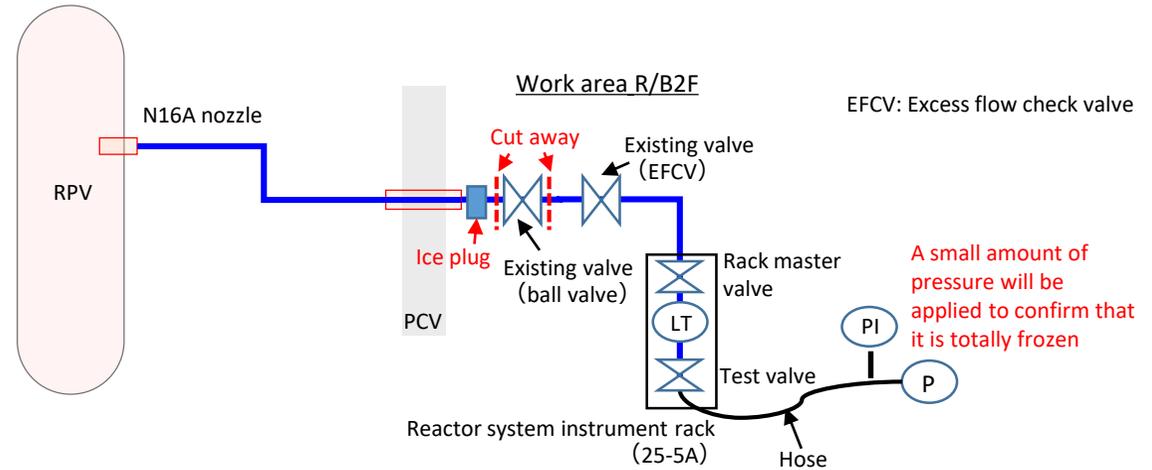
Concept diagram of pipe freezing (X-28-c)

① Freezing and pipe cutting

- The pipe will be flooded with filtered water. A freezing jig will be used to completely freeze the pipe after which the existing valve will be cut out with a pipe cutter.
- The inside surface of the pipe shall be examined to ensure that there are no adhesions that may impact the investigation.

Refrigerant (dry ice + alcohol) replace regularly

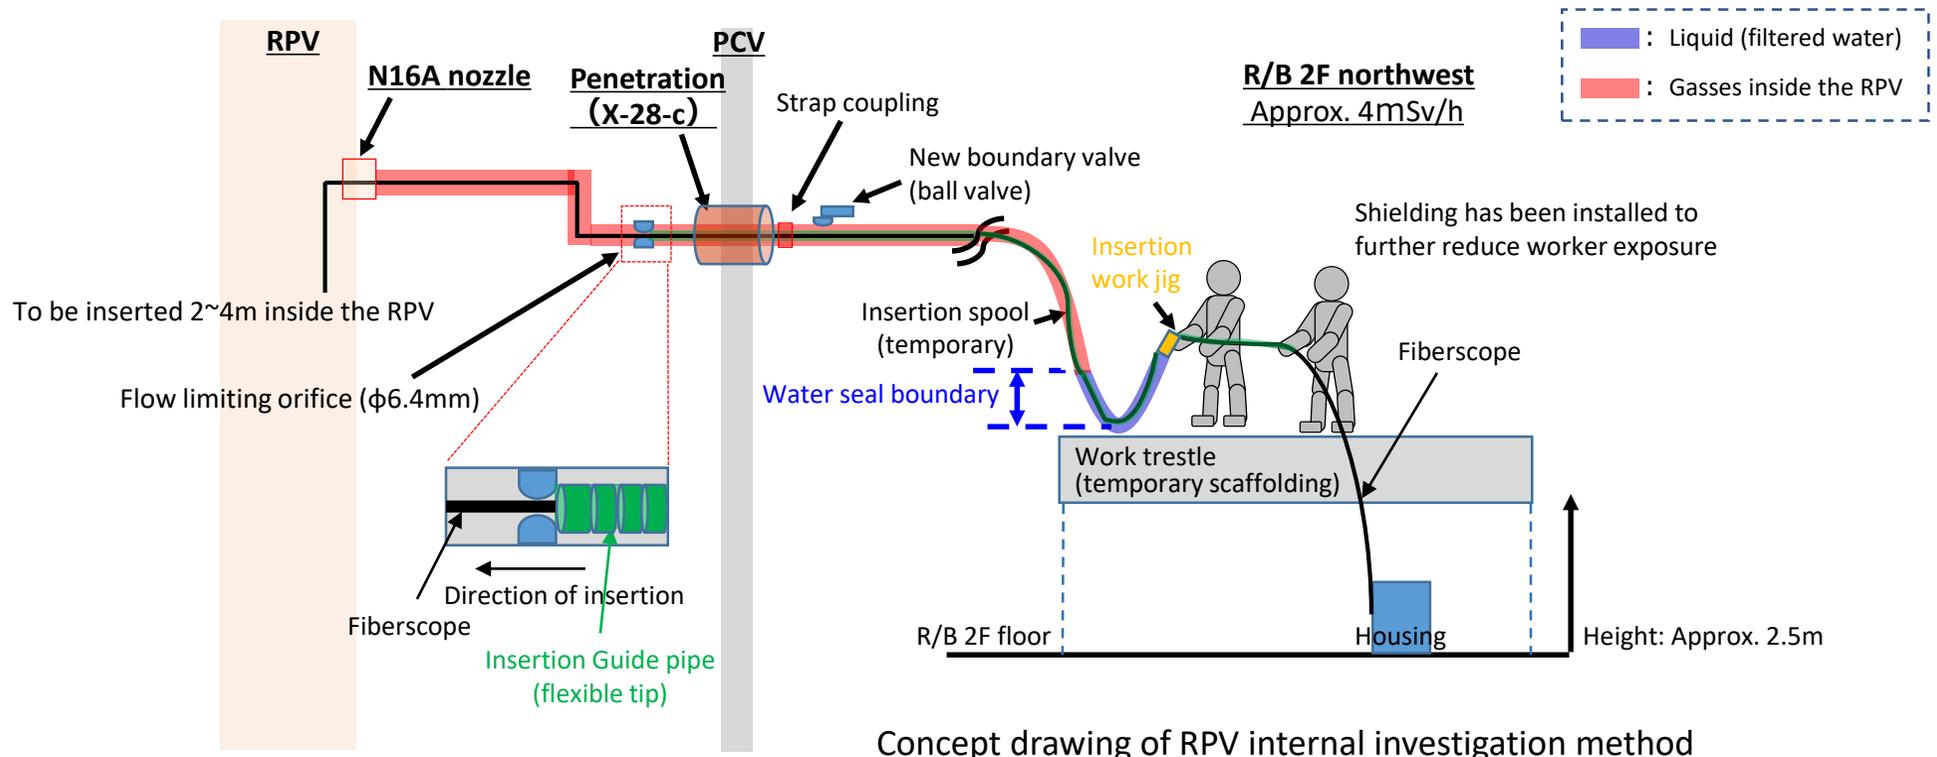
- While the investigation is underway, a water seal boundary will be maintained and the pressure of the PCV will be reduced in order to prevent gasses inside the RPV from leaking into the work area.

- From the top of the work trestle, an insertion work jig, which is a tool for assisting insertion of the investigation device, will be used to manually insert the insertion guide pipe (flexible tip, coil spring) and investigation device simultaneously. (After passing through the flow limiting orifice, only the fiberscope will continue to be inserted)

- After reaching the inside of the RPV the investigation device will be used to touch reactor internal structures and there is a high possibility that it will be subject to $\alpha\beta$ contamination, so in order to ensure worker safety, whether the device can be recovered or not will be decided at each step of the way as the device is withdrawn into the investigation device recovery unit.

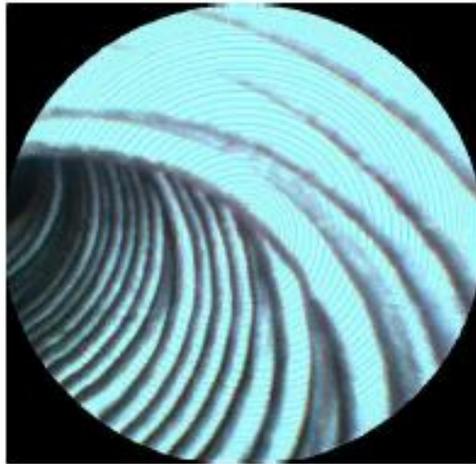
① After passing through the insertion spool, we have confirmed that footage can be obtained without being impacted by the water seal.

Right in front of the orifice (inside the guide pipe)

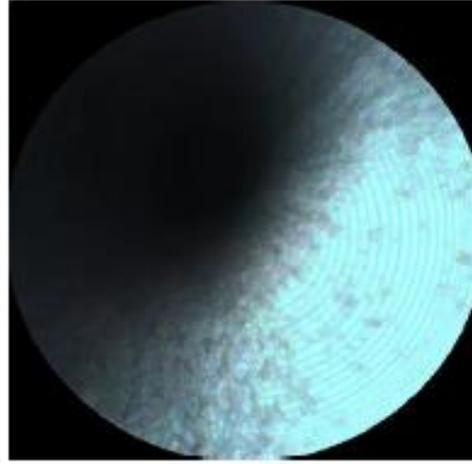
After passing through the orifice (inside the pipe)

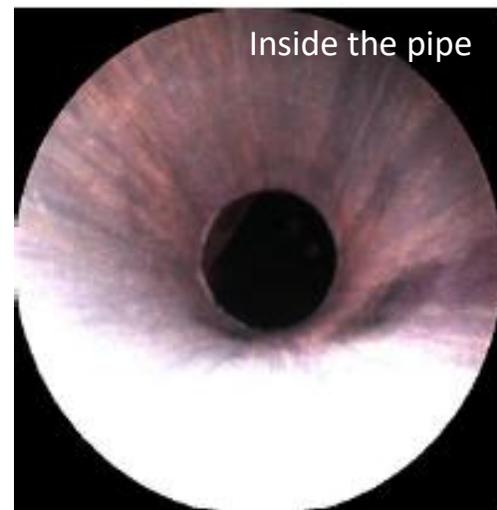
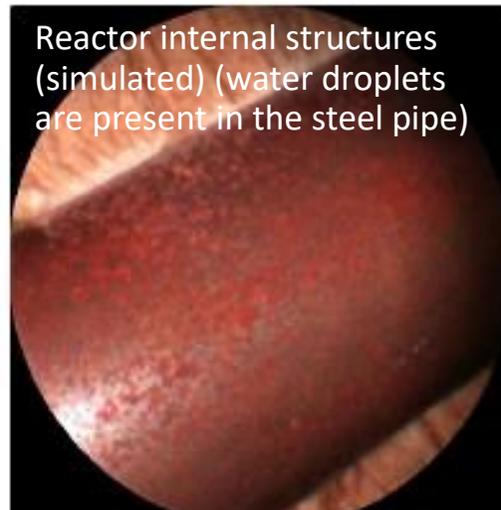
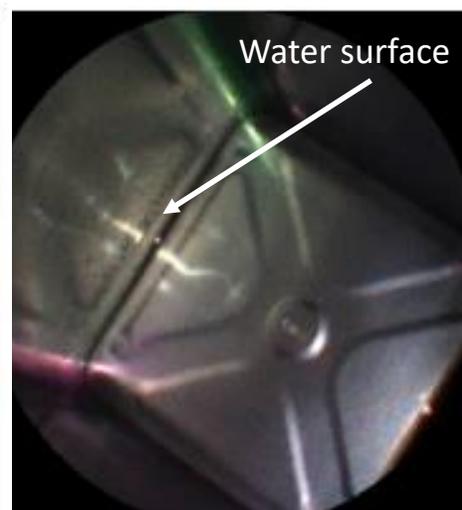
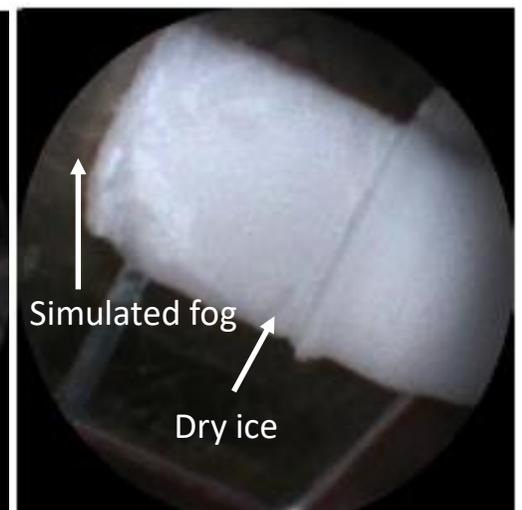
② We have confirmed that footage of reactor internal structures (simulated) can be obtained in the dark, foggy environment.

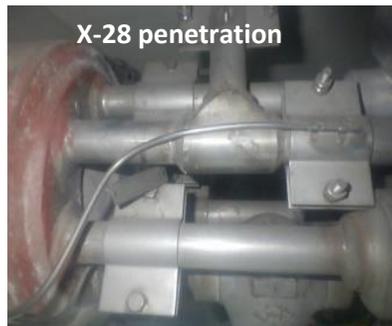
X-28 penetration

- Blue line: Pipe cleaning location
- Green line: Nitrogen injection location (no work)
- Red line: Sampling/pipe head pressure confirmation location
- Yellow line: Sampling location
- Black line: No work

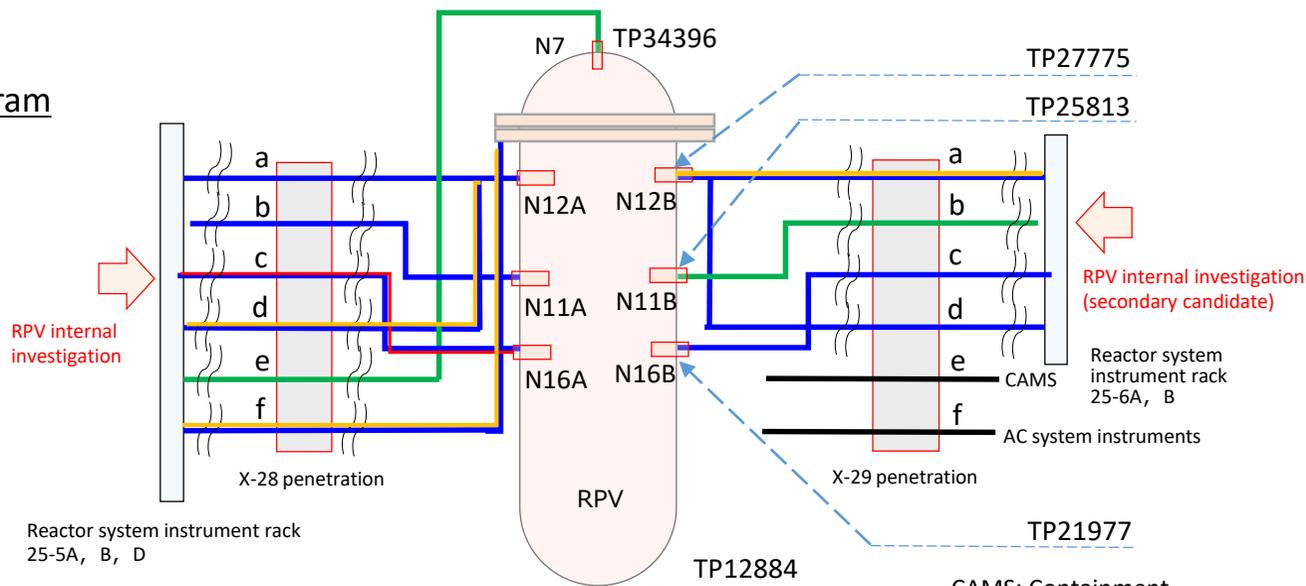
Detailed schematic of penetration and nozzle positions

CAMS: Containment atmospheric monitoring system
AC: Activated carbon system
